SUCCESS STORIES

Ultrasound Solutions

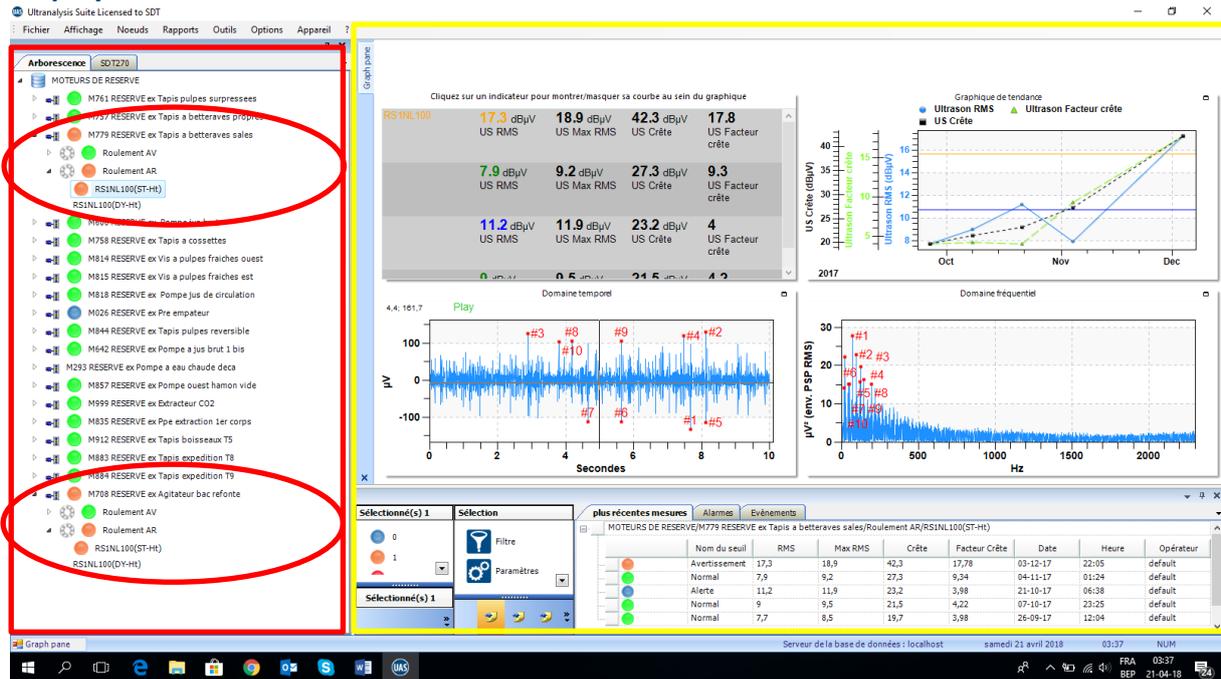
Display of the database in the UAS software

□ Display of the asset hierarchy including all rotating machines under monitoring and alarm statuses for each piece of equipment. In the present case, 19 rotating machines are monitored, 2 of which have exceeded the warning threshold for the bearings of the rear motor.

□ Display of the software graphic tools (matrix, trend curves, time signal, FFT spectrum, measurement time history).

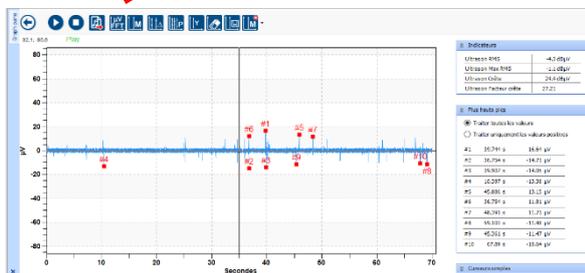
Measurement carried out on October 16, 2018

On the time spectra (same scale), we can observe the occurrence of shocks compared to the first measurement carried out in 2018. The trend curves show the evolution of the RMS static value: from **-4.3 dBµV in 2018 to +16.8 dBµV in 2019**.

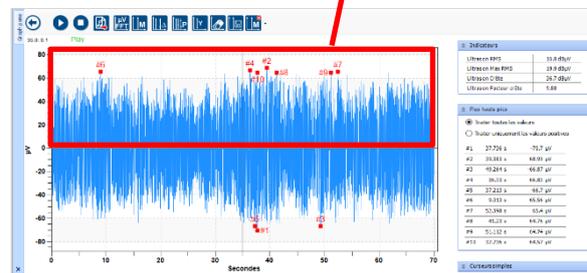
Measurement carried out on September 20, 2019

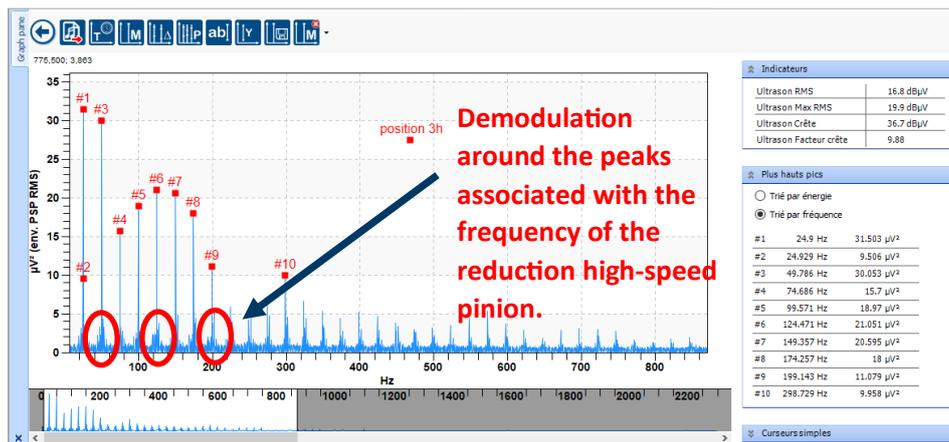
Listening to the bearing and analyzing the frequency spectra (see chart below) has allowed to confirm this diagnosis by observing the emergence of significant peaks associated with this gear damage.

We can observe repeated shocks associated with the frequency of the high-speed input drive pinion of the reduction gear (24.93 Hz and its harmonics) with demodulation at each peak. Broken tooth and teeth clearance. Replacement of the reduction gear during a scheduled production shutdown, which

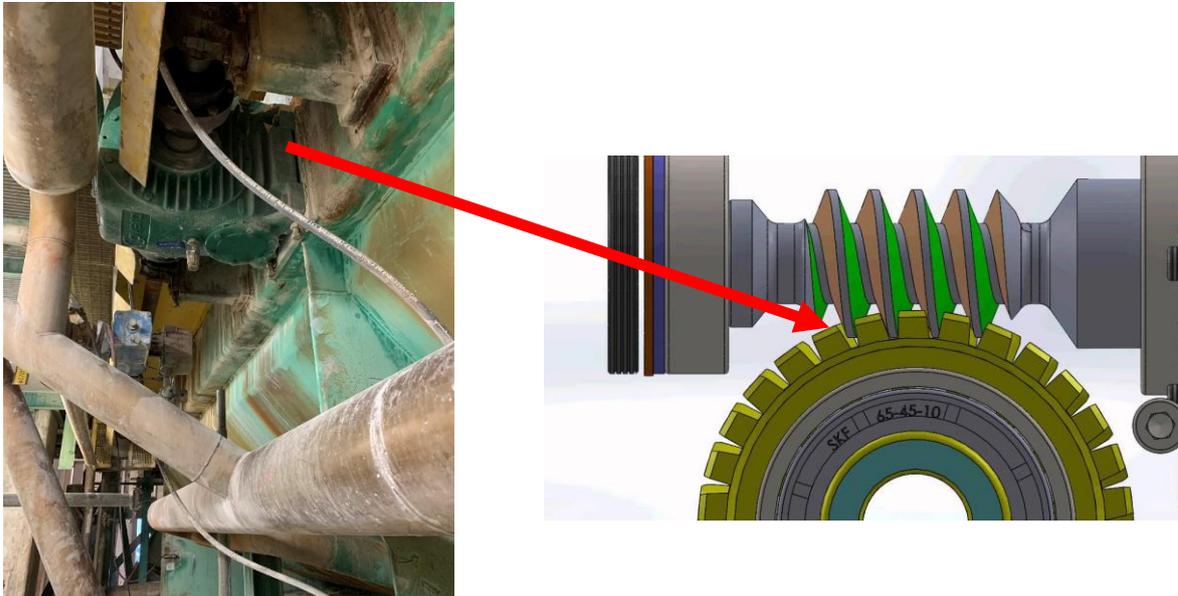
We can observe that between each revolution of the worm screw, there is a phenomenon occurring, which can be heard through the ultrasound detector as a sliding of the gear (worm screw/bronze wheel).

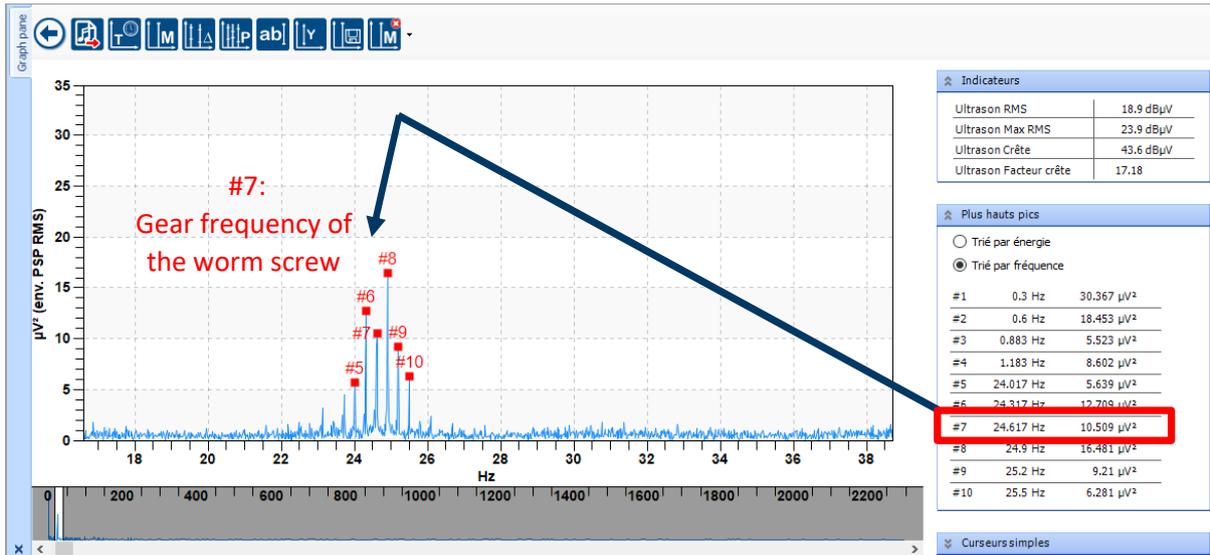
Zooming in on the envelope spectrum highlights the dissymmetry of the modulation around the meshing frequency, which is characteristic of a damaged gear mesh.

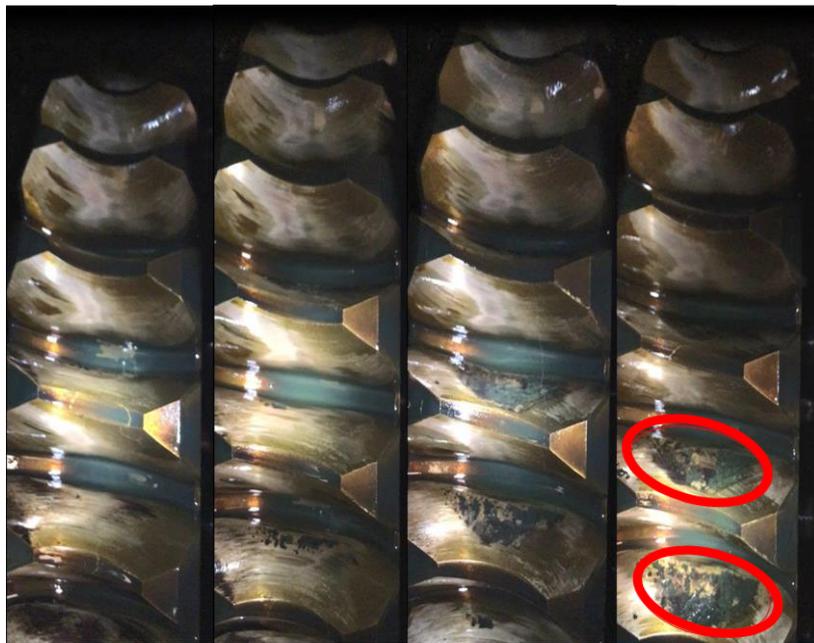
The endoscopic video inspection of the worm screw of the reduction gear confirmed the ultrasound diagnosis.

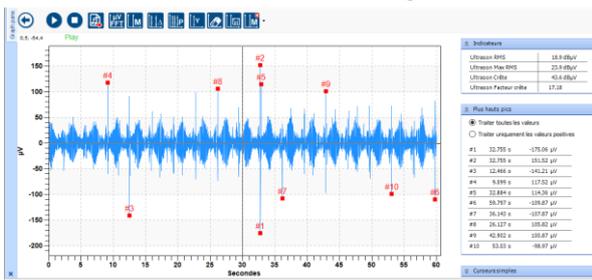
Measurement carried out on July 10, 2018

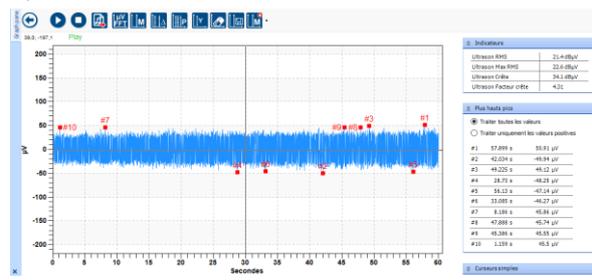
Measurement carried out on October 29, 2019
After replacement of the reduction gear

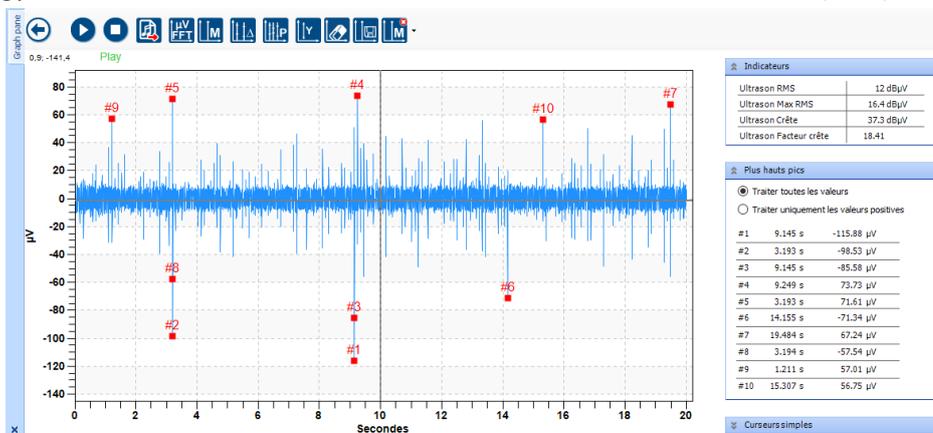
From the beginning of the monitoring of this reduction gear (August 2018) using ultrasound technology, the occurrence of shocks can be observed on the time waveform (TWF).

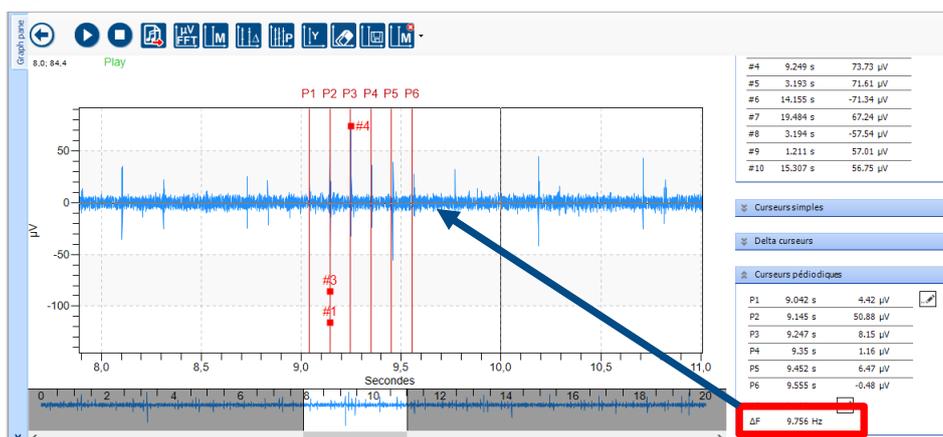
Below we focused on 3 seconds of the measurement, and we apply a periodic cursor to identify peak recurrences.

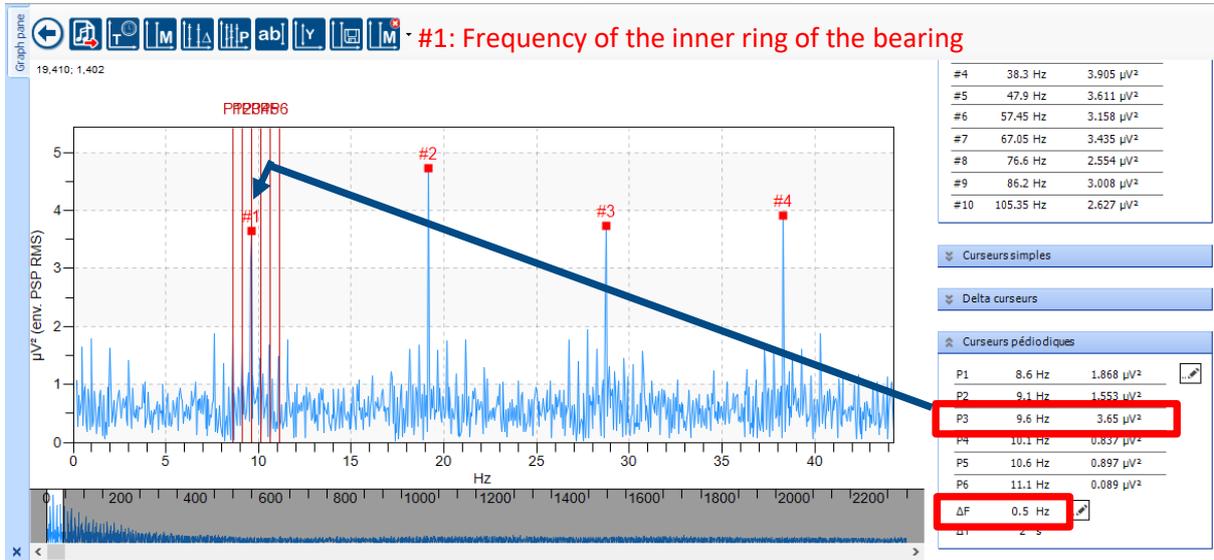
By looking at the envelope spectrum, one can observe repeated shocks at **9.756 Hz** (see the table of characteristic frequencies below) related to the frequency of the inner ring of the bearing of the low-speed reduction gear (opposite side of transmission).

The amplitude of the scaling-type defect is modulated at the fundamental frequency of the rotation speed.

On the spectrum, this is evidenced by a peak at P3 (#1) corresponding to the bearing defect modulated at ΔF as confirmed on the harmonics: #2, #3, #4.

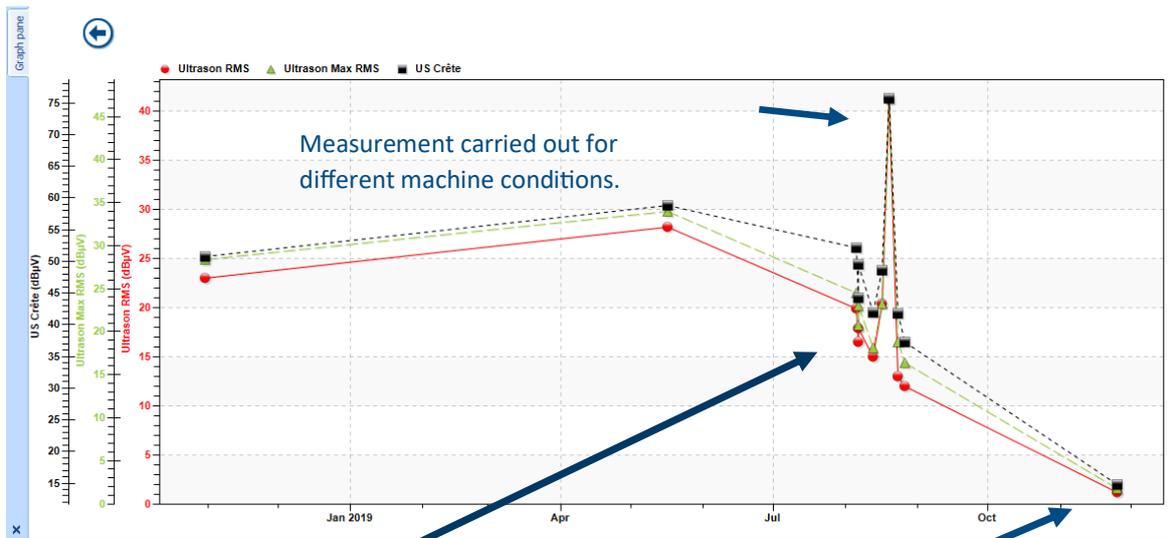
The trend curves show the decrease of the RMS value in red on the graph above, also confirmed by the other indicators, **from +12 dB μV in 08/2019 to +1.2 dB μV in 11/2019.**

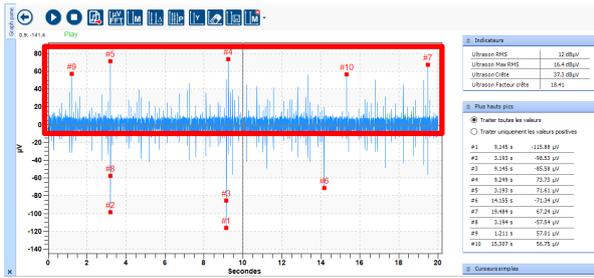
Measurement carried out on August 26, 2019

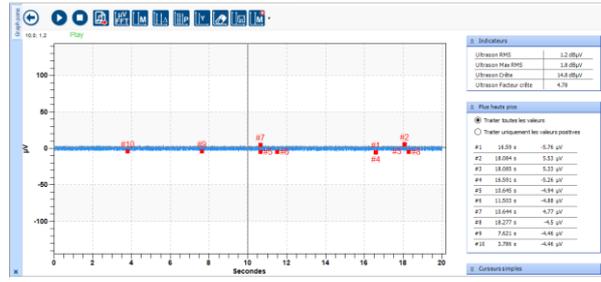
Measurement carried out on November 25, 2019
After replacement of the reduction gear

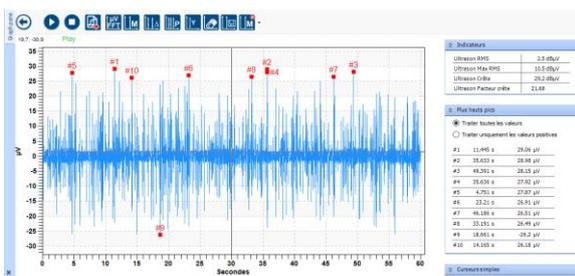
Measurement carried out on October 16, 2018

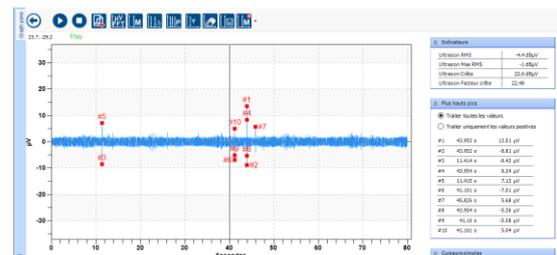
Measurement carried out on January 07, 2019

On the trend, one can observe the occurrence of high value in the RMS right from the beginning of the monitoring of this bearing. After replacement of the bearing, all shocks disappeared. The rolling elements were no longer held in their housings.

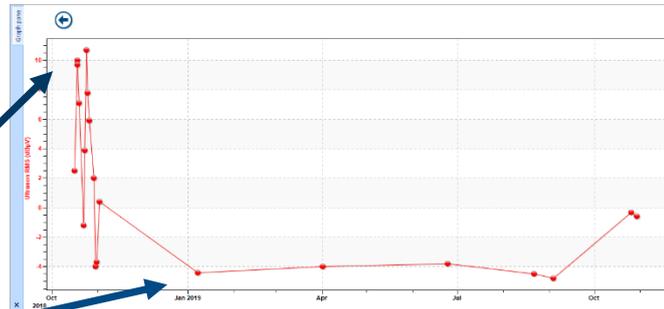
The trend curve shows the decrease of the RMS value after servicing (**from +10.7 dBµV in October 2018 to -4.4 dBµV in January 2019**).

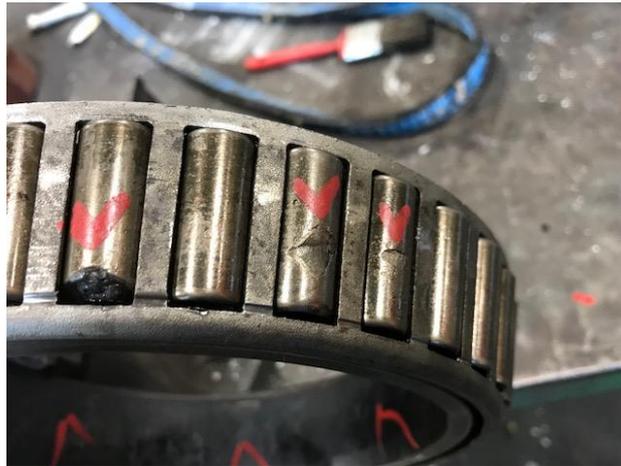
Rolling elements

Images of bad bearing – no secondary damage occurred:

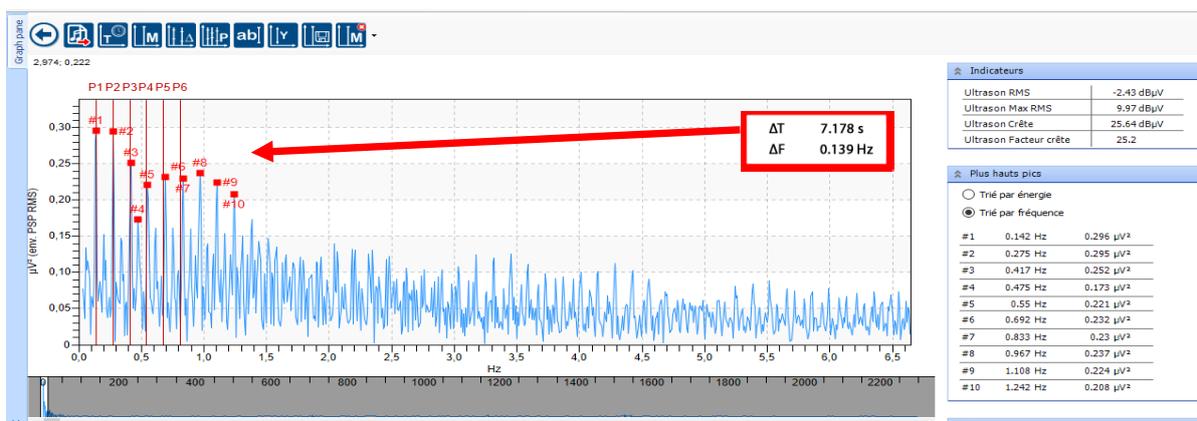
The spectrum shows an impact at the rotation speed (0.13 Hz) of the shafts of the rotating machine, along with its harmonics. Sub-harmonic frequencies can also be observed at 0.5 x the rotation speed, which is a characteristic spectrum for a rotational clearance due to friction or significant impacts. No impact due to bearing frequencies are observed. Our diagnosis is confirmed by the time waveform.

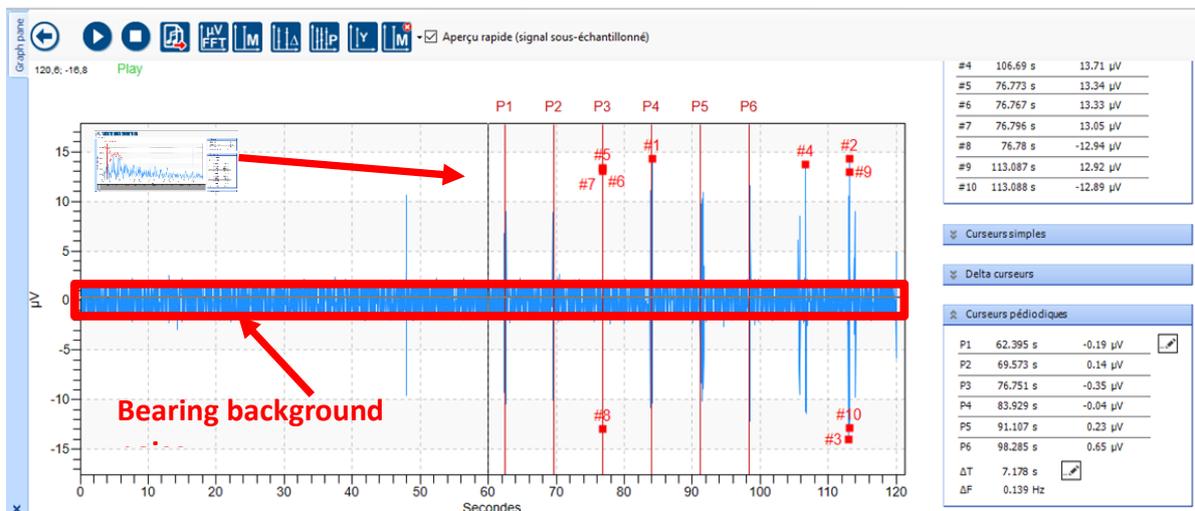
The graph shows that the observed impacts are indeed associated with the rotation speed of the shafts of the machine at 0.13 Hz, i.e., a rotation speed of 8 RPM.

In terms of energy, these impacts are not necessarily constant for each shaft revolution (time signal recorded over a period of 2 minutes) and can be clipped if the gain is not suitable.

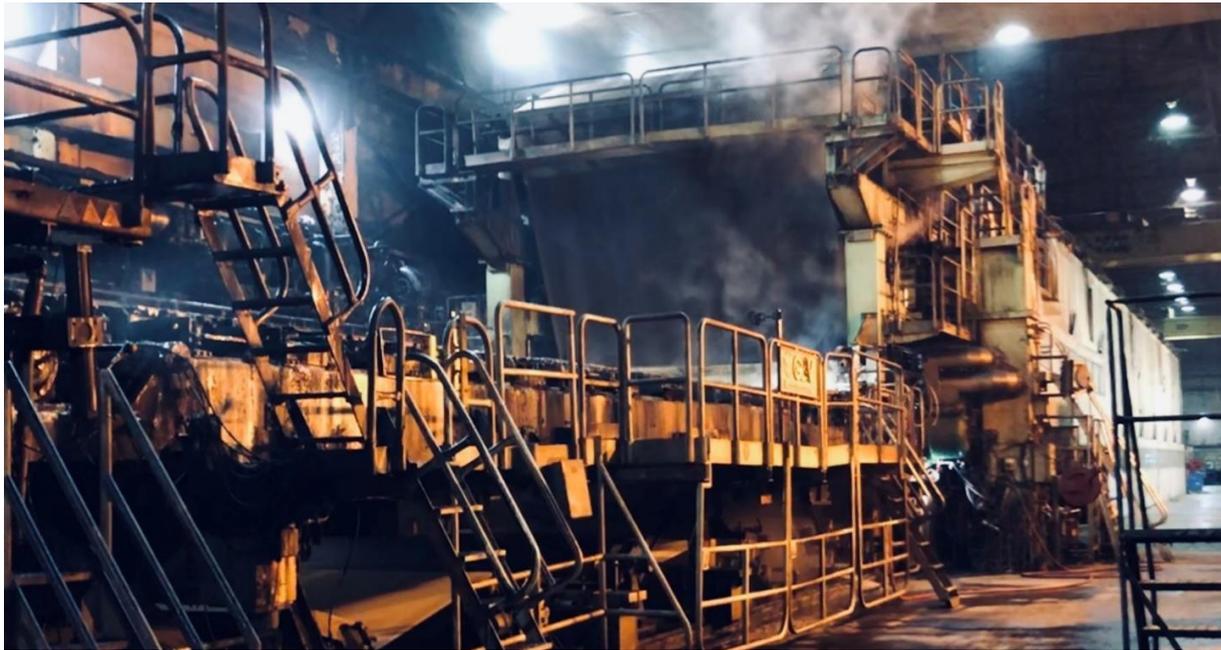
Dryer section felt rolls – previously greased on a time-based schedule delivering 40 grams of grease every 4 weeks before the ultrasound program was implemented.

Ultrasonic greasing program started; first dryer felt roll greased from an RMS of 14.1 dBµV down to 12.2 dBµV after delivering only 20 grams of grease.

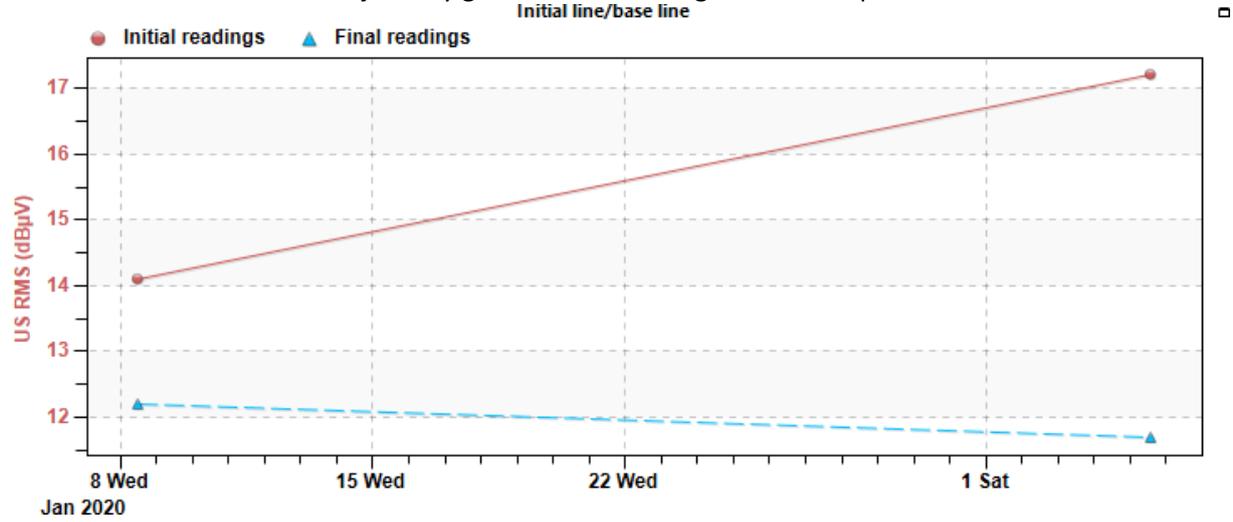
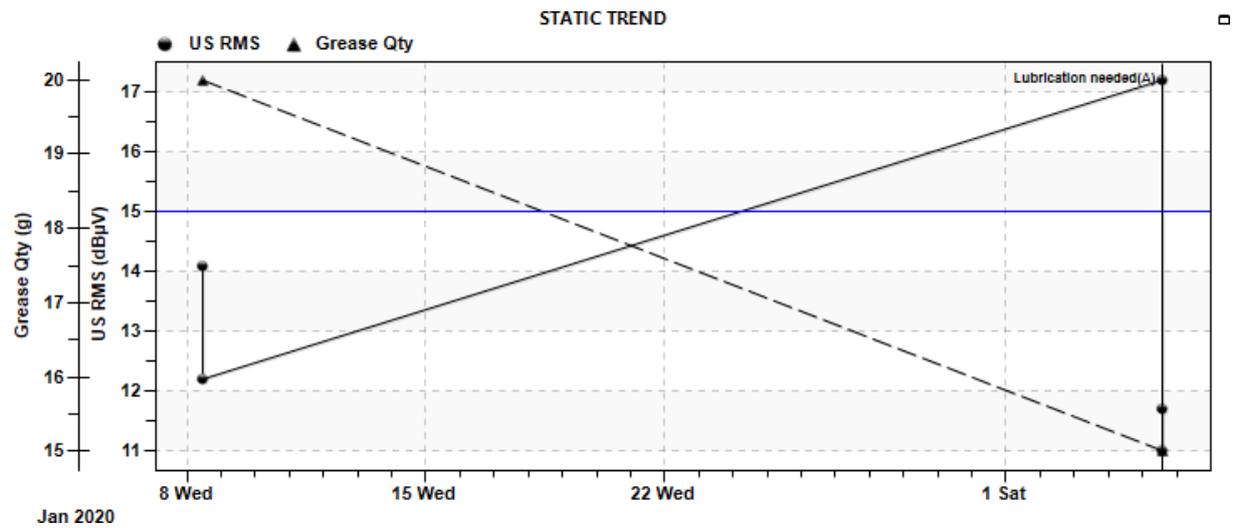
An absolute alarm at 15 dB μ V was added to indicate whether the bearing needs lubrication (over and the LUBExpert will prompt for greasing, under it will return a message of "lubrication not needed").

This eliminates the need to inject any grease if the bearing does not require it.

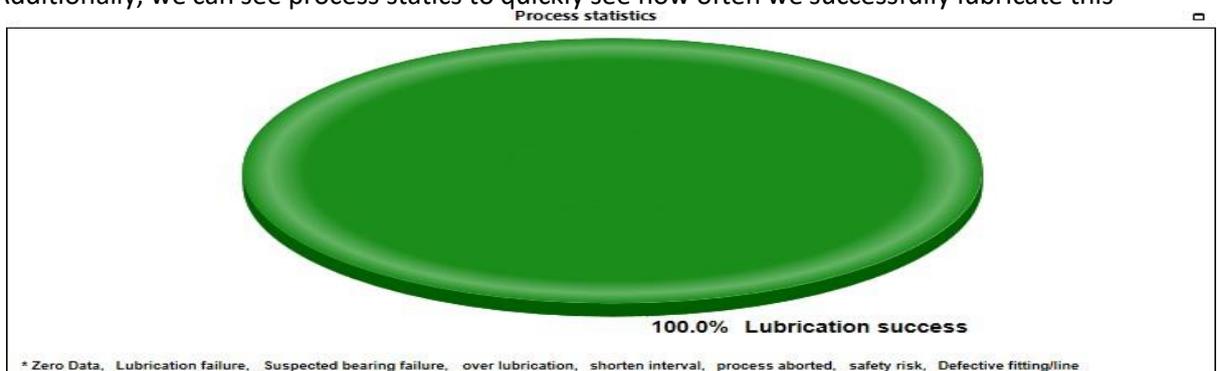
Additionally, we can see process statics to quickly see how often we successfully lubricate this

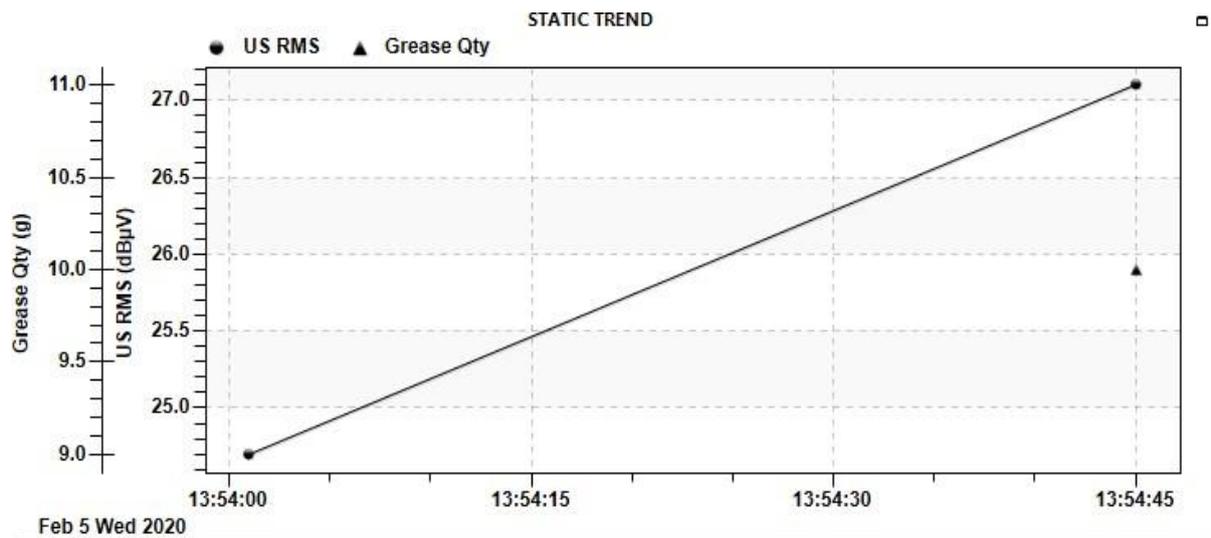
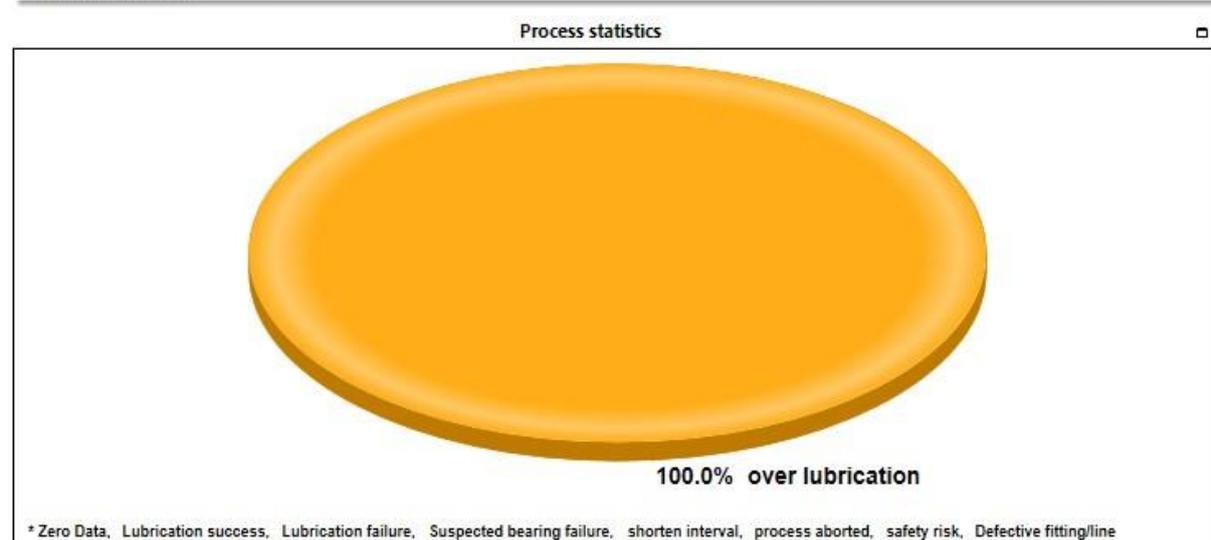
lubrication status on the LUBExpert.

However, keeping in mind that we were previously delivering 40 grams to this bearing, we have effectively prevented an additional 30 grams of unnecessary grease being injected into this bearing which would have increased friction levels, heat, and wear even further.

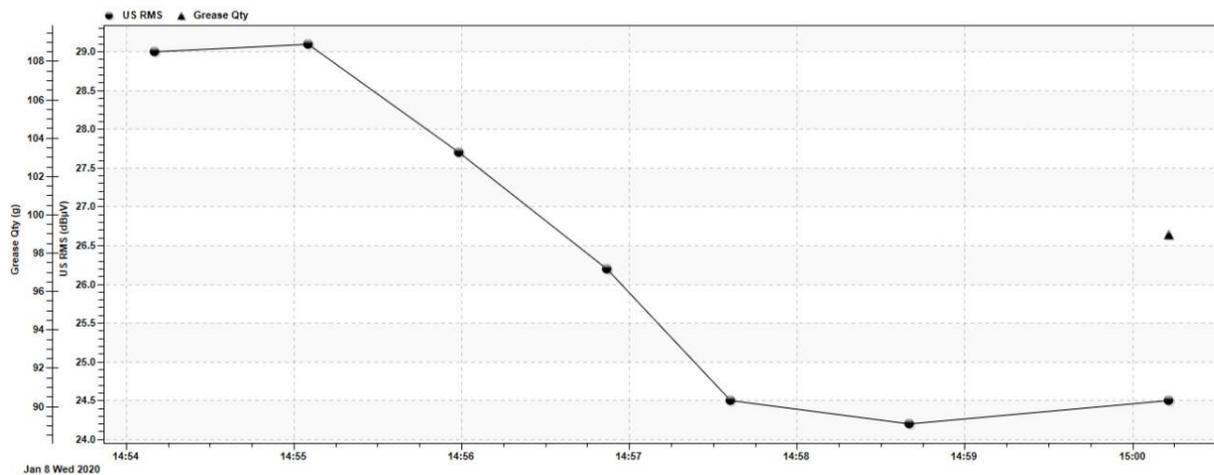
The Ultranalysis® Suite 3 trend shows us that we have successfully greased the bearing to the optimum level as expected.

This initial check prevented what could have been another catastrophic failure during production, increasing reliability on this roll and ensuring proper lubrication, reduced friction, and wear on this bearing.

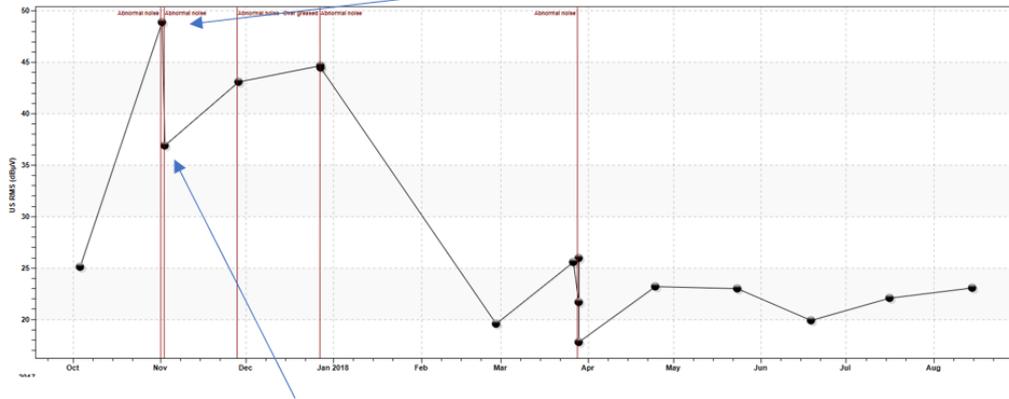
Ultrasound Trend - high RMS ultrasound values in early November

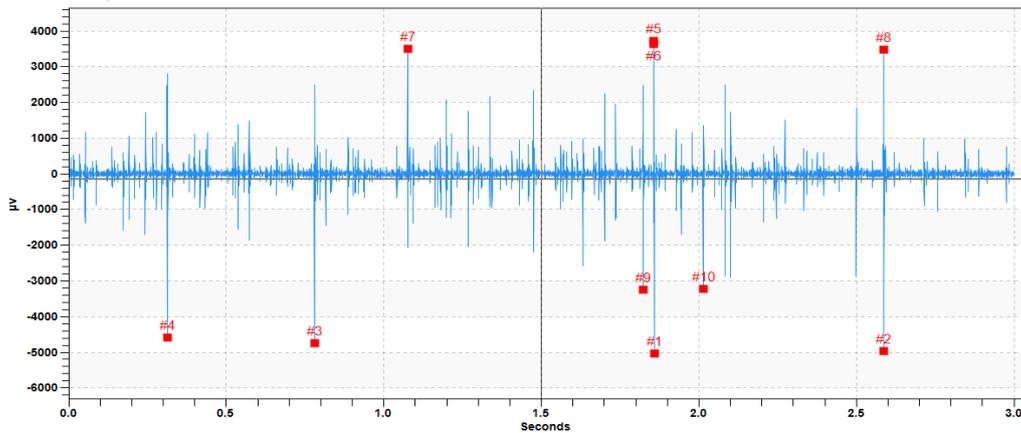
November 1st ultrasound reading:

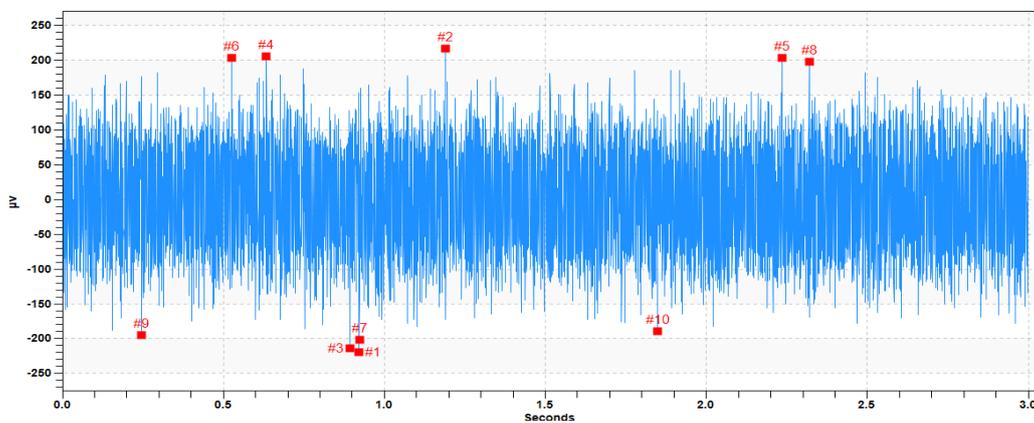
Ultrasound reading after greasing on November 2nd:

Ultrasound levels decrease as predicted.

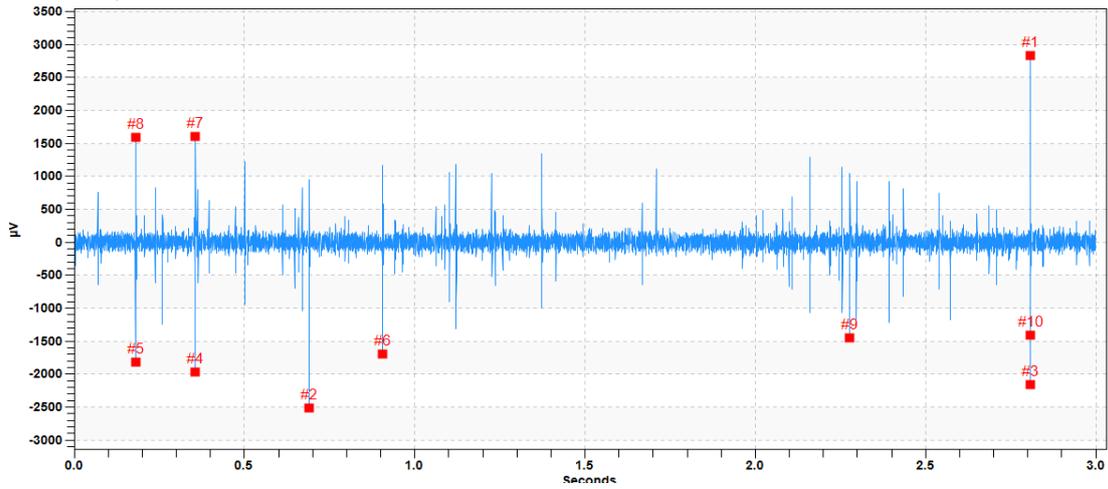
Ultrasound reading on November 28th (still containing high peaks as November 2nd):

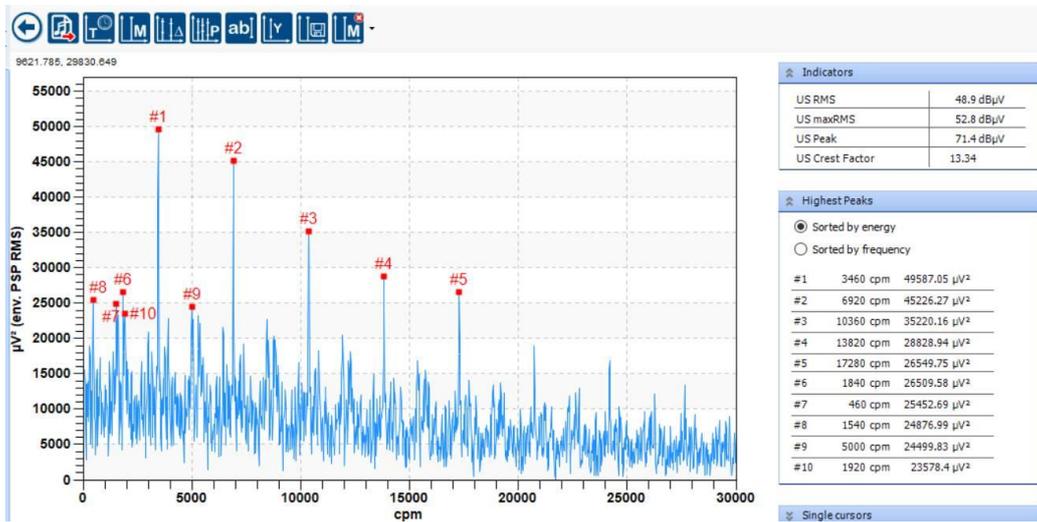
Levels rise back up. Bearing defect is very clear:

Defect clearly visible. The bearing is finished.

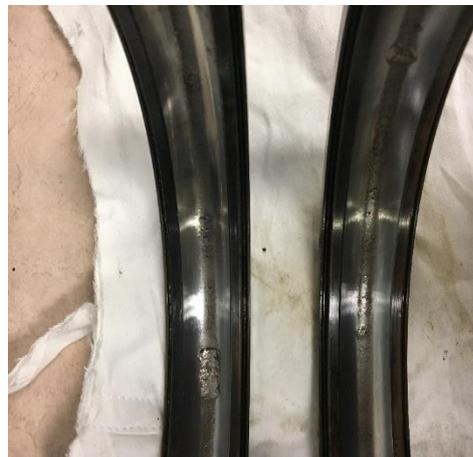
Outer race damage:

Figure 3 Outer race damage (BPFO)

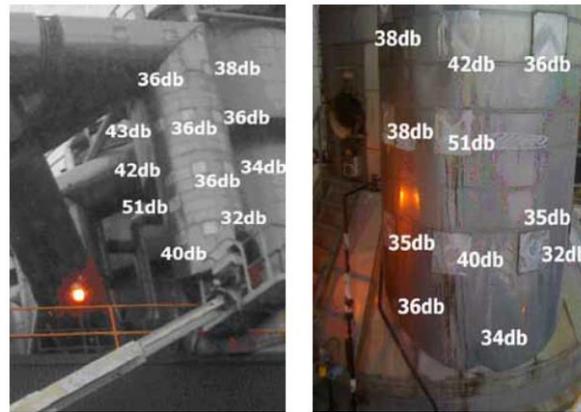
Diagram shows dB levels mapped out using SDT RS1 Contact Probe. Vacuum leaks detected through 4" insulation and outer sheet steel. Loudest areas were cut away and patched with Gor-Tex™ patches.

The black liquor evaporator uses a 7-effect counter flow method to concentrate the mixture. Using the OSI PI monitoring software, Mr. Frei stated their evaluation set the most likely location to be in the 4th effect stack. The pictures here show the map of decibel levels after we conducted the survey. The decibel levels taken on the inside area of the stack dropped as we moved away from the high of 51 dB, down to 38 dB.

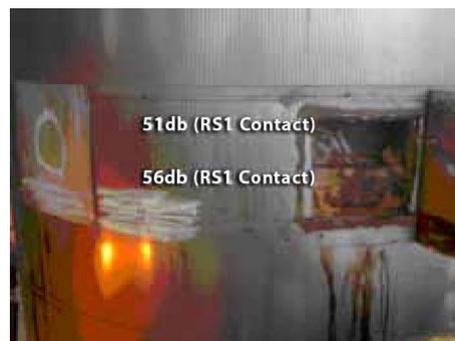
Wall thinning correlated to high dB values.

As the additional pictures below will show, there was a strong correlation between the locations of the leaks and the thinning of the wall of the stack. At the location of the highest ultrasound, 51 dB, the wall was found to be 0.091" thin. The thinnest area found on our initial survey.

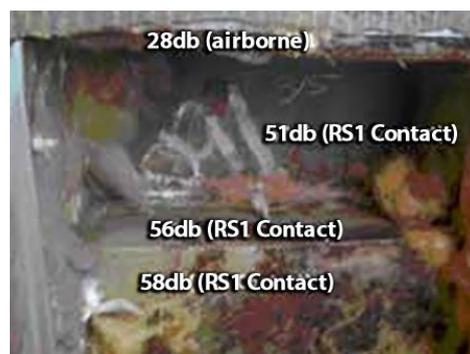
When I brought the airborne sensor near the 51 dB access door, the airborne sensor jumped to 32 dB – 33 dB and gave the telltale whooshing sound of rapidly moving air. When I used my hand to separate some of the insulation away from the metal flange, the airborne sensor levels rose to 38 dB.

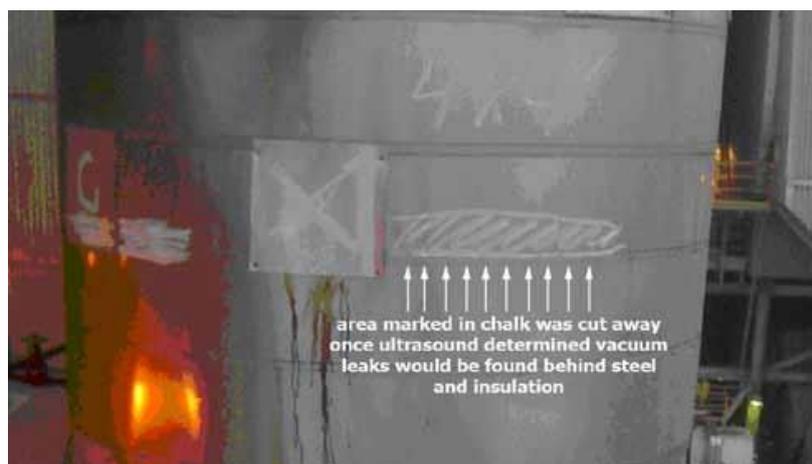
Opening the access door allowed further pinpointing with RS1 ultrasound probe along the underside of the metal flange area.

The exact number of holes was too numerous to count. Also, many of the holes had blended together from the corrosion.

As soon as Mr. Rose removed the sheet steel we could see where the insulation had collapsed around the vacuum pull of the stack. As the insulation peeled away, the holes were immediately visible. We placed two rubber sheets over the large holes to prevent the loss of vacuum. The sheet on the left covered the largest area of corrosion, about 8" wide. The 2nd major area of damage was about 1½" wide.

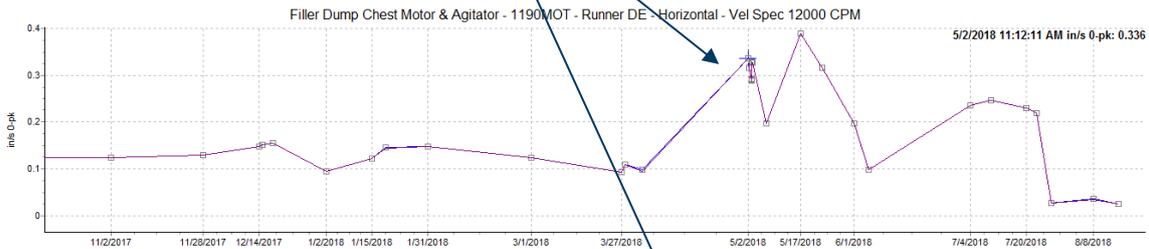
During Ultrasound & Vibration data collection at the beginning of May increased Vibration levels could be seen as well as increased RMS (friction levels) in Ultrasound. The Ultrasound could also hear impacting coming from the bearing.

Vibration

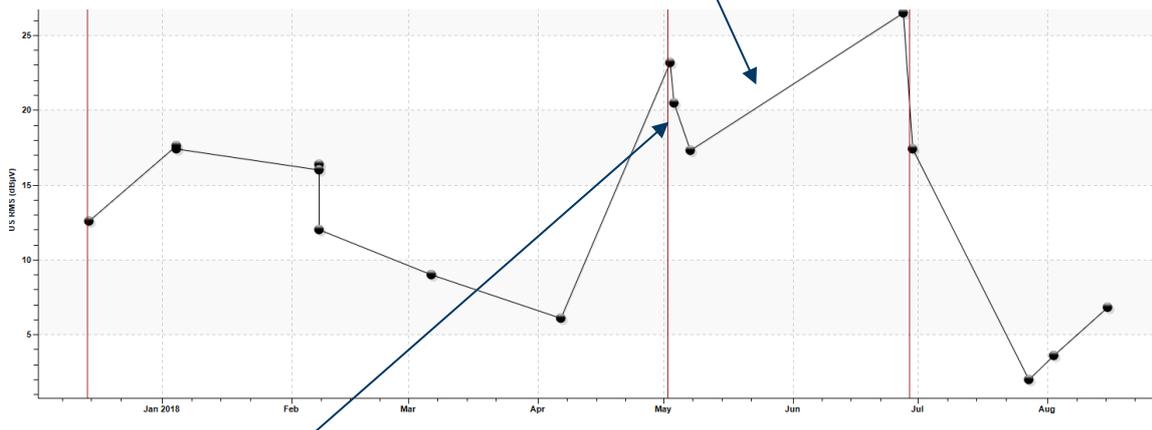
Ultrasound

Greasing the bearing on May 3rd reduced the friction as seen by the drop in RMS over a few days and masked the impacting, but the impacting returned as seen by the Crest factor going back up to 11.88 by the May 7th. This is indicative of the bearing having a defect.

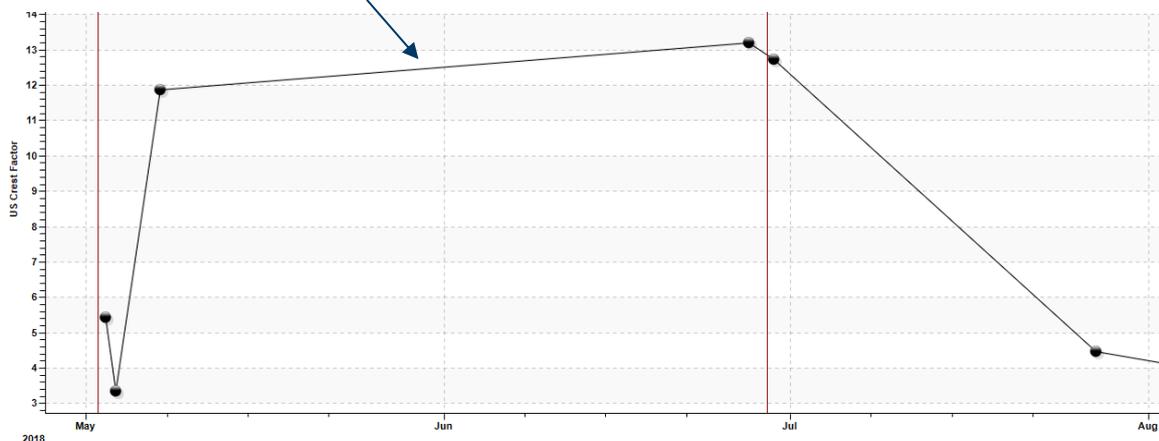
May 2nd – First Indication of increased friction & Impacting in Ultrasound.

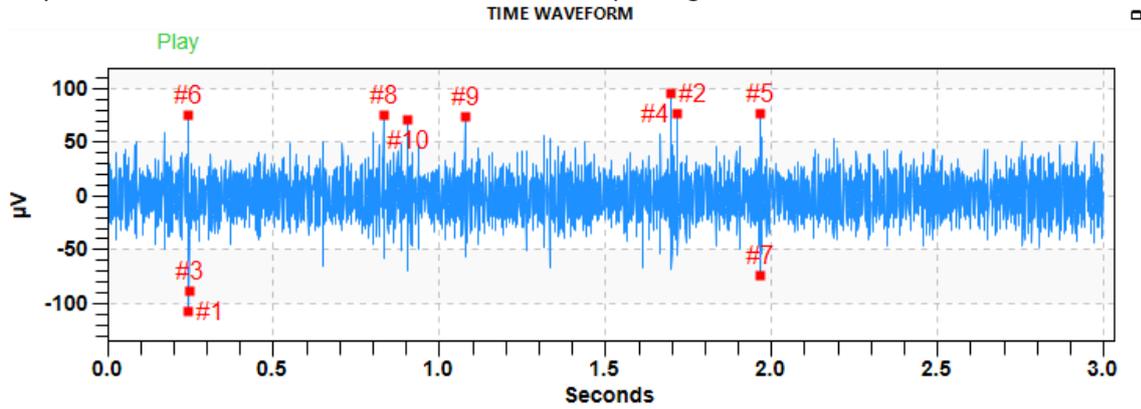
May 3rd – Greased Bearing. Reduced Friction.

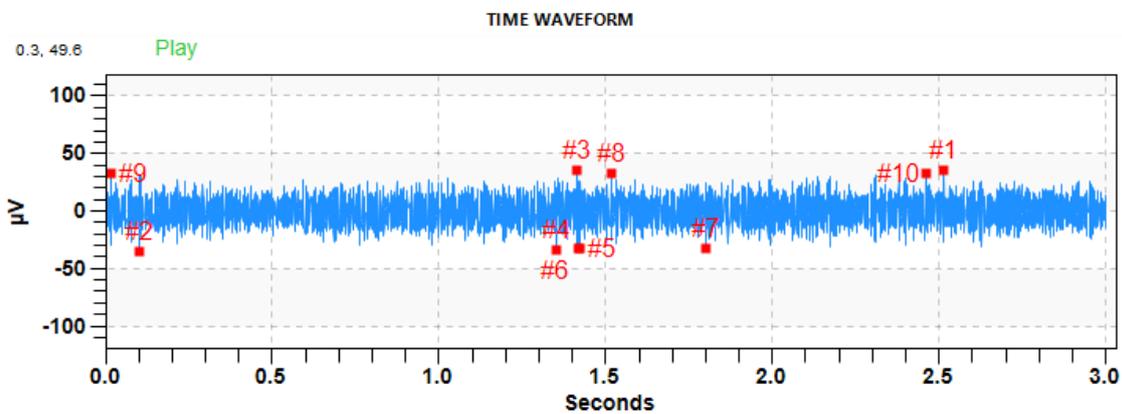
May 7th – Impacting back four days after greasing. Bearing has a defect.

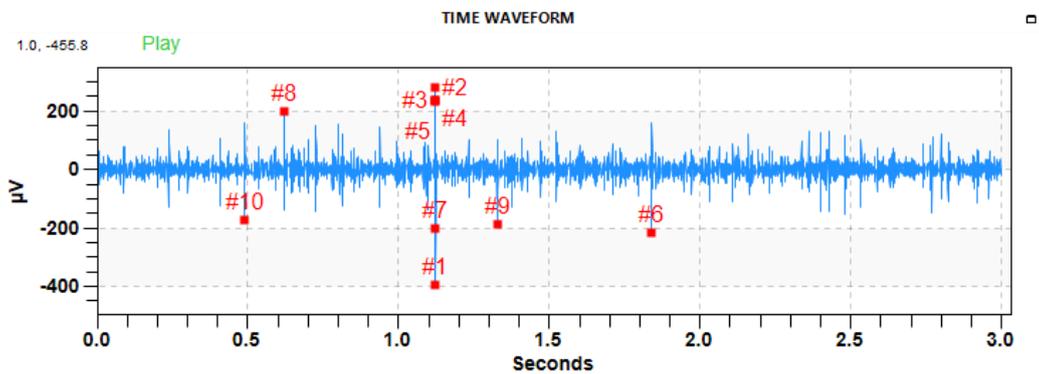
June 27th – Bearing being monitored and greased regularly but by end of June Impacting significantly worse. Scheduled for swap at next shutdown on July 24th.

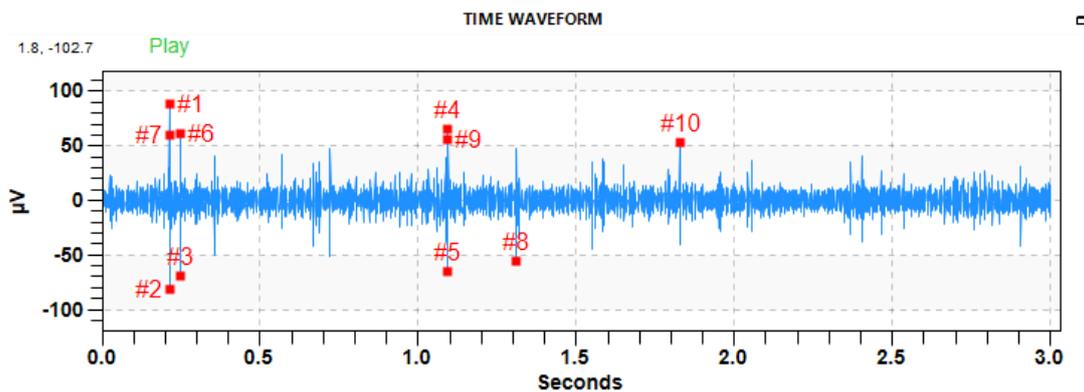
July 27th – New Ultrasound reading after bearing replaced.

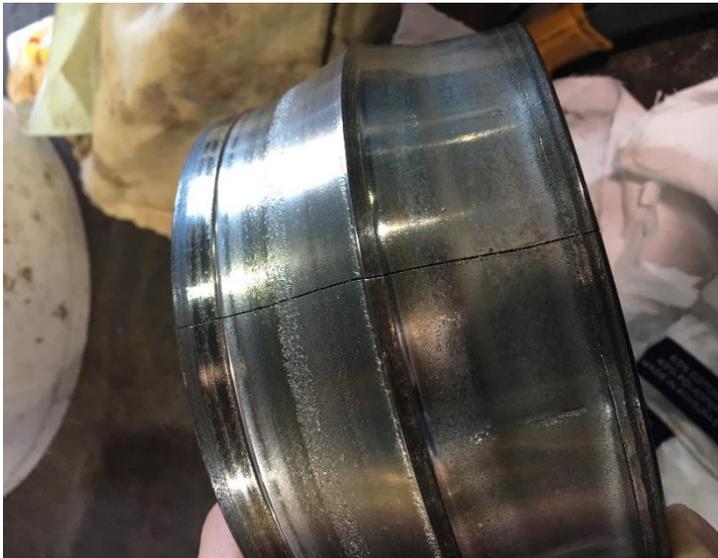
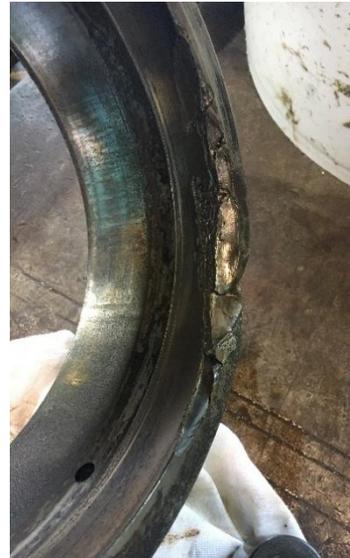
Pictures of the DE Agitator Bearing after it was removed on July 24th shutdown:

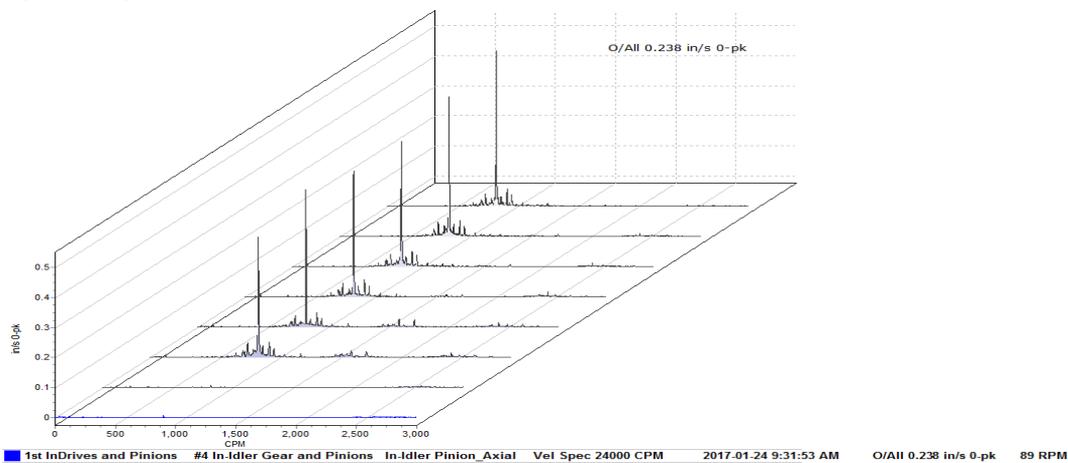
This report will cover the findings on Motor & Gearbox. This vibration was not present until this motor was changed. The motor gearbox is now vibrating excessively in the axial direction across the whole machine train when it is under a load. Usually in vibration analysis, most frequencies can be the in-drive position 4 and 6 where the 900 CPM frequency is not significant in amplitude. Related to the rotating speed of the malfunctioning component unless it is a natural frequency problem. The frequency of interest is 900 CPM, which is not related to the rotational speed of the machine. The waterfall below illustrates the high vibration in the axial direction across the machine. The First two readings belong to the In-Drive. This eliminates the In-Drive as the source of the vibration.
