SUCCESS STORIES

Ultrasound Solutions

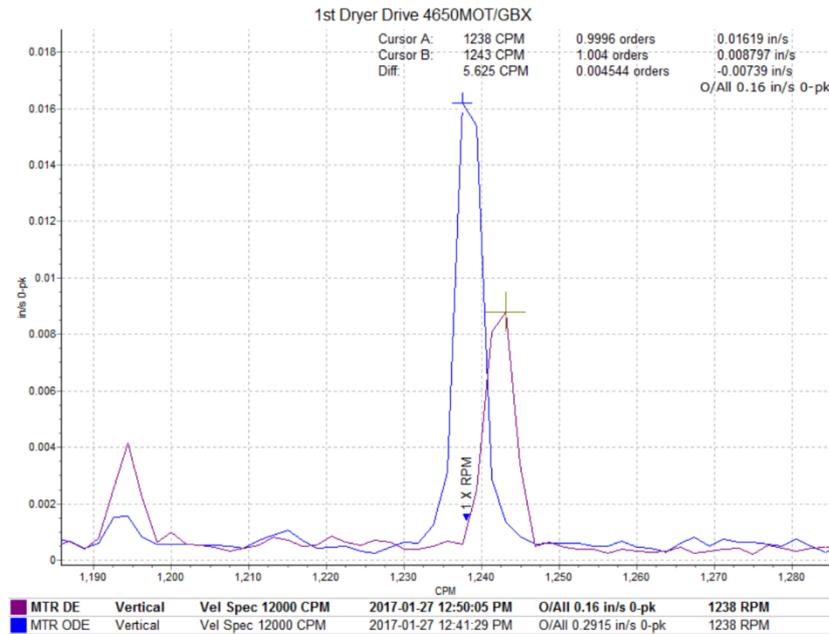
The two spectrums below illustrate the variation in speed on the motor. The first is on the DE and the second is on the ODE vertical.

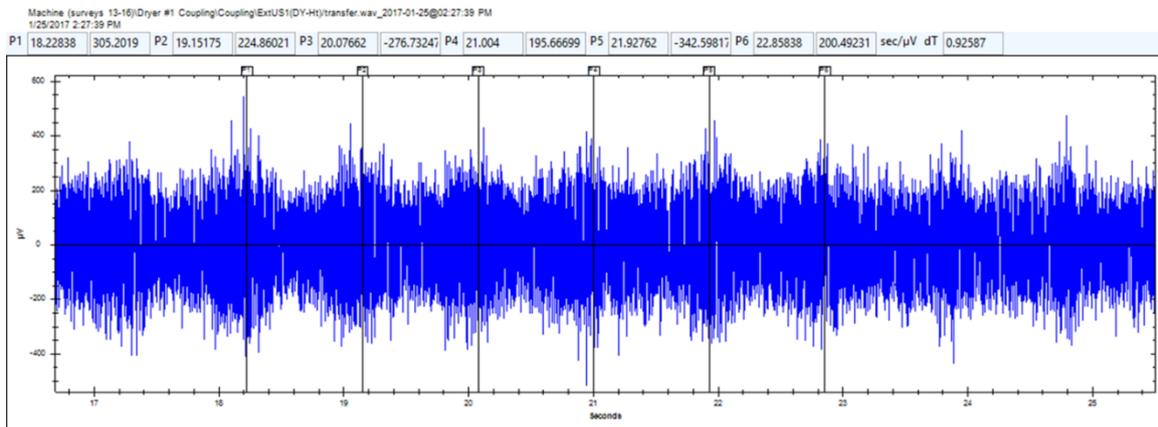
Ultrasound readings were also taken on the output coupling. It was generating a pulsating noise which was repeating every 90 CPM or at the output speed of the gearbox possibly due to the variation of the load on the coupling due to the variation in speed.

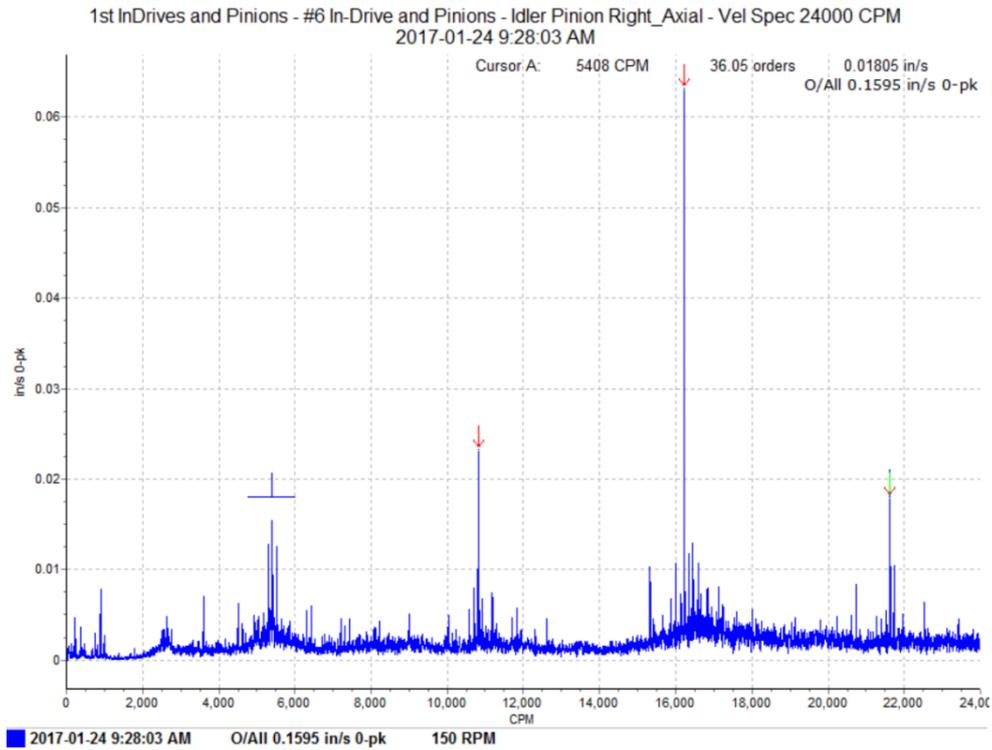
In-drive Misalignment

There is also evidence that there is a misalignment condition between the output of the gearbox and the In-Drive.

Gear Misalignment is the probably the most prevalent cause of gear failure. Typically, this results from coupling misalignment between the input and/or output drive systems and the mating components. This produces Gear Mesh Frequencies (GMF) and sideband frequencies, spaced out at the rotating speed of the faulty gear. Gear misalignment can also occur internally if the gear shaft support bearings are not properly aligned with respect to one another. While not common, this problem will usually lead to premature bearing failure before gear problems are considered severe.

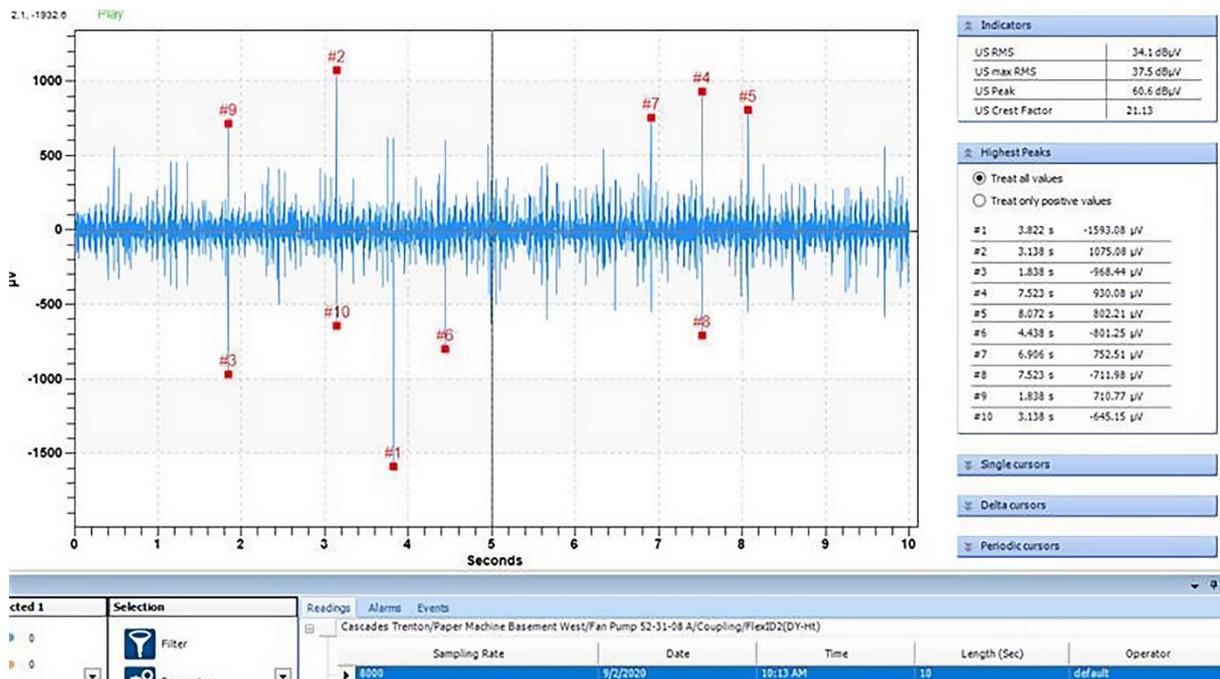
The following are the time-wave and spectra ultrasound measurements, and the vibration measurements taken on the coupling of a DC motor connected to a fan pump. By using two technologies we were able to fully diagnose everything wrong with this asset.

First, let's start with the ultrasound readings. As you can see in the time-wave measurement, this coupling appears to be in bad shape with lots of impacting at its regular run speed. When you look at the spectra you can note something strange, because of recurrences clearly identified with the periodic cursors. After making this discovery our data collectors from the Partnered Ultrasound team decided to utilize vibration analysis where we discovered the motor run speed was fluctuating.

When a firing card fails, then 1/3 of the power is lost, resulting in momentary speed changes in the motor's rotation. This can lead to high amplitudes at 1/3X and 2/3X SCR frequencies. As you can see on the vibration measurement this motor was firing at 1/3X SCR which is 7200 CPM meaning 2/3rds of the firing cards were faulty.

Using two condition monitoring technologies our Partnered Ultrasound Team was able to fully diagnose the problem on this asset. Ultrasound to find the broken coupling and vibration to find 4 blown fuses out of the 6 on the DC motor.

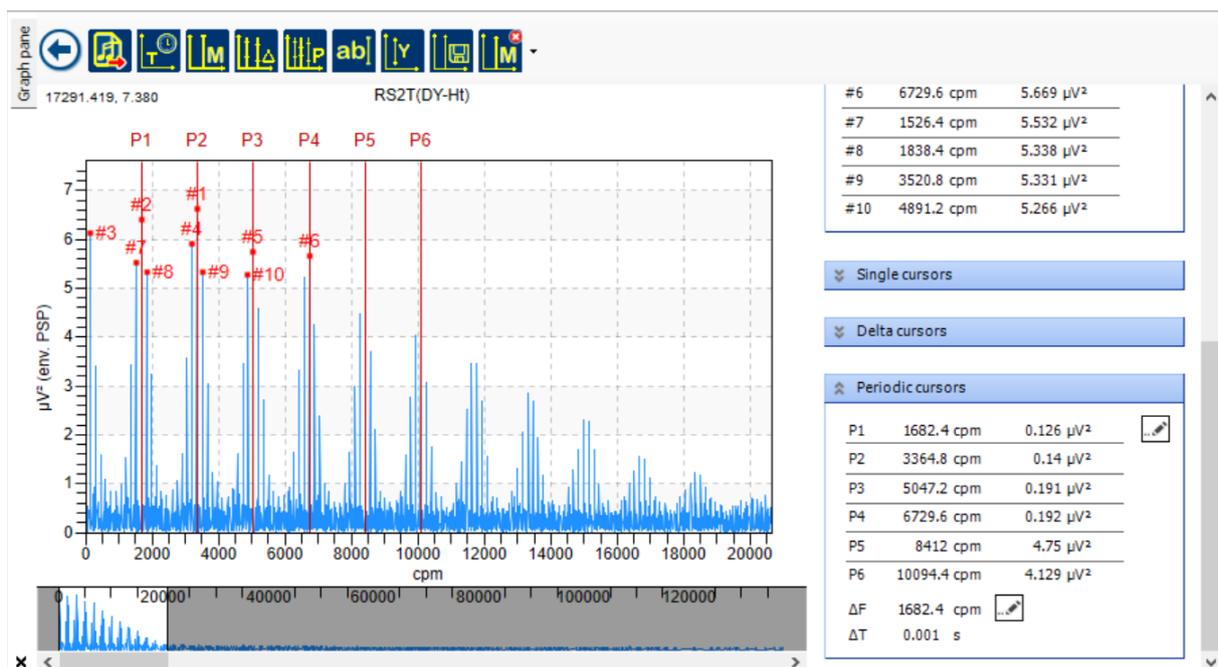
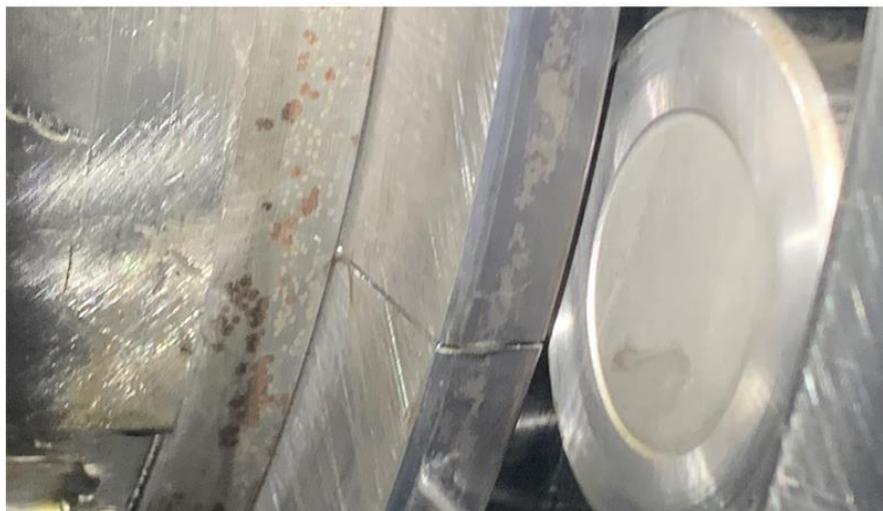
Paper roll with a defective inner race detected with ultrasound (UAS3 and SDT340).

The following is the spectrum of a slow-speed bearing (150 RPM), on a large roll (4-foot diameter), in a paper machine. Gilles Lanthier, our Partnered Ultrasound Senior Analyst found this defect using his SDT340 and performed analysis using UAS3 software. This find was then confirmed using vibration analysis.

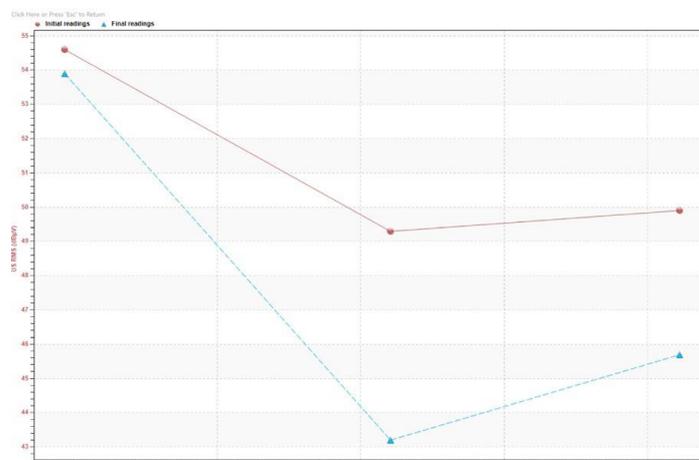
Greasing of bearings using ultrasound, often described as best practice, helps us understand how much grease needs to be applied. Ultrasound is a good measure of friction - too little or too much grease in a bearing produces elevated friction levels. Using ultrasound, the right quantity of grease is determined by assessing the levels.

SDT LUBExpert ensures that the right quantity of grease is applied to each bearing using ultrasound, condition-based lubrication.

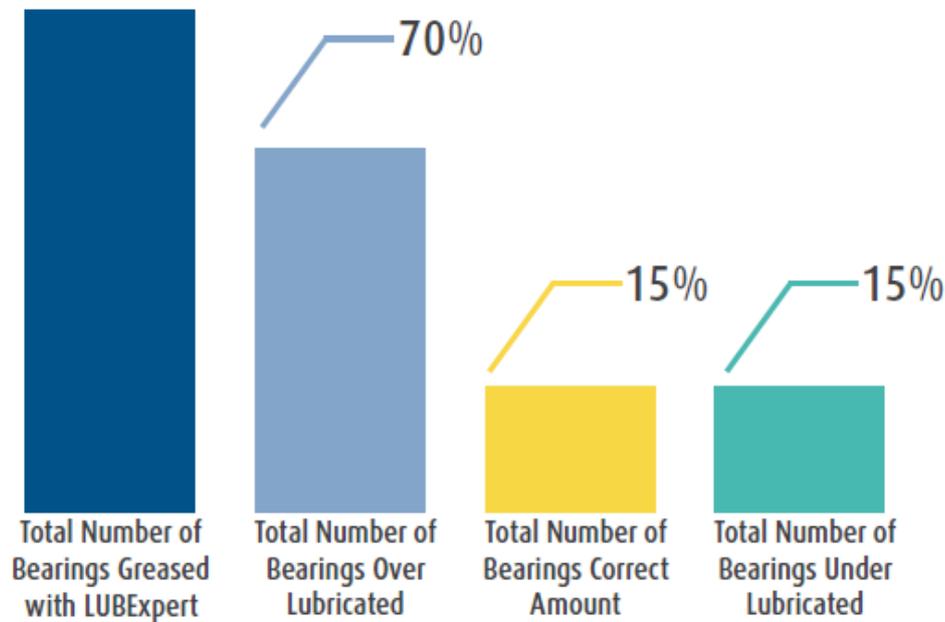
indicated that approximately:

- 70% of bearings were being Over Lubricated;
- 15% of bearings were Under Lubricated; and,
- 15% of bearings had the correct replenishment rate.

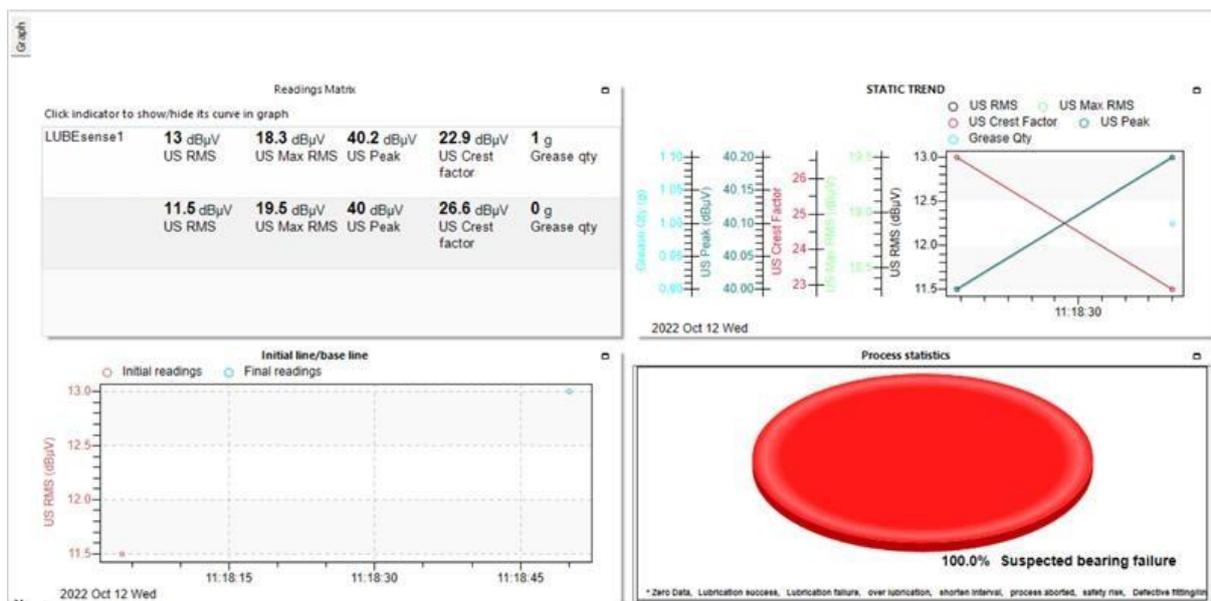
The outer race bearing defect was found by the Partnered Ultrasound Team during a routine lubrication route using a LUBExpert Dynamic.

After analyzing the dynamic ultrasound data in UAS3, it was confirmed that there was a suspected bearing failure.

UAS3 LUBExpert Dashboard Configuration 1

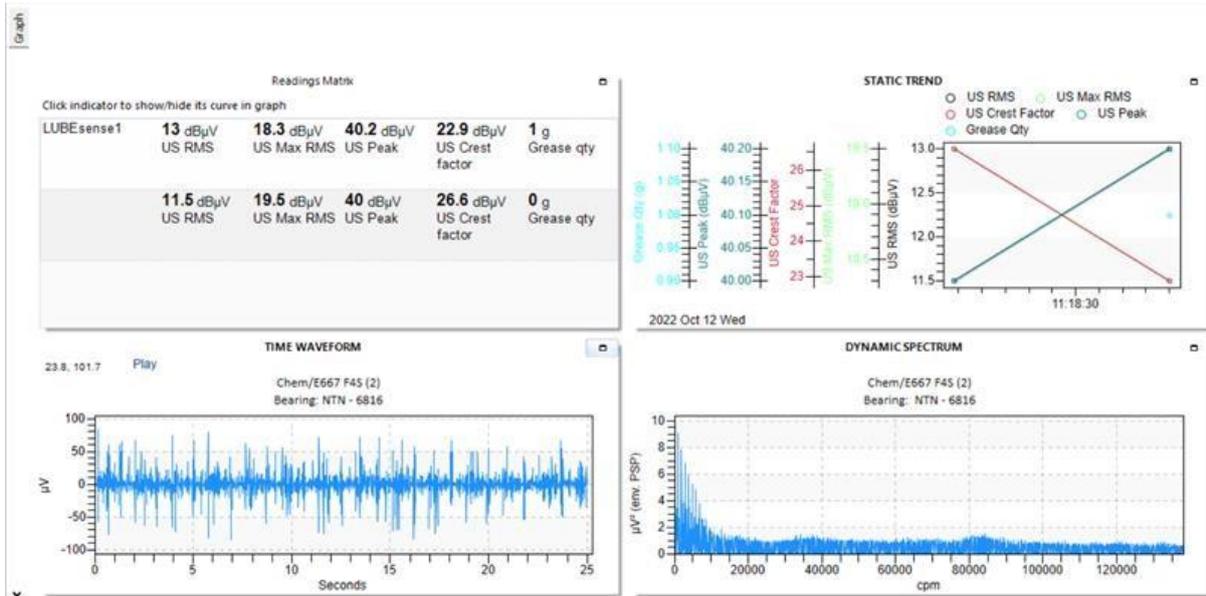
UAS3 LUBExpert Dashboard Configuration 2

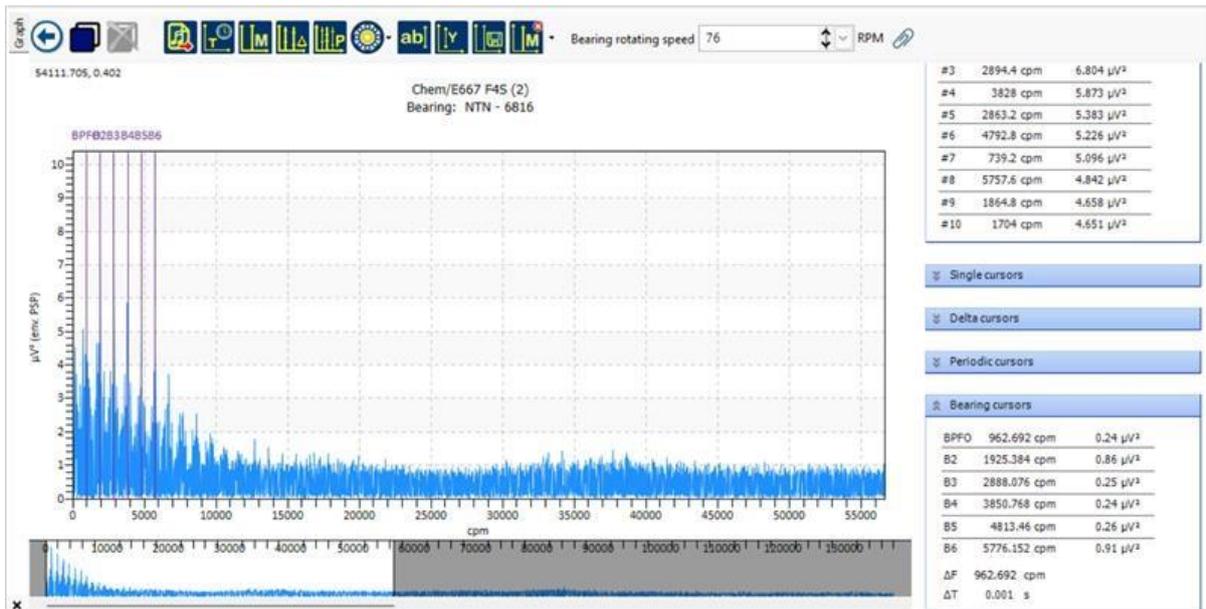
Further analysis using the Bearing Toolbox found that the impact was caused by an outer race defect.

Failed Bearing 2 – Figure 2 – UAS3 Bearing Toolbox, BPF0 Fault Frequency Cursors.

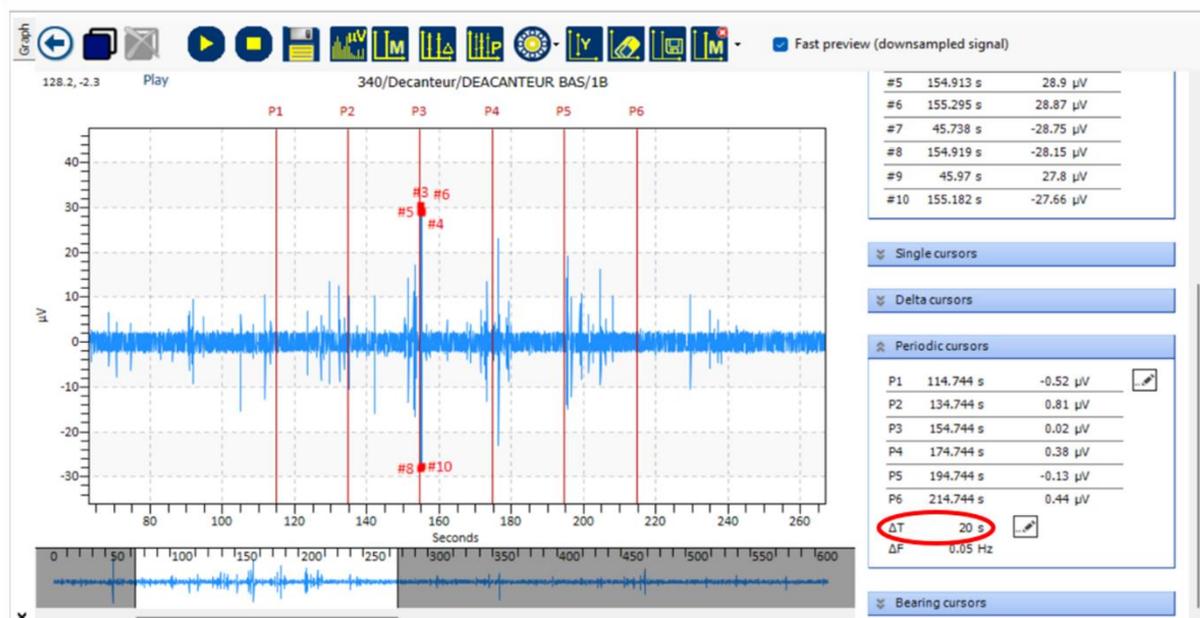
The 10-minute time waveform recording can be observed below in Figure 1.

Figure 1 - 10 Minute Time Waveform of Wastewater Decanter Centrifuge Pinion

The motor powering the wastewater decanter is turning at 1785 RPM. The first reduction through a belt and planetary gearbox is 52.1 to 1. ($1785/52.1=34.26$).

The second reduction is at a ratio of 11.6 to 1. ($34.26/11.6 = 2.95$). Giving us the speed of the pinion.

Observed in Figure 1, we can see a similar pattern to that in Figure 2. There is a pronounced spike every time the problem tooth tries to mesh with the teeth of the bull gear. The time between impacts corresponds to 1/RPM of the gear with the tooth problem. This data analysis lead SDT's Reliability Technicians to believe there is a cracked/broken tooth on the pinion gear.

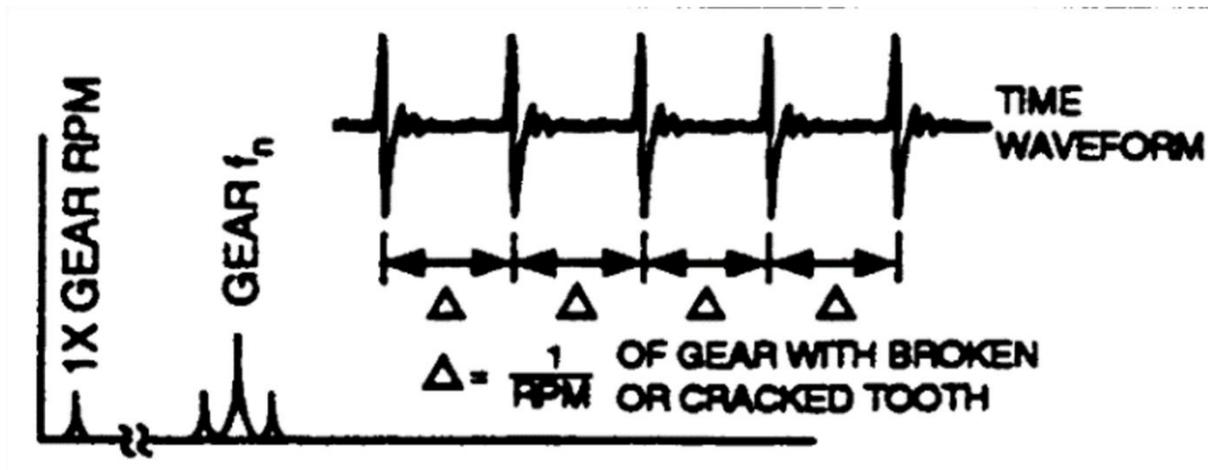
Cracked and broken teeth generate high levels of ultrasound at 1 x RPM in the time waveform. Figure 2 depicts what a typical time waveform looks like when dealing with a cracked or broken tooth.

Figure 2 - Cracked or Broken Tooth

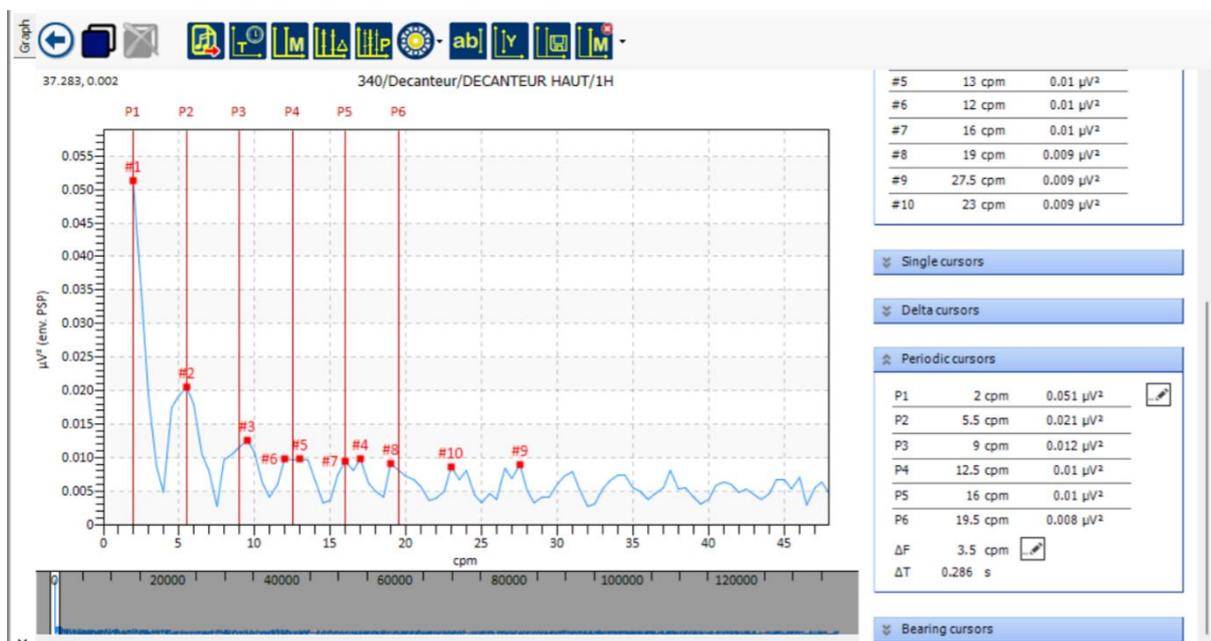
Figure 3 - FFT on the Pinion

As observed in the pinion's FFT, it can be seen that high levels of ultrasound above the sound floor are appearing at 1 X RPM.

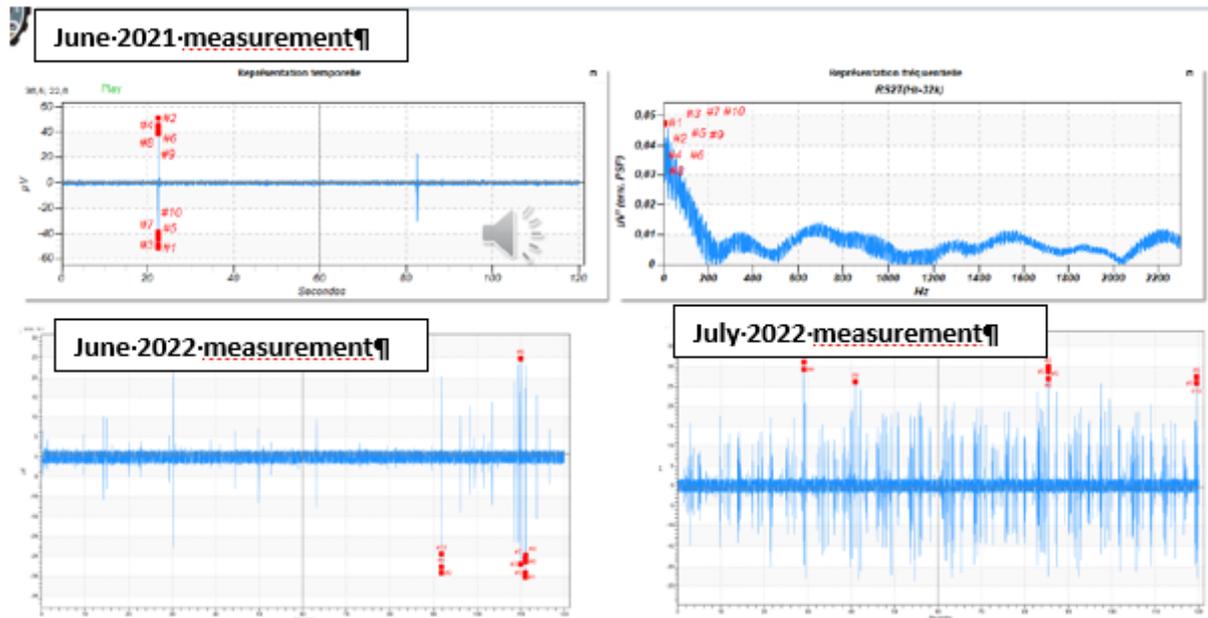
The image above shows a rather evolutionary time waveform. Relatively normal measurements in June 2021 gradually shift towards the beginnings of unusual shocks in June 2022, culminating in a much more serious situation the following July.

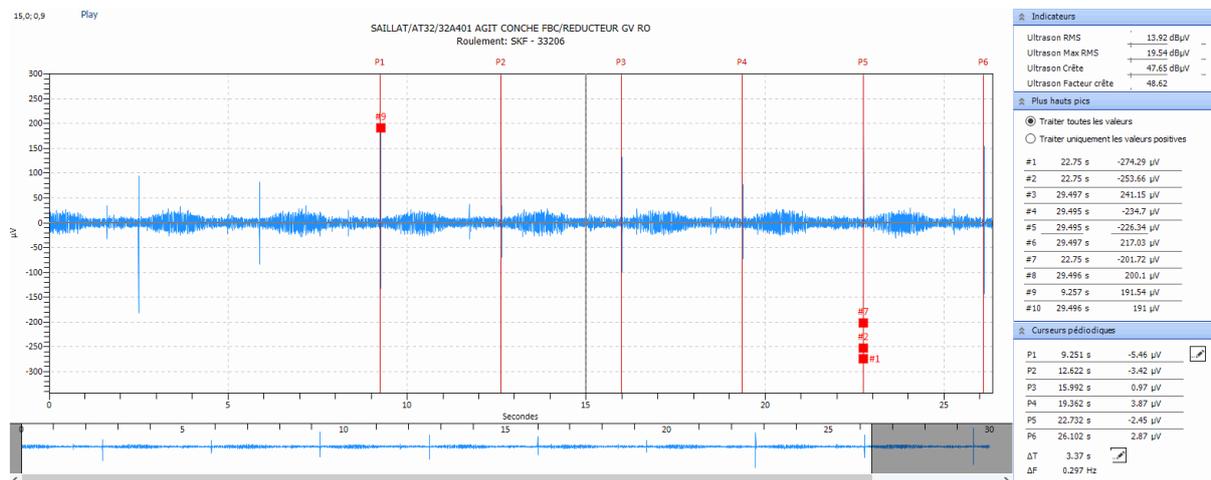
One day, the team in question decided to solve this noisy mystery using the SDT340, a state-of-the-art ultrasound measurement device. They positioned it strategically to investigate the sources of this annoying noise. After careful ultrasound listening, they discovered something interesting: shocks at a frequency of 0.3 Hz on the GV/PV points, visible in the UAS3 software in the image below.

The time waveform and frequency spectrum clearly showed a clear impact at 0.3 Hz on the GV and PV points. The maintenance team then focused their attention on the coupling location, as this was where the noise seemed to originate.

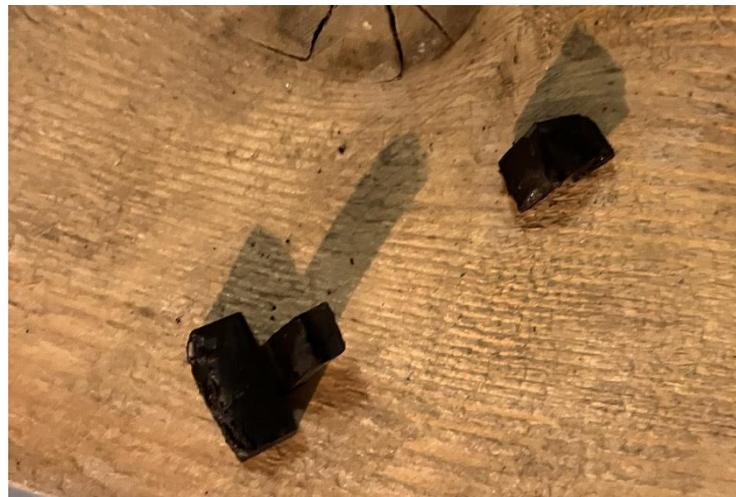
Initial diagnosis revealed that the problem affected both the PV and the GV. By moving the ultrasound sensor, they noticed that the noise was most intense at the coupling bell. On closer examination, they found that the flector was completely torn, as shown in the image below, which explained the shocks and noise. The shocks showed a coupling backlash, causing a modulation on the spectrum that even masked the GV rotation frequency.

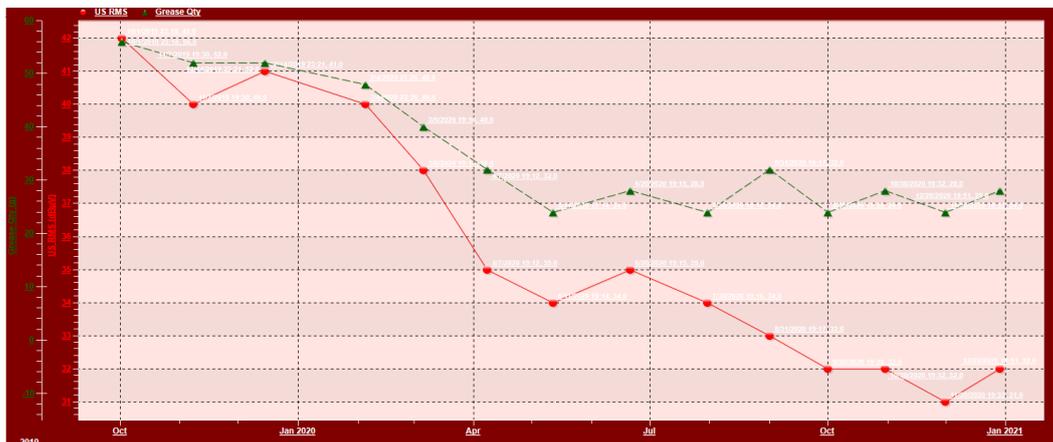
Picture 1

- Lube technician took care of 35 – 40 bearings per day (per shift)
 - That includes work task preparation, data collection, on-site analysis based on triggered alarms, LUBExpert guided grease replenishment, data overview and possible strategy corrections, and reporting.
- All bearings showed an excellent response (as one in the picture 1 below), operating at the minimum friction and wear level:

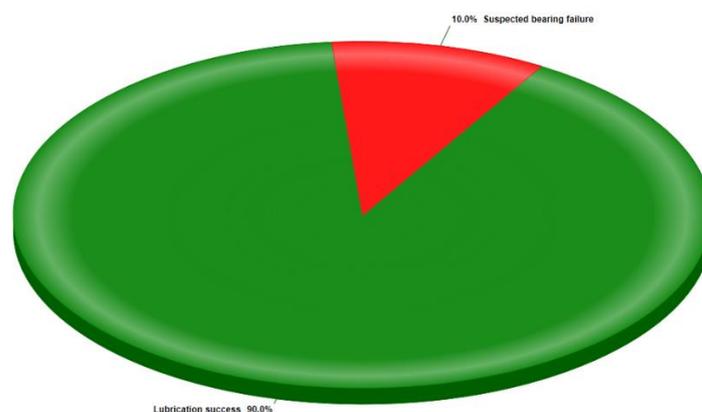
Picture 2

- Process statistics (as shown in picture 2) showed high level of performance, correct lubrication practice and strategy settings, as well as additional observations and condition assessments:

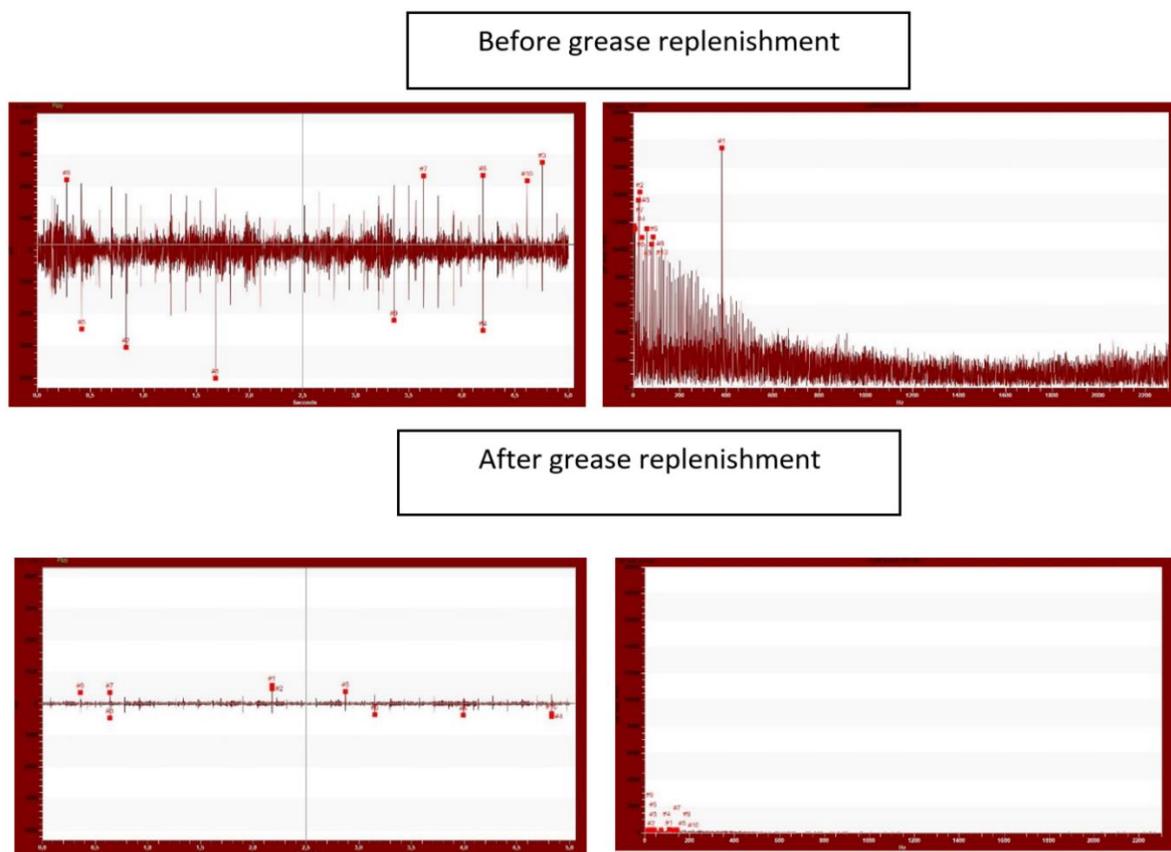
Picture 3

Here is what it looks like in the first week of implementation. Bearing successfully greased with declared condition as “Suspected bearing failure”, TWF and Spectra collected before and after grease replenishment (picture 3):

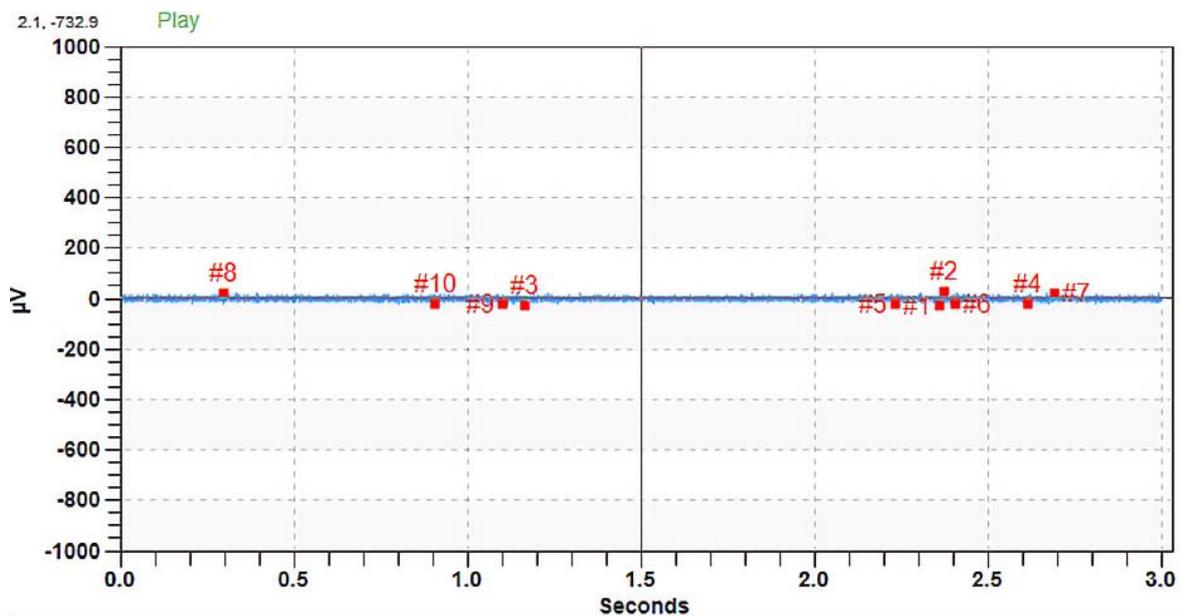
Left Insulators: TWF

The time waveforms have been scaled identically. Ultrasound was present throughout the whole cabinet, but the source of the problem produced the loudest ultrasound. Corona was present.

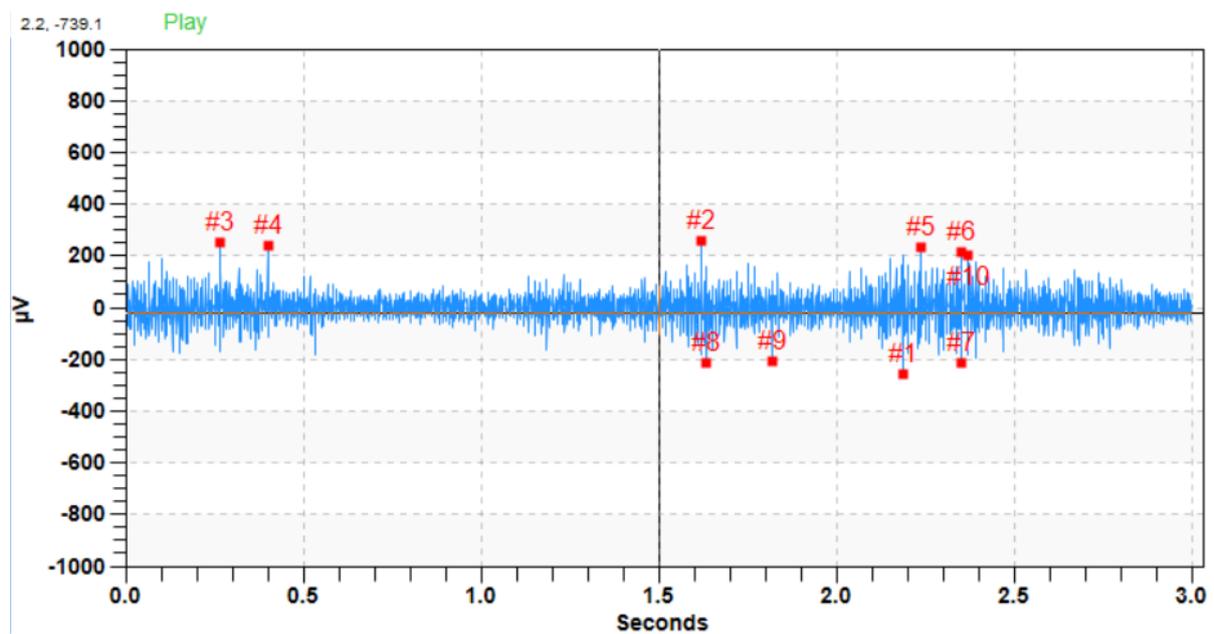
Middle Insulators: TWF

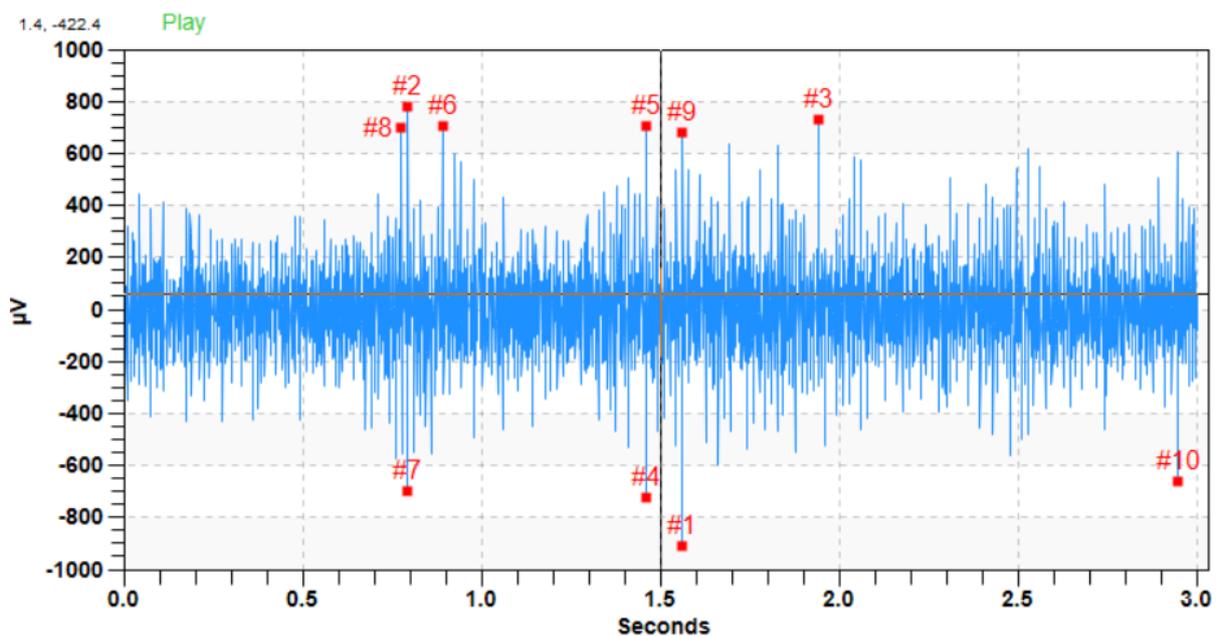
Right Insulators: TWF

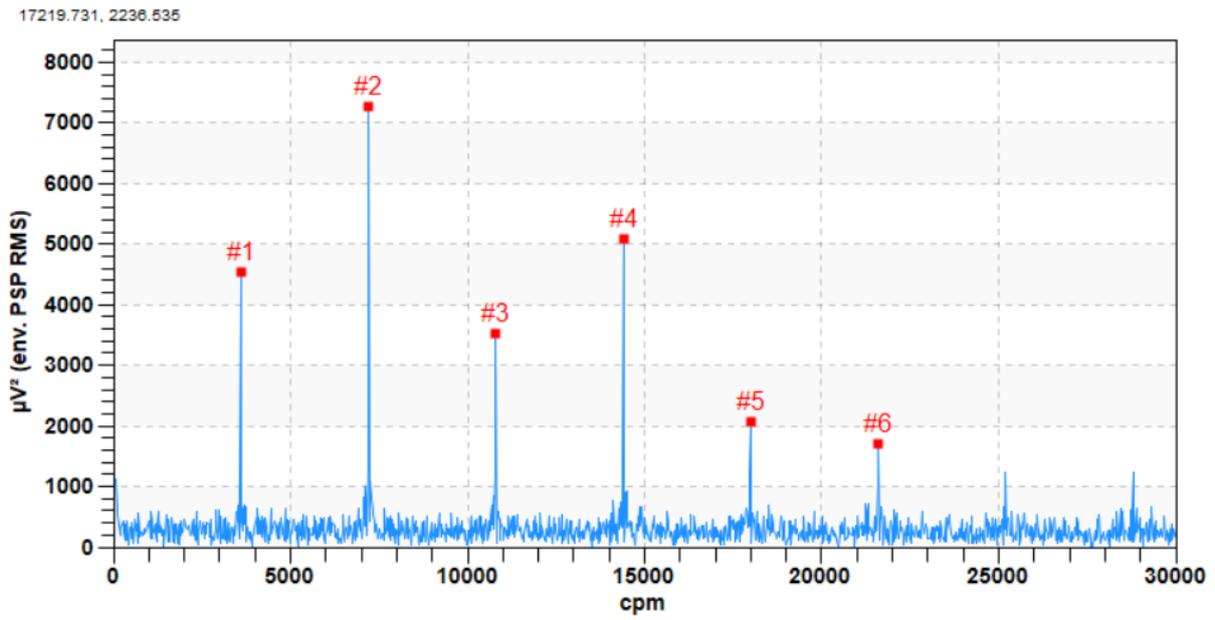
The FFT below clearly showed the signals being produced at harmonics of 3 600 CPM or 60 Hz which is the electrical frequency used in North America.

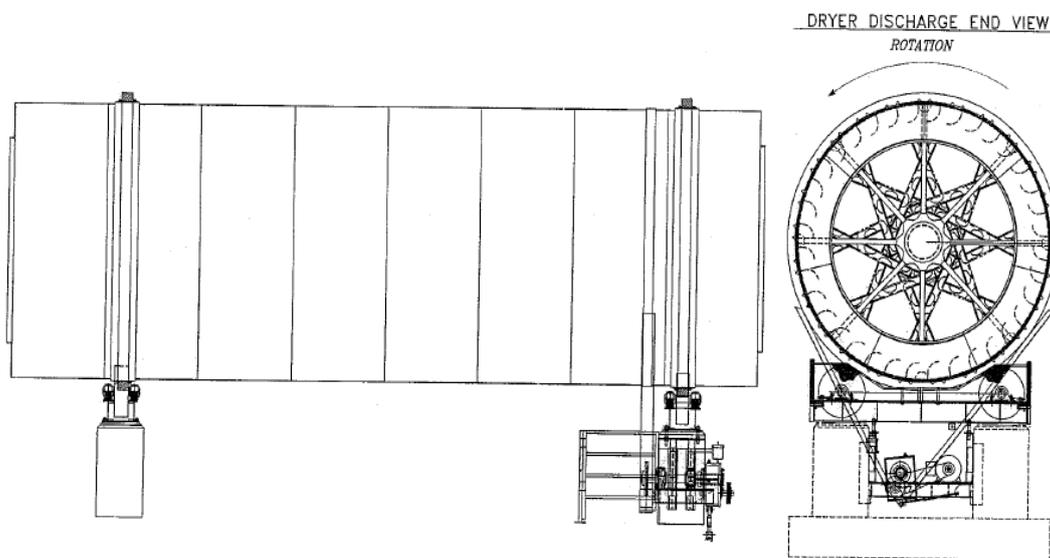
In a factory, they have two dryers that allow them to dry a product destined for animal food. These large dryers have a drum 40 feet long, 13 ½ feet in diameter, which rotates about 4.2 RPM and has a weight of about 53 000 pounds and is supported by four trunnions. These consist of a roller that rotates at 25 RPM and two bearings Dodge P4B-IP-315R (it is a bearing 22 220 inside).

Bearing defect frequencies of DODGE 22220 (Hz)					
	RPM	FTF	BSF	BPFO	BPFI
1 fundamental	.42	.177	1.32	3.18	4.32
1 harmonic	.83	.353	2.64	6.36	8.64
2 harmonics	1.25	.530	3.97	9.54	12.96
3 harmonics	1.67	.707	5.29	12.72	17.28

The ultrasound time waveform and spectra clearly showed impacts.

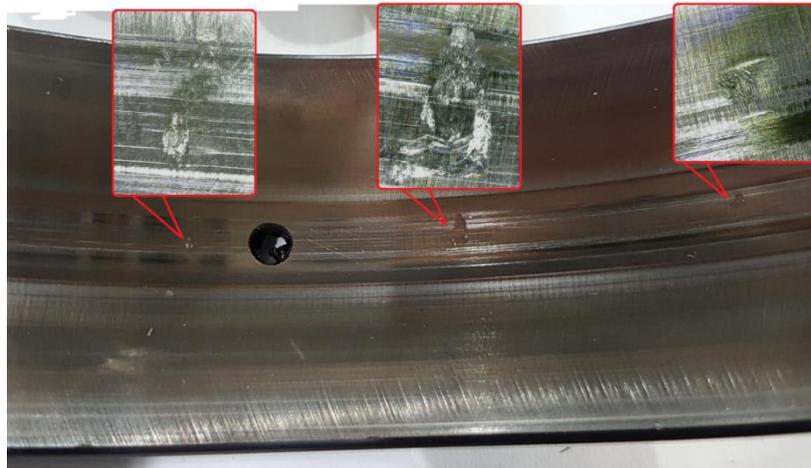
The bearing was inspected, and the outer race had cracks.

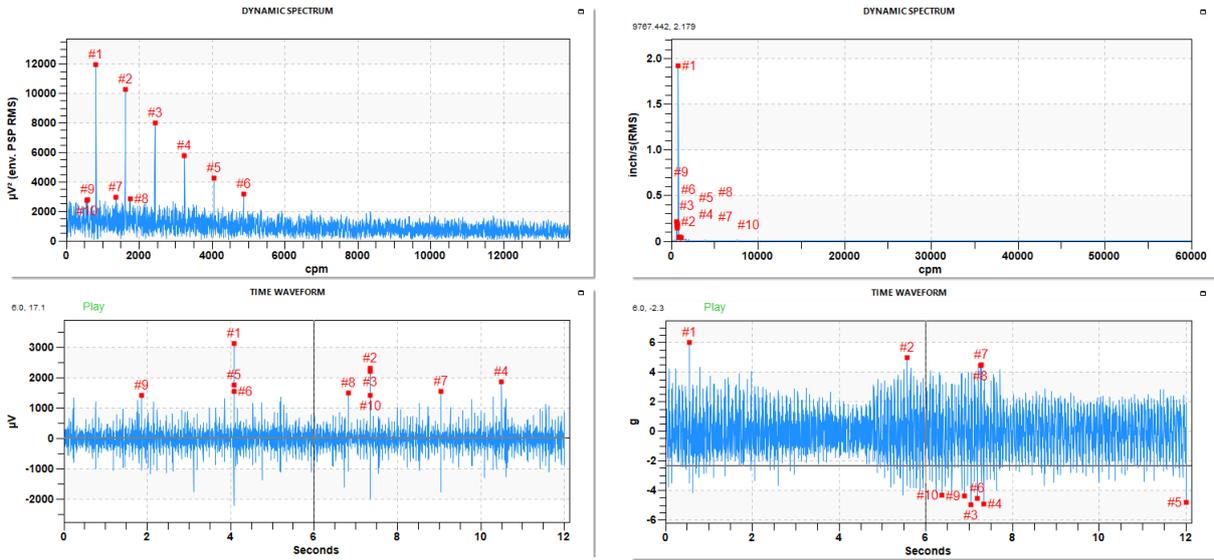
Bearing #1 drive side.

Amplitude 12 000

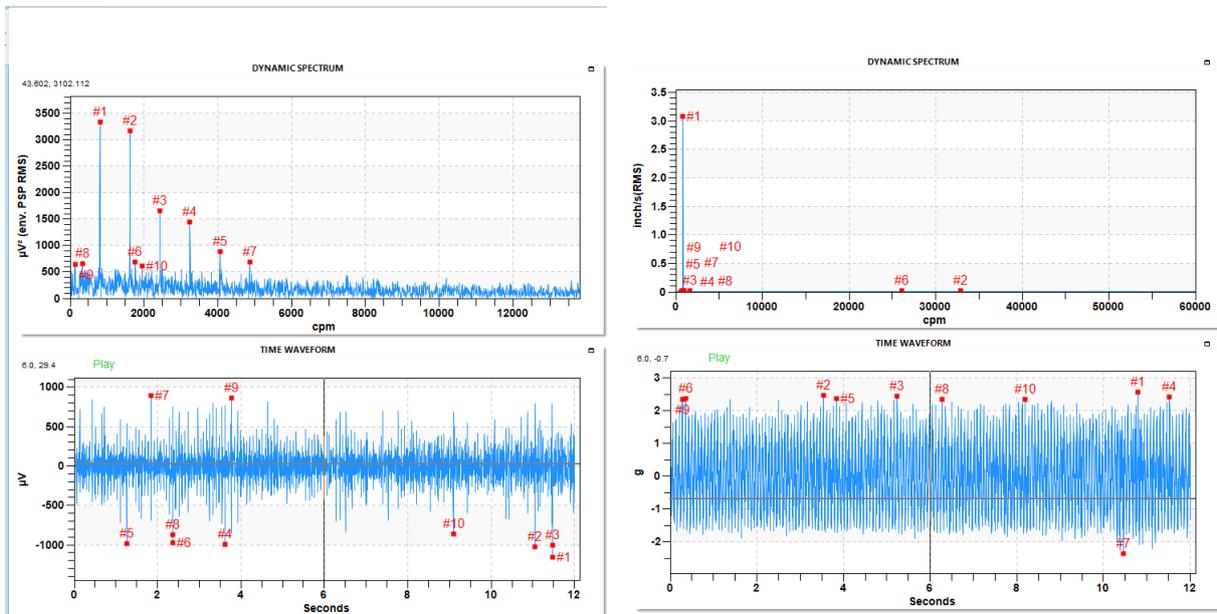
Bearing #2

Amplitude 3 500

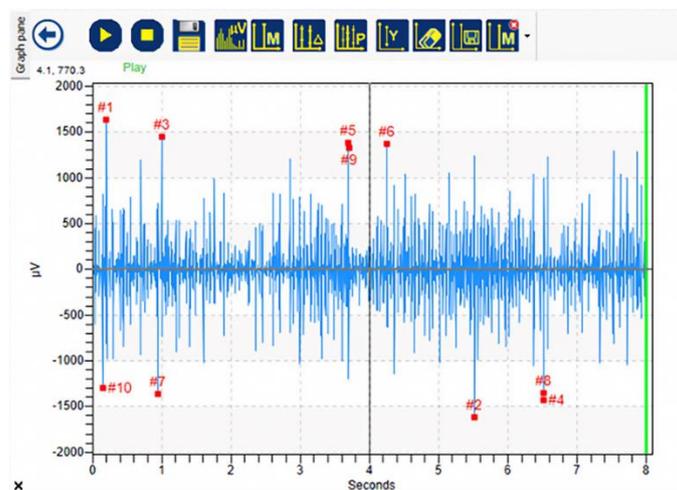
Upon arrival to the crane, he began listening to the bearings on the input shaft and the brake drum side of the gear box. Immediately, John recognized something didn't sound right. He made it known to the crane technicians and went to upload the data to UAS3 so he could perform an analysis. John immediately recognized very high peaks in the wave form as well as an audio signal full of impacts.

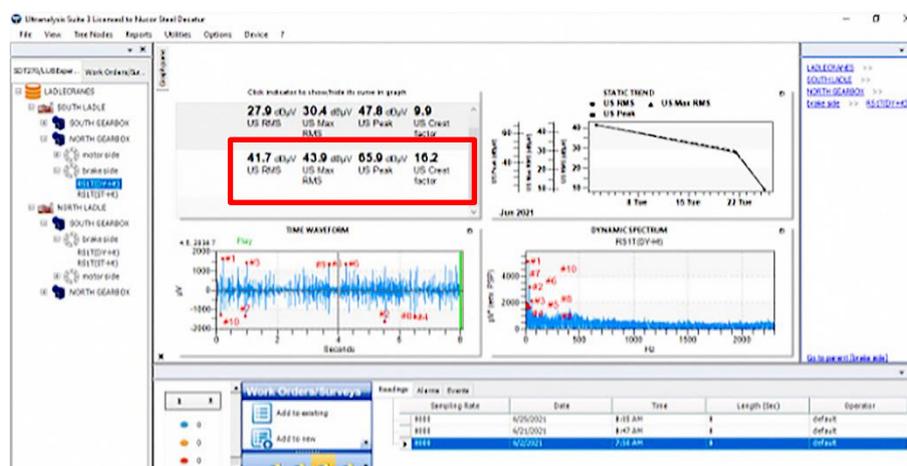
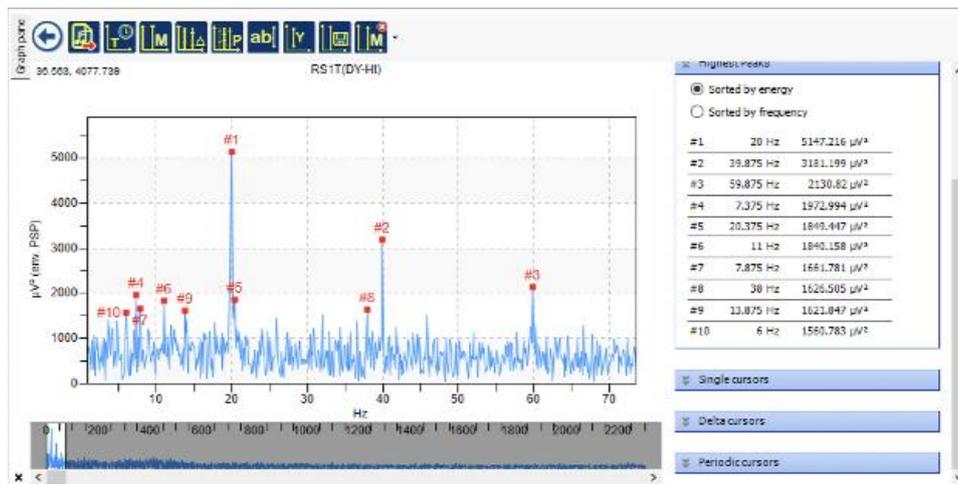
He immediately went back to the crane technicians to review with them the data he had found. John briefed them on the 4 condition indicators (41.7 dB μ V rms, 43.9 dB μ V max rms, 65.9 dB μ V peak, and 16.2 crest factor).

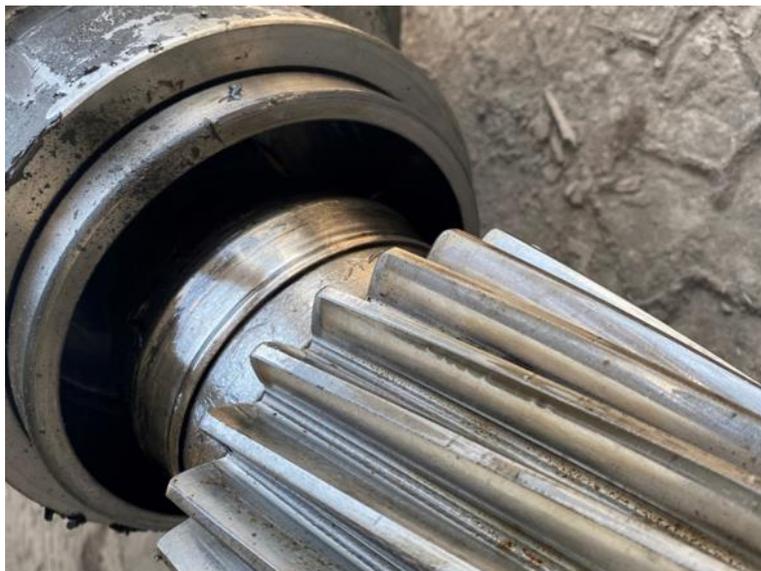
Below is the input shaft bearing right after being pulled out of the gearbox. As you can see all the rollers are gone and had to be fished out of the bottom of the gearbox. Fortunately, they didn't get caught in the gears causing further problems.

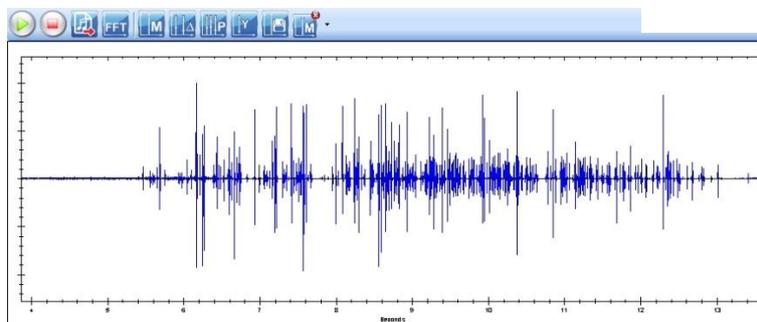
The thermogram showed no hot spot.

The time signal shows the presence of short-lived successive flashovers that are not repetitive and are typical of tracking.

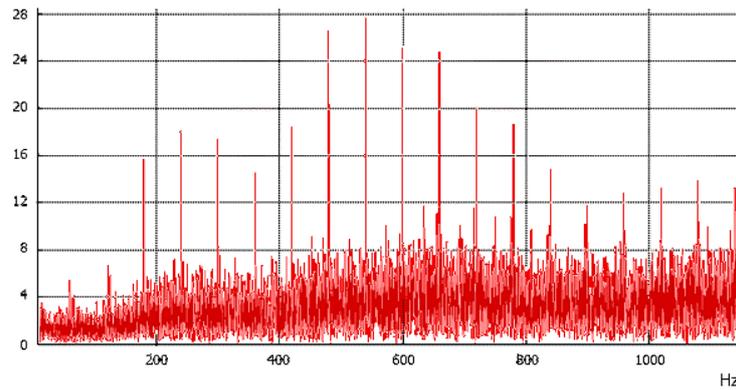
Tracking was confirmed by analyzing the spectrogram. However, it also revealed the presence of a destructive corona.

The frequency signal shows peaks at the fundamental frequency (60 Hz) and at its harmonics, which is typical of a destructive corona. It also shows noise between the peaks, which is typical of tracking.
