SUCCESS STORIES

Ultrasound Solutions

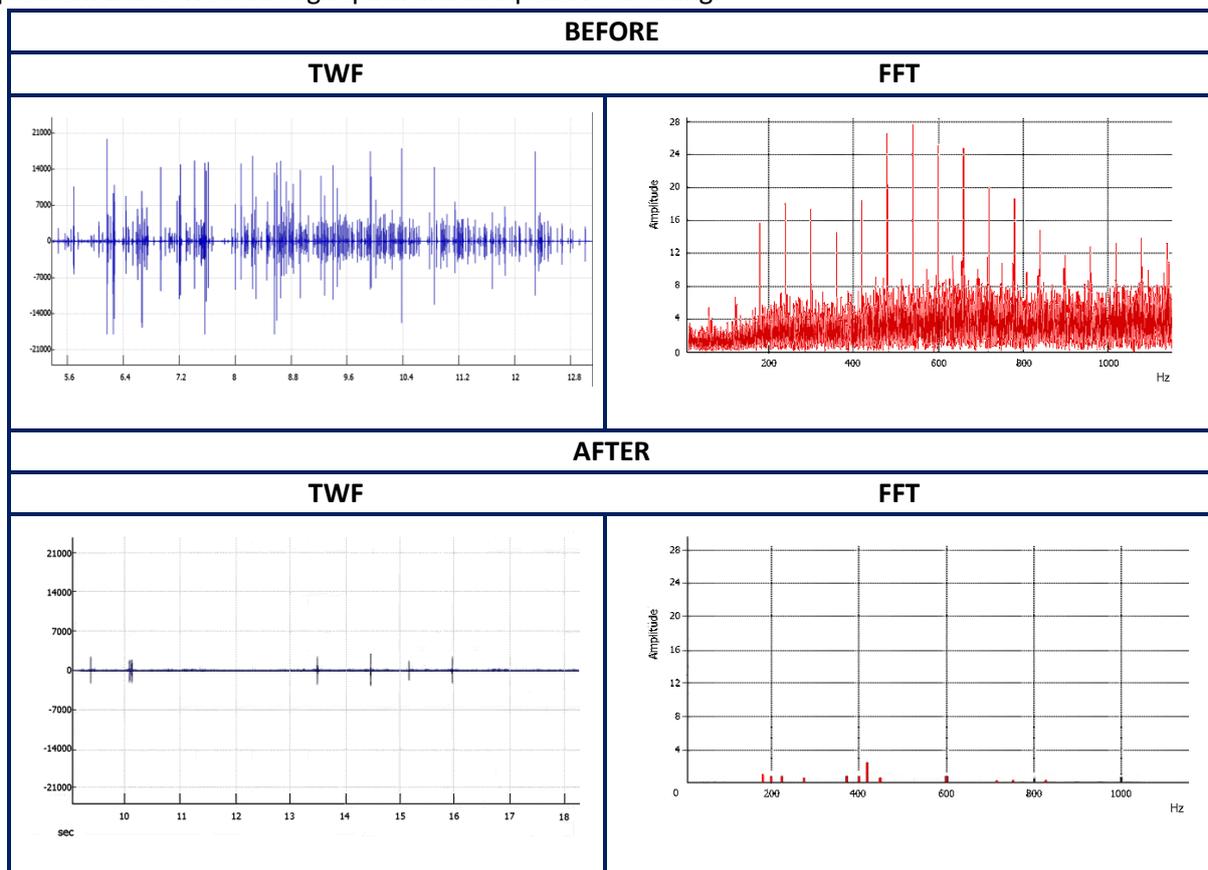
Finally, a new data collection was carried out after restarting the system. The curves below show the results obtained before and after the maintenance operation. They clearly demonstrate that the problem was solved through quick and inexpensive cleaning.

Top: measurements prior to maintenance. Bottom: after maintenance. Please note that time and frequency representations are on the same scale.

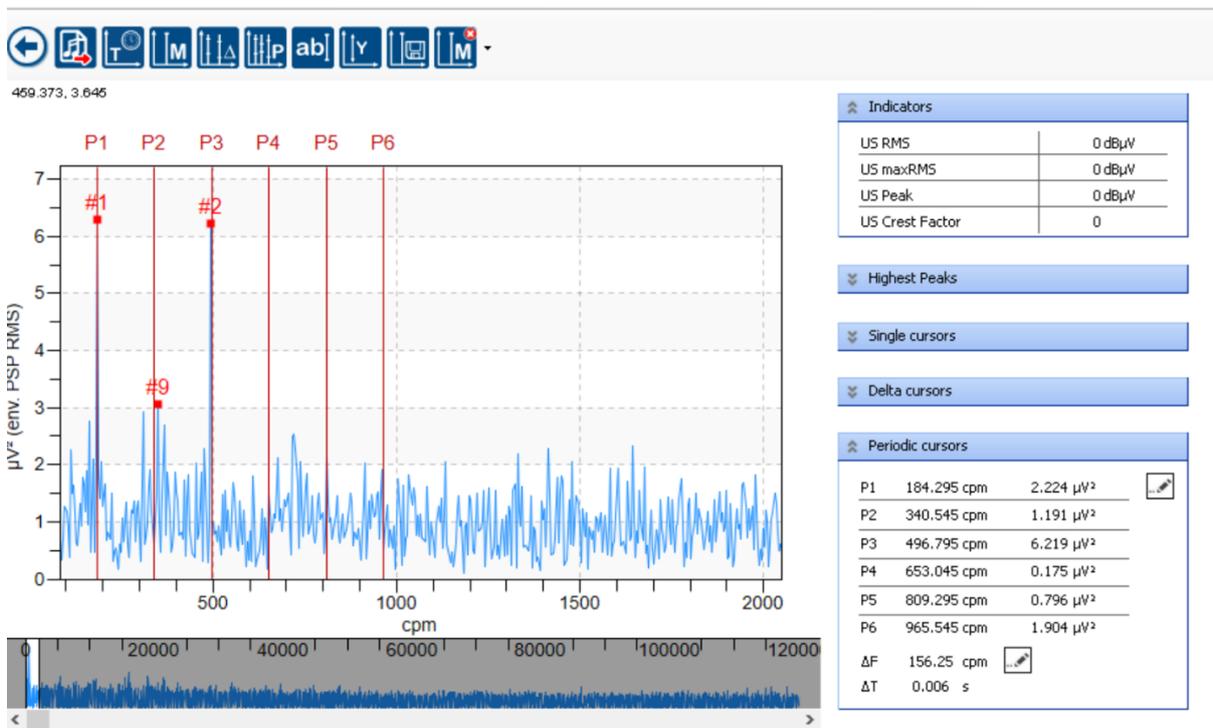
Random impacts. No exact multiple harmonics. Lubrication issue.

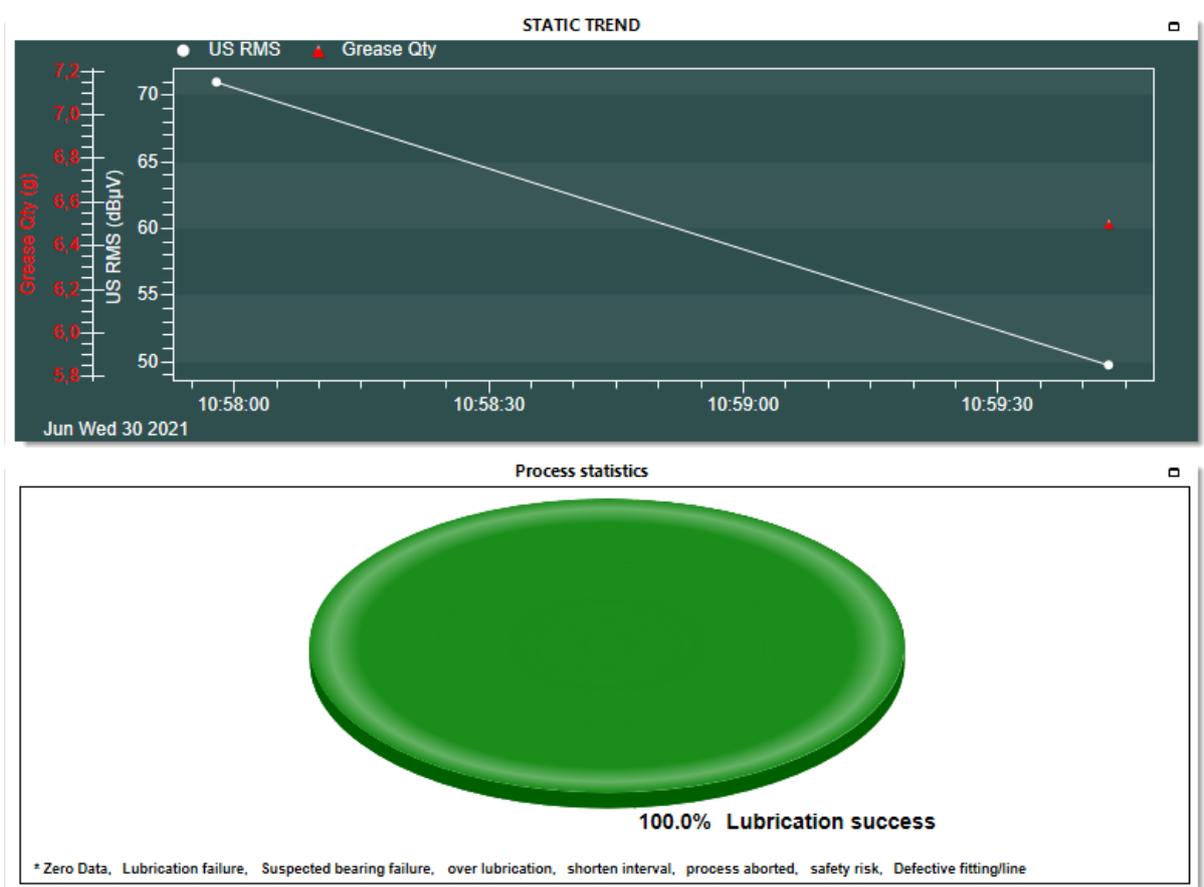
Applied: 6.5 grams

Outcome: Lubrication success

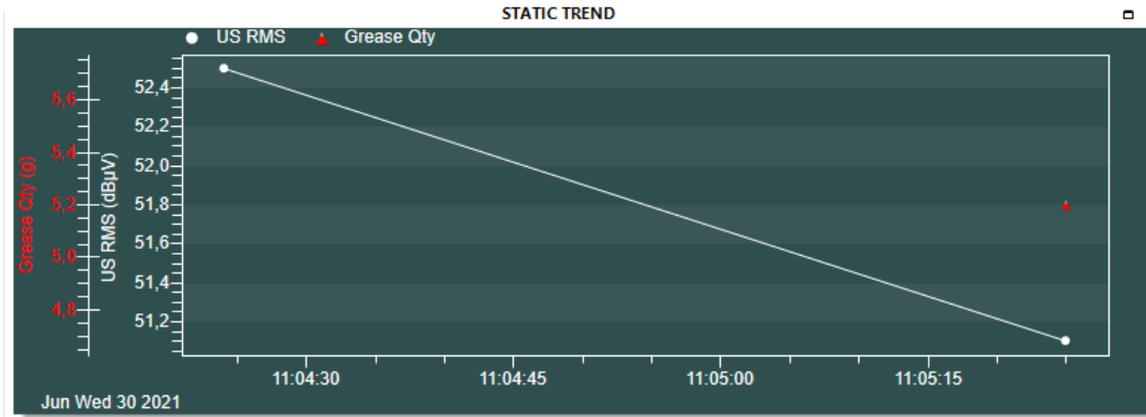
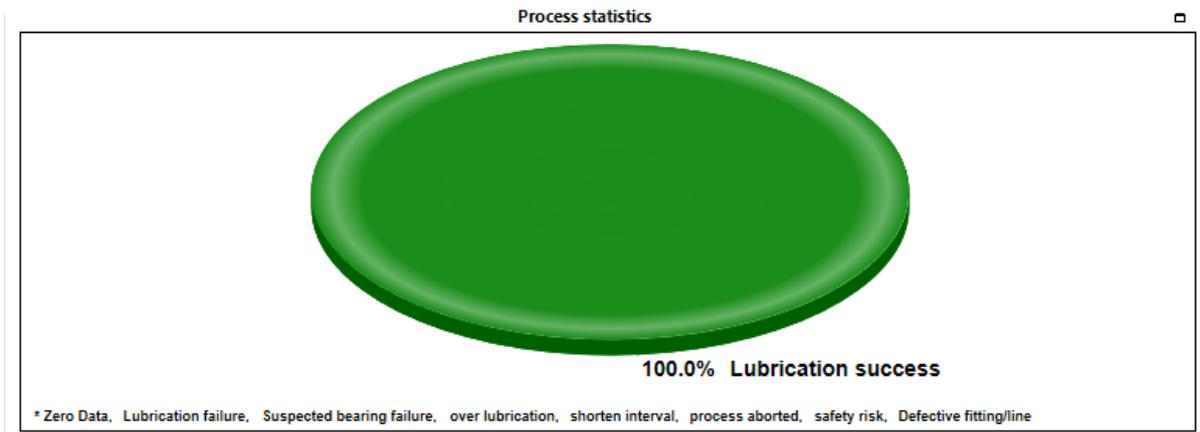
Fan 2 Motor DE:

Applied: 5.2 grams

Outcome: Lubrication success

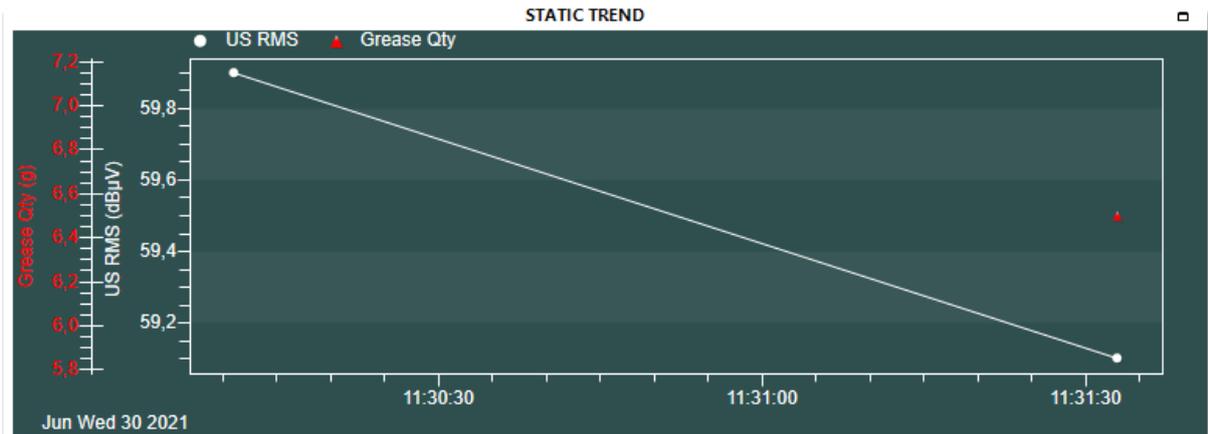
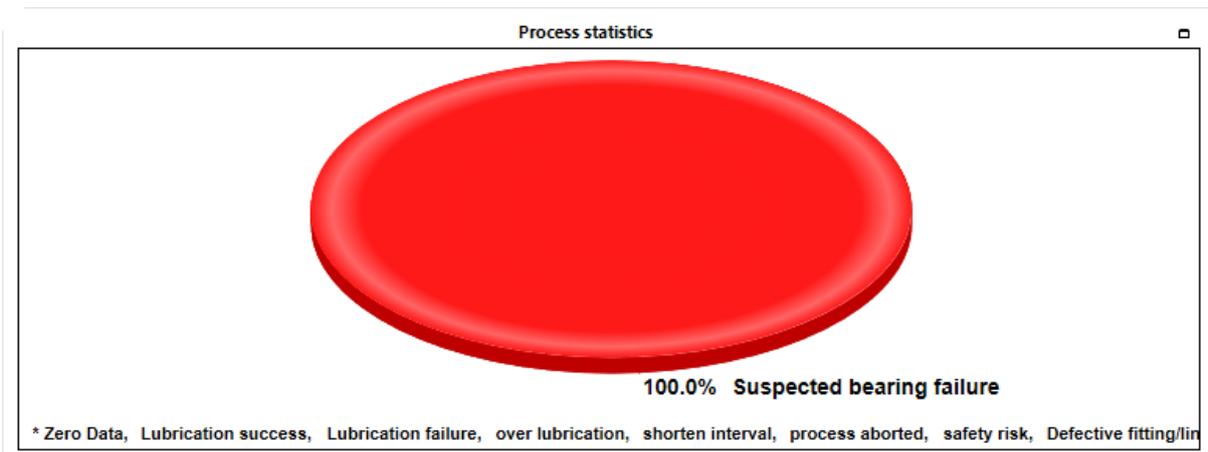
Fan 1 Motor NDE:

Applied: 6.5 grams

Outcome: Suspected bearing failure – Data reported to CM team

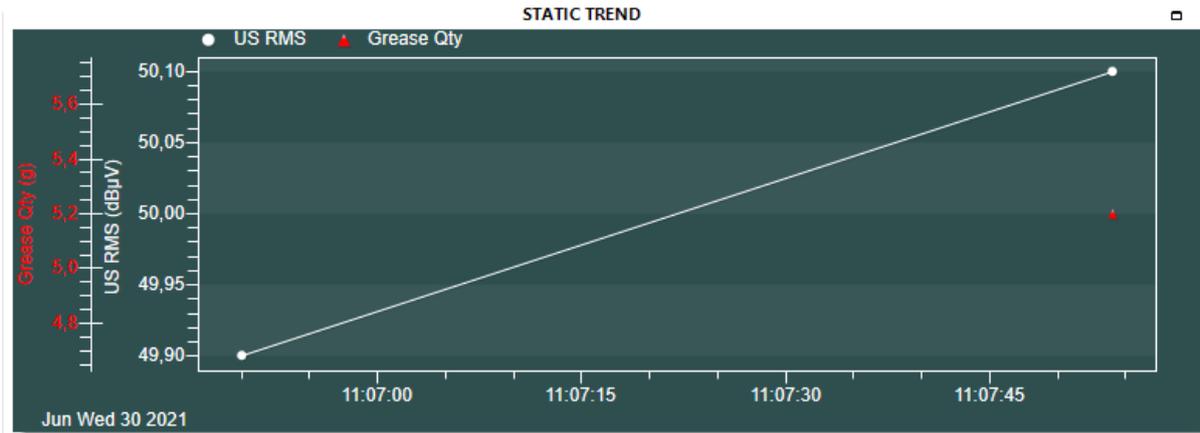
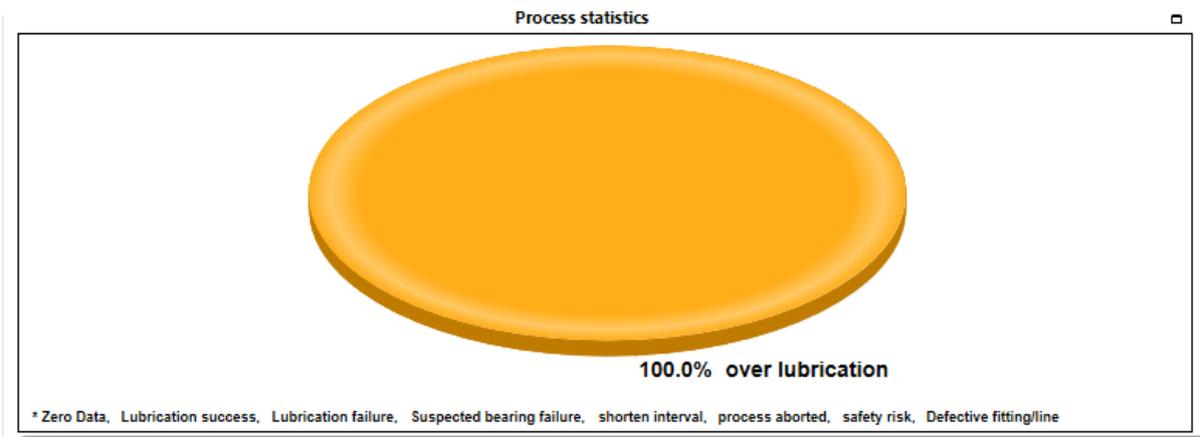
Fan 1 Motor DE:

Applied: 5.2 grams

Outcome: Over Lubrication – Bearing didn’t need any grease

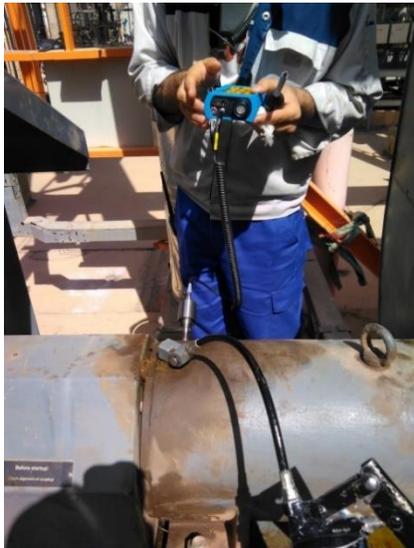
Figure 2 - Collecting ultrasound data with SDT270 while replenishing lubricant.

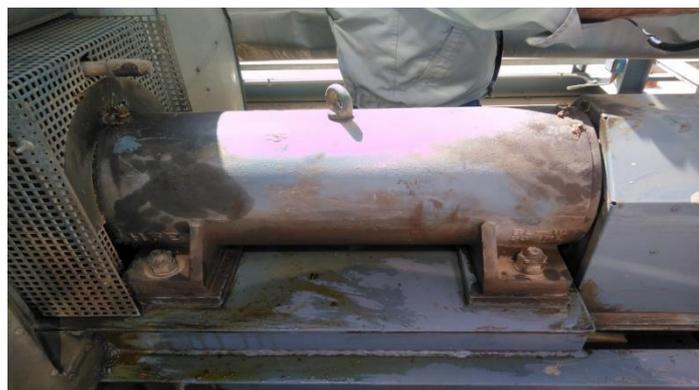
Figure 1 - Two fan bearings with different load. Why do they share the same grease replenishment protocol?

Following the facility’s lubrication procedure raised several red flags. Figure 2 shows two bearings driving the fan. Why would two identical bearings, but with different loads, have the exact same grease replenishment protocols? Maybe it’s purely out of convenience; since the lubricator is there to grease the drive end bearing, might just as well pump a few strokes into the non-drive end.

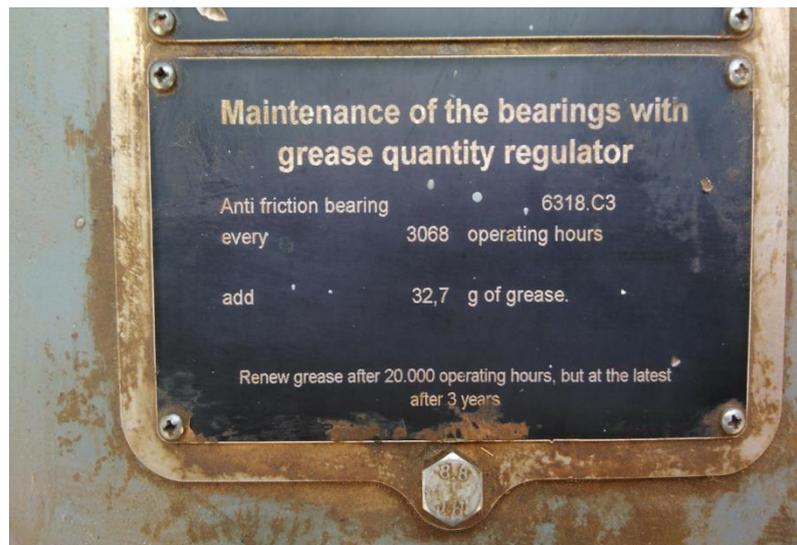
Figure 3 - This motor had a secondary plate reminding lube-techs which grease type to use.

Another issue that disturbed the SDT trainer was the instructions stamped on the motor plate. See Figure 3 – Maintenance of the bearings with grease quantity regulator”. This stamp instructs the owner of the motor to add 32.7 grams of grease (grease type not identified) every 3 068 operating hours. Haris wondered if the OEM took into consideration the installation of the motor in a climate that is very hot and humid in the summertime, but cold, snowy, and dry in the winter.

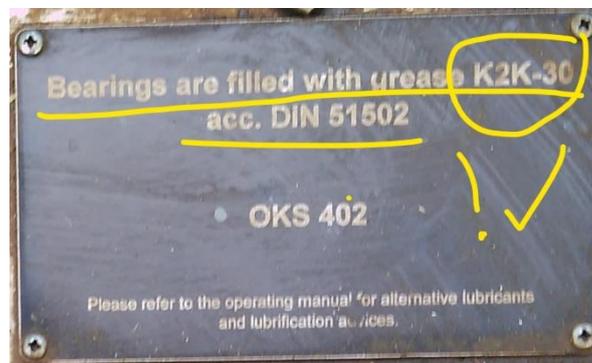
Figure 4 - OEM instructs the owner to grease on a time-based schedule without considering the operating environment.

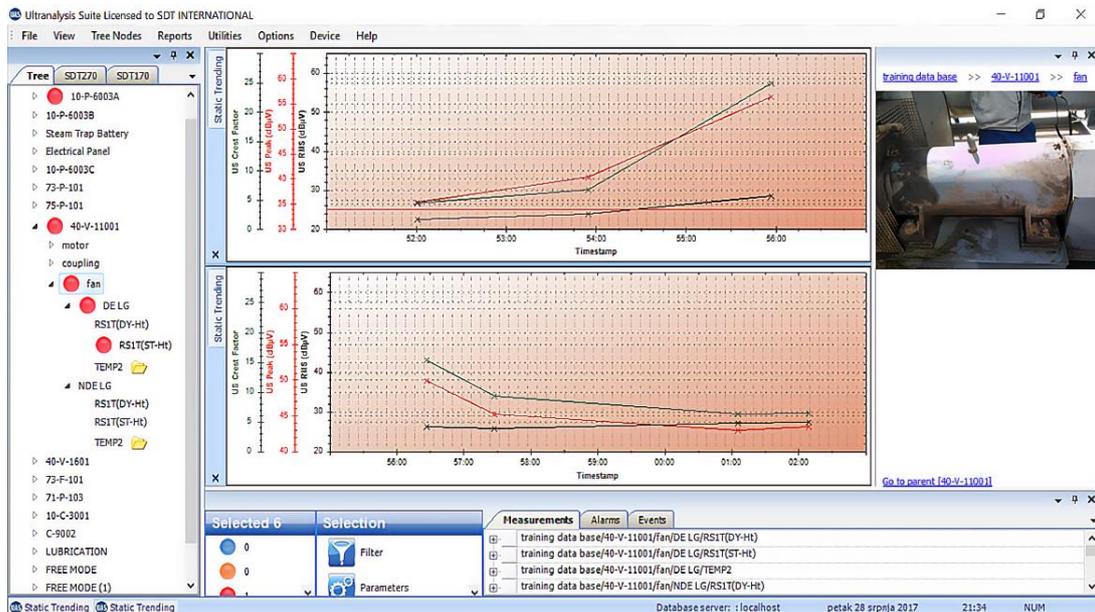
shot captured from UAS, the companion software to LUBExpert. The top trend is the drive end bearing. Within four minutes, the overall RMS increased by 7 dB μ V while the Crest Factor and Peak spiked sharply.

Figure 5 - Top trend graph illustrates drive end bearing after lubrication. It is badly.

The bottom trend is from the non-drive end bearing. Adding the requisite amount of grease had no positive outcome for the Overall RMS which stayed stable at 26 dB μ V. The drop in Crest Factor and Peak readings, however, indicates the bearing may be entering a failed state. More frequent condition monitoring with complimentary technologies such as vibration analysis will ensure any machine downtime is scheduled on the client's terms, not the machine's.

For those unfamiliar with these data formats, Overall RMS, Max RMS, Peak, and Crest Factor are used to bring synthetic meaning to ultrasound STATIC data. Sadly, following OEM procedure resulted in over lubrication of the DE bearing.

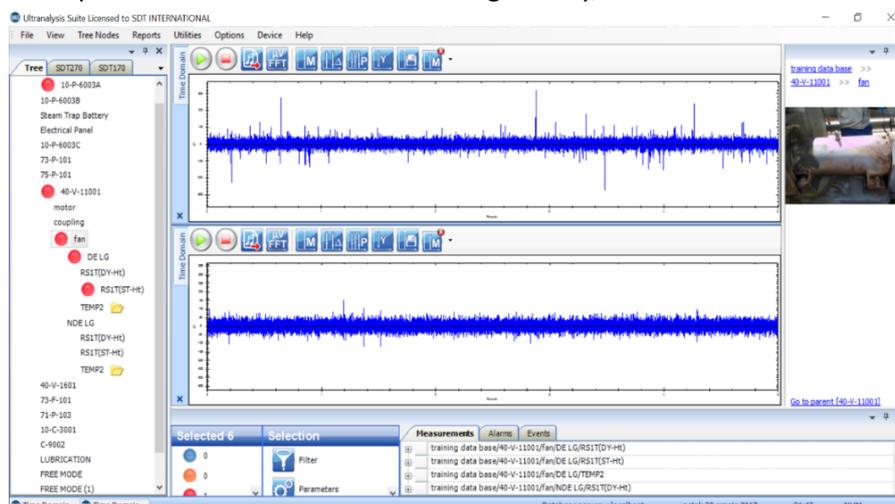
To drive home the point, Haris also captured DYNAMIC signals from the drive end bearing. As seen in Figure 6 the time signal before (bottom) and after (top) reveals new peaks and impacts forming. Over lubrication causes pressure to build inside the bearing. Ideally, the lubricant wants to feed from the

Figure 6 - Dynamic data from drive end shows the emergence of defects (top) after bearing was over-greased following OEM recommendations.

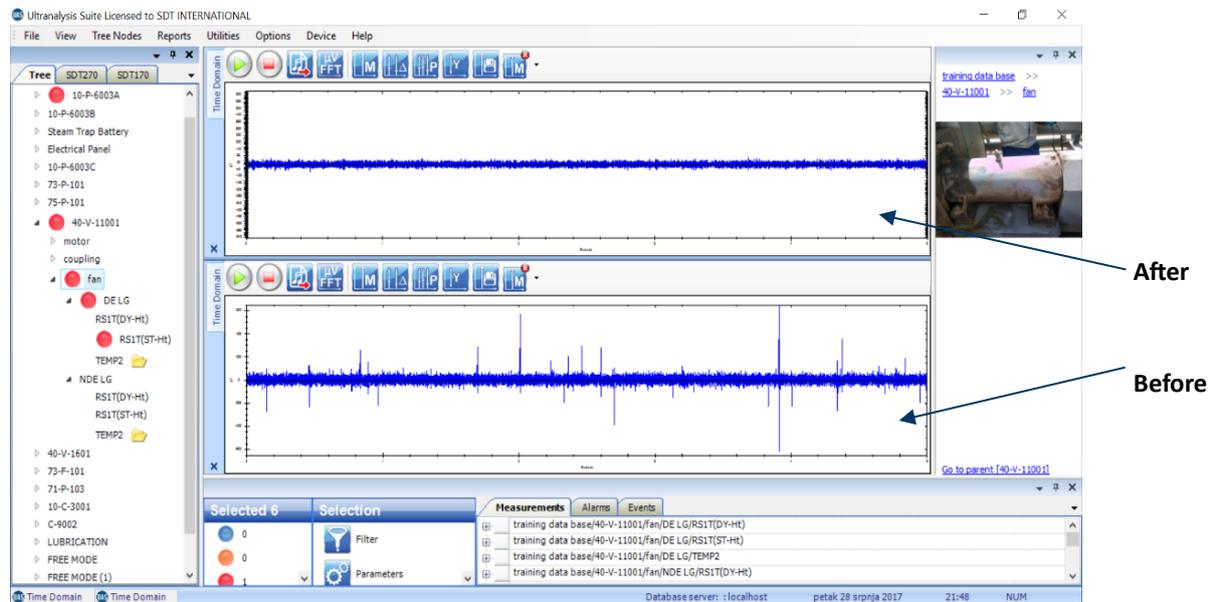
Finally, Haris collected DYNAMIC time signals on the non-drive end bearing. In Figure 7 the bottom time signal shows dominant peaks that are clearly random impacts. After lubrication those peaks are gone, as you can see in the top time signal, Figure 7. It appears that replenishing the grease in the non-drive end had some positive benefits, and those benefits are clearly illustrated in UAS.

Figure 7 - The non-drive end bearing has defects as shown by this dynamic time signal. Ultrasound assisted lubrication with SDT allowed the CM team to identify this potential fault.

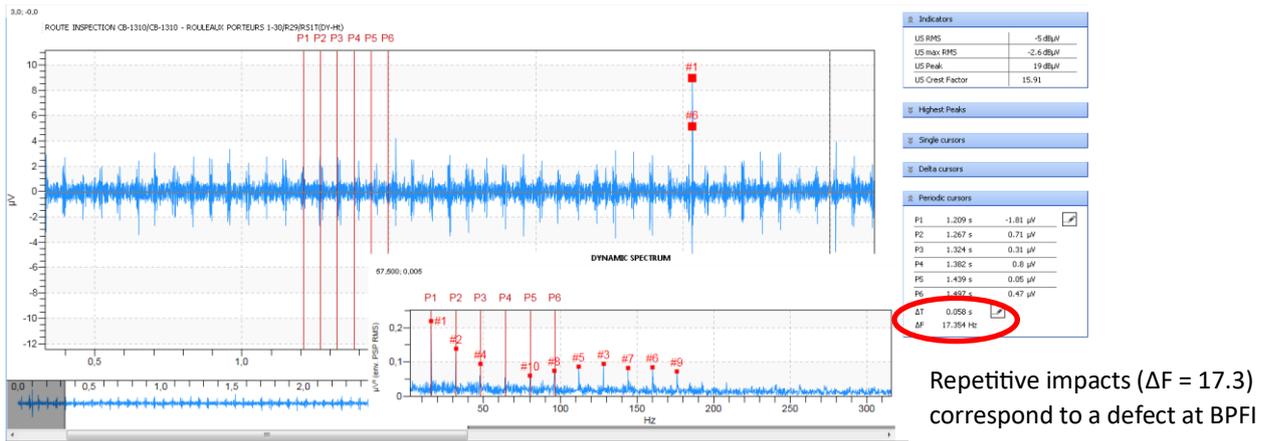
January 3, 2018: Roller Bearing R29 Internal Rolling Cage Failure (BPFI)

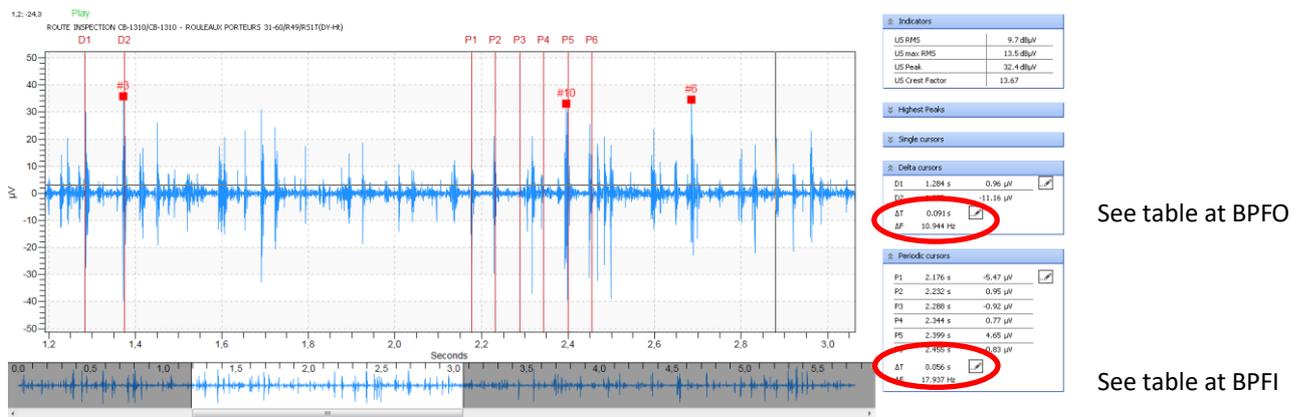
January 25, 2017: Roller bearing R49 presence of internal and external bearing failure (BPF1 and BPFO) may be that it was on two different rolls.

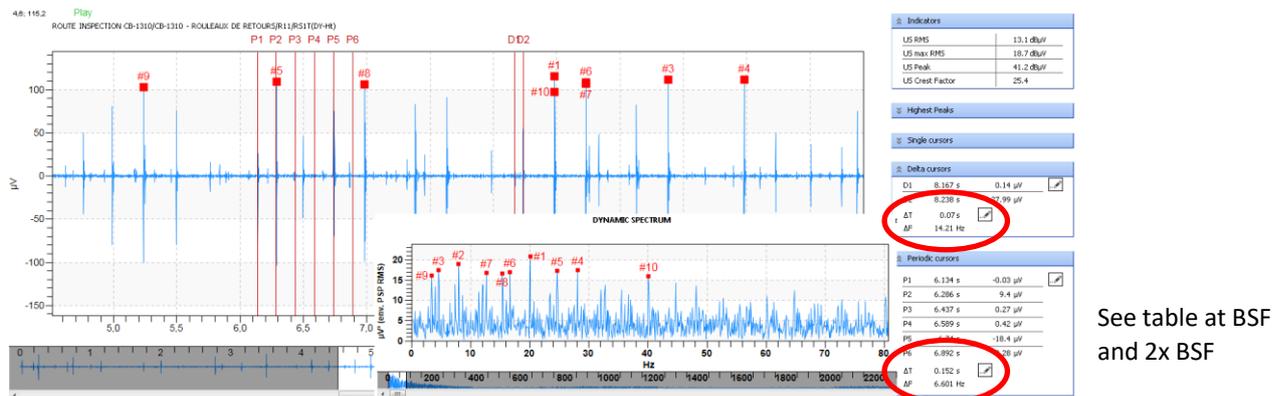
August 20, 2018: Roller back R11 bearing ball bearing frequency (BSF)

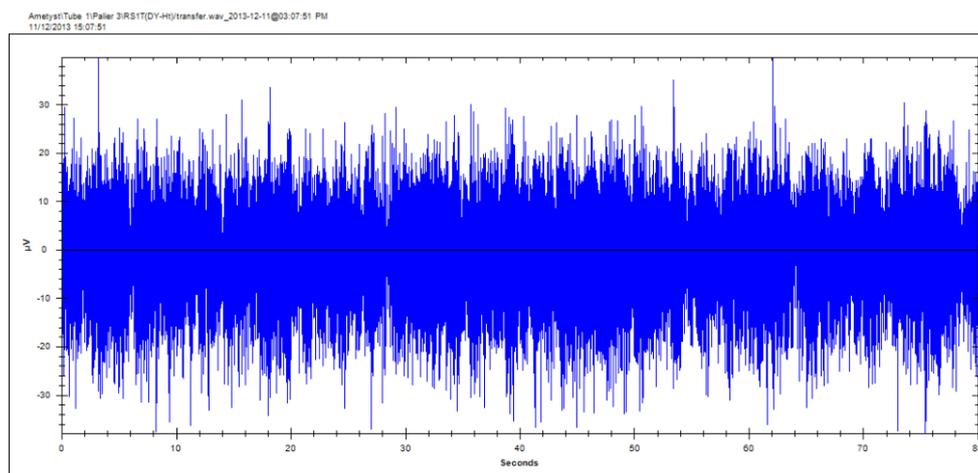
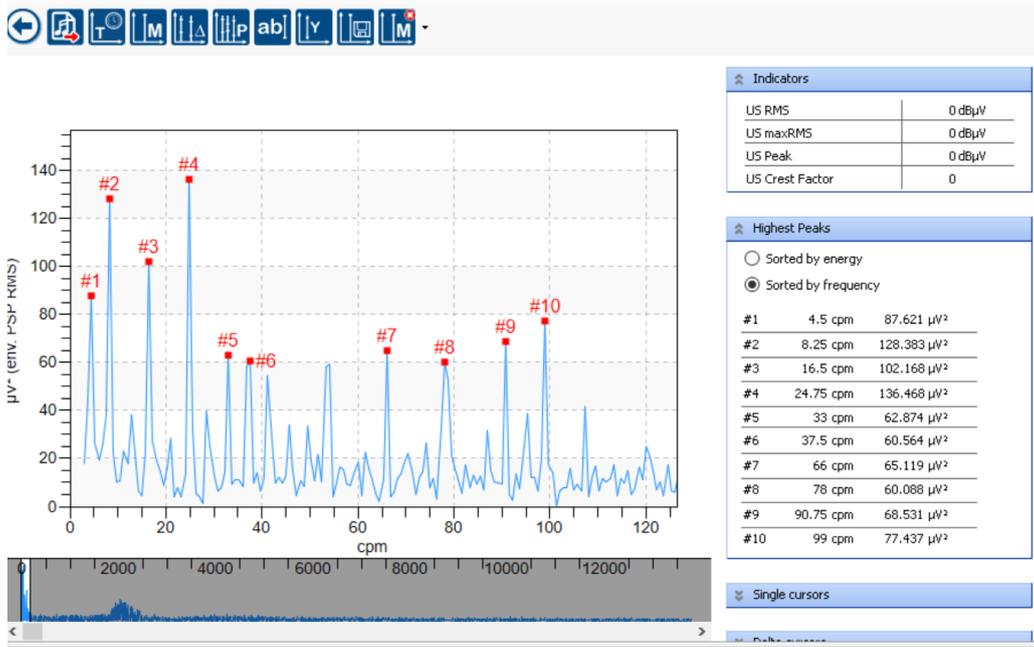
Bearing #3

Emergence of peaks on the bearing 3 spectrum, which is not the case on the bearing 2. The RMS value is 12,8 dBµV concerning the spherical roller bearing 3 and -9,7 dBµV for the spherical roller bearing 2. Replace the spherical roller bearing 3.

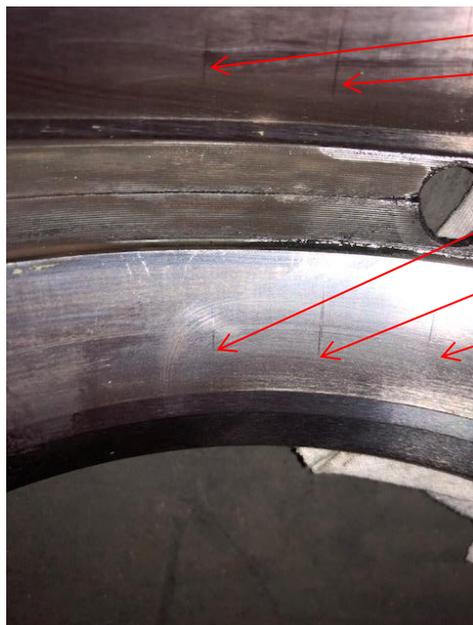
Below is a picture of the outer race of the bearing when taken out and inspected.

Grooves are worn into the outer race, and this is what the ultrasound was detecting as each rolling element contacted it. Eventually this would lead to a failure of the bearing.

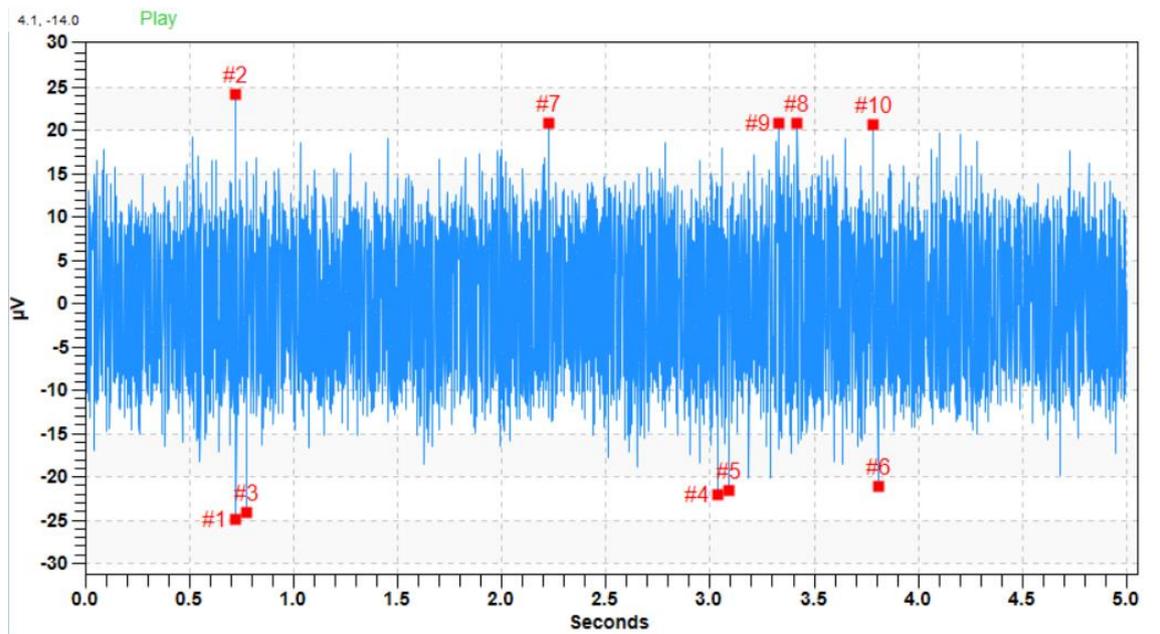
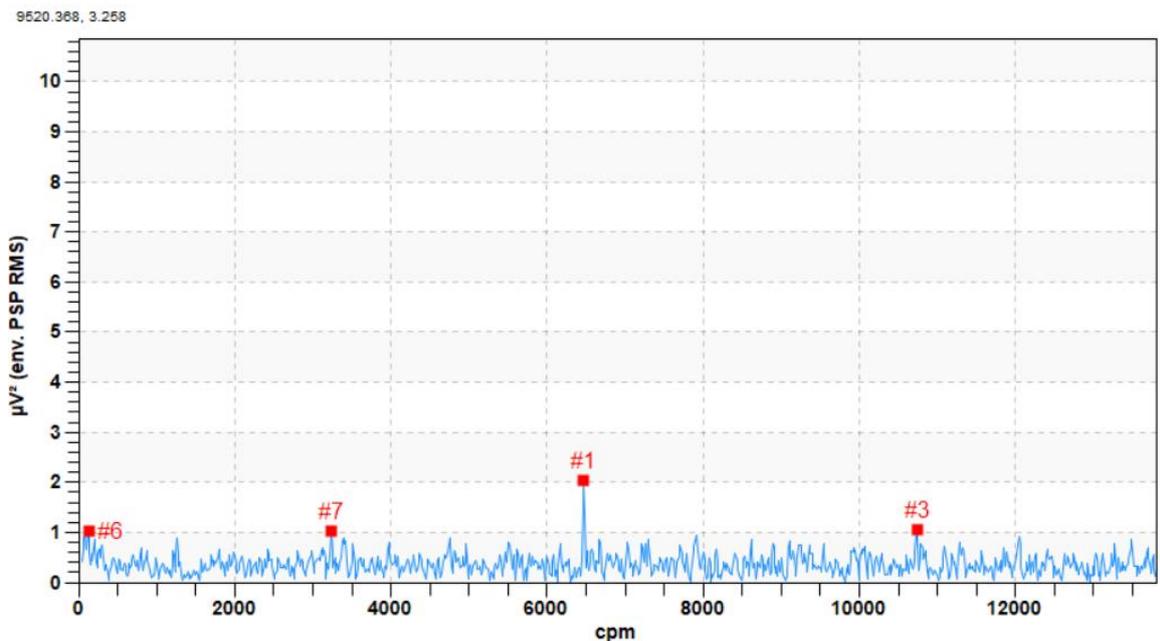
Grid coupling with no problems

No real impacting – very low energy being generated.

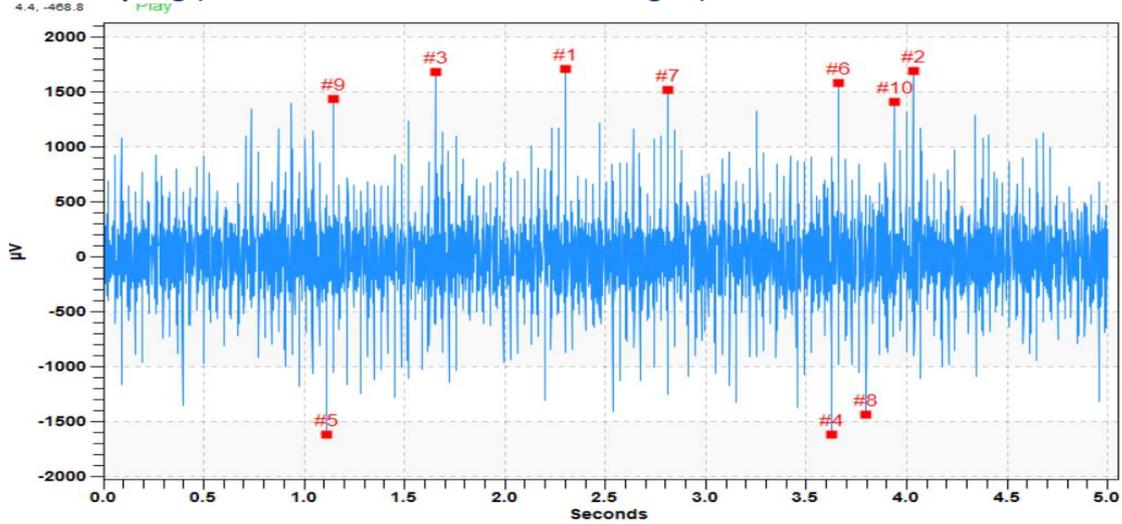
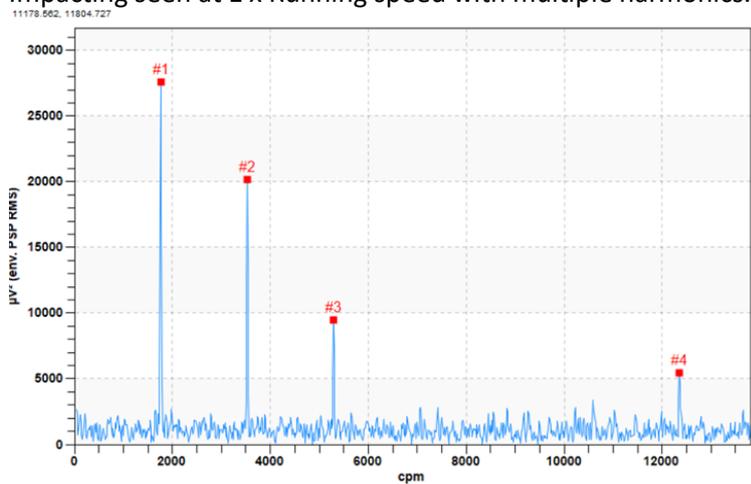
Grid coupling (Lack of lubrication and worn-out grid)

Impacting seen at 1 x Running speed with multiple harmonics.

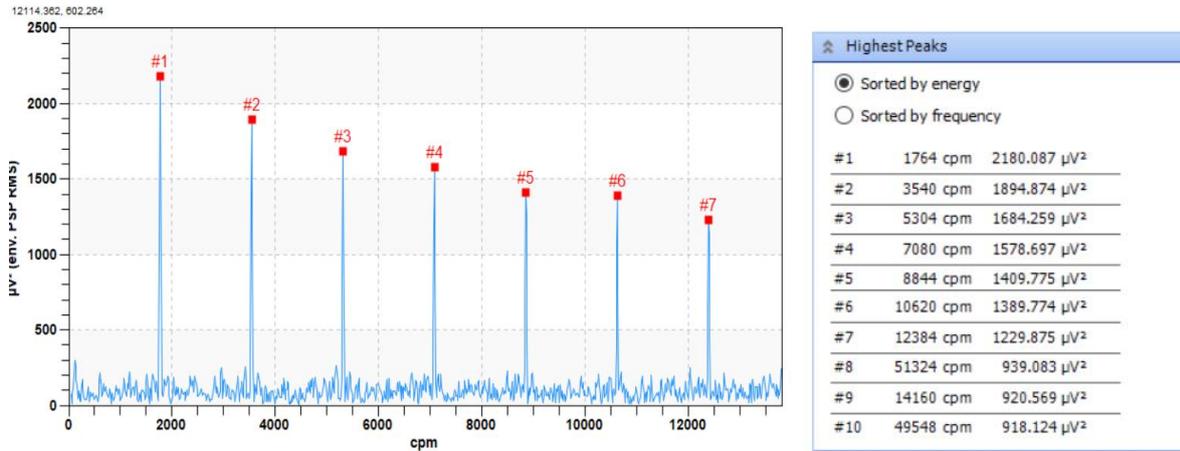
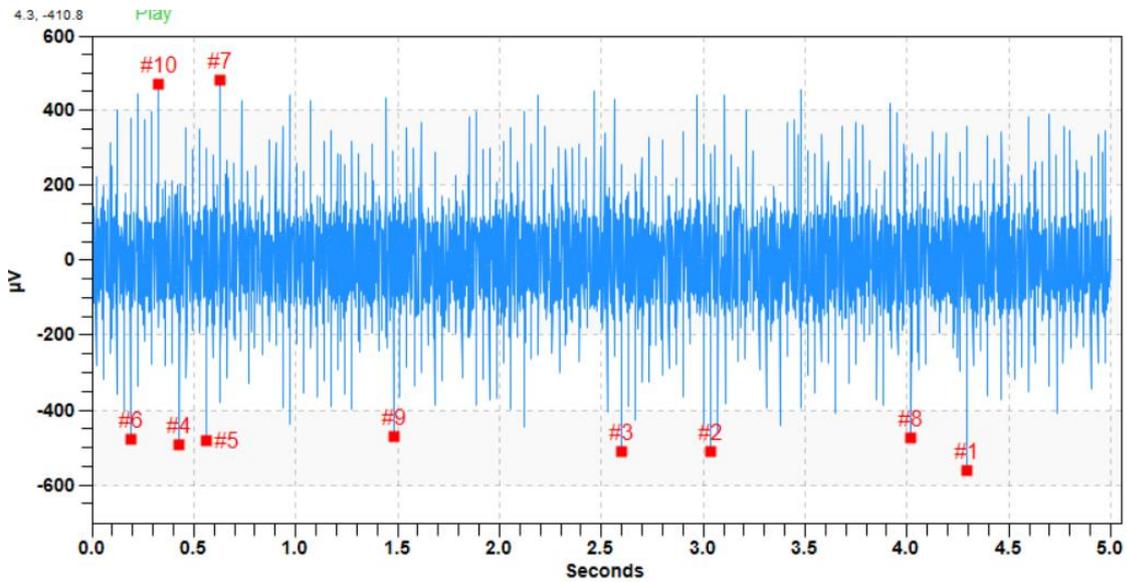
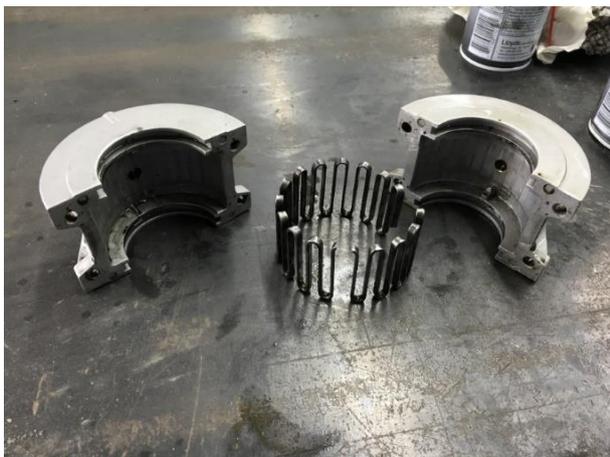
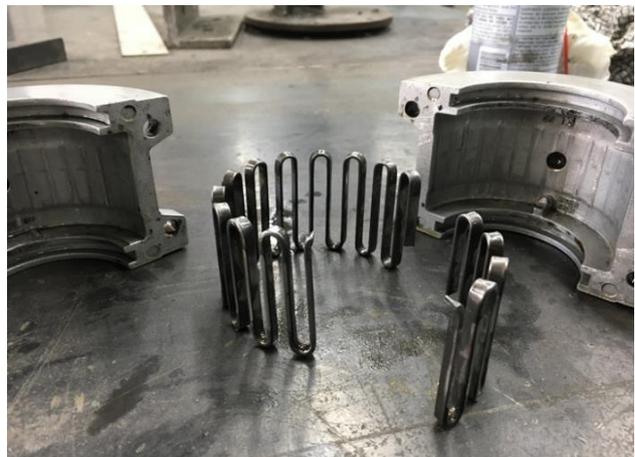
Grid coupling (broken grid)

Impacting seen at 1 x Running speed with multiple harmonics

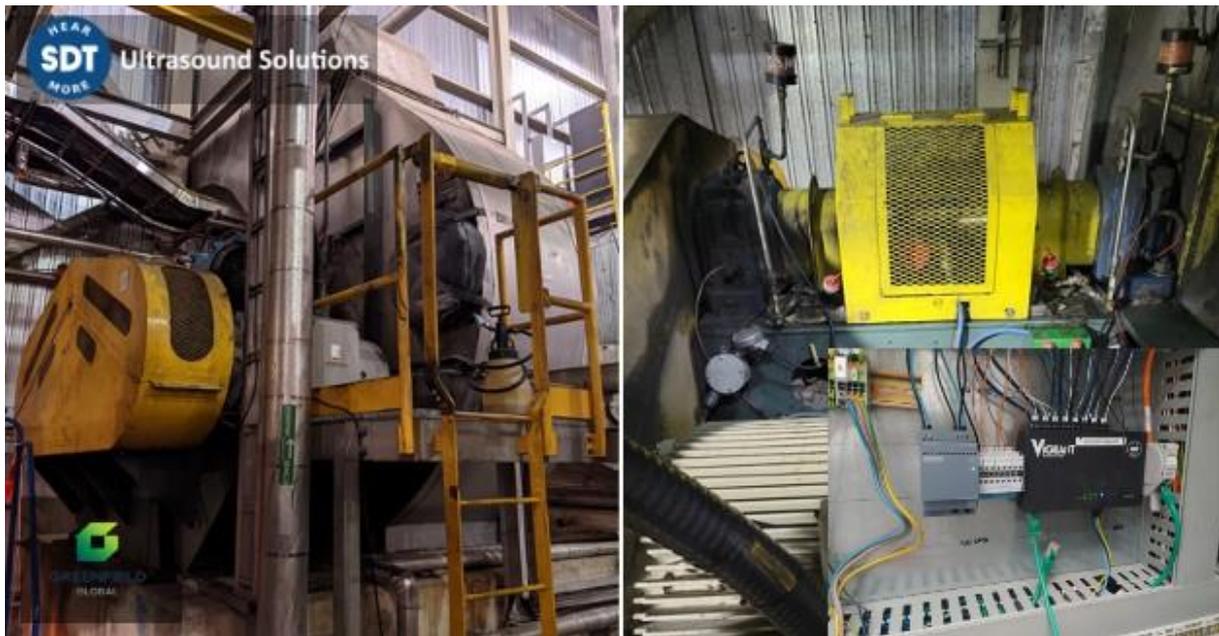
This BF-9401 Area Pulling Fan plays an integral role in Greenfield Ethanol's manufacturing process. It is a critical component to their Thermal Oxidizer Equipment. If this fan goes down, production is severely hindered, and possibly even stopped all together.

Vigilant System Permanent Install on Critical Fan Bearing

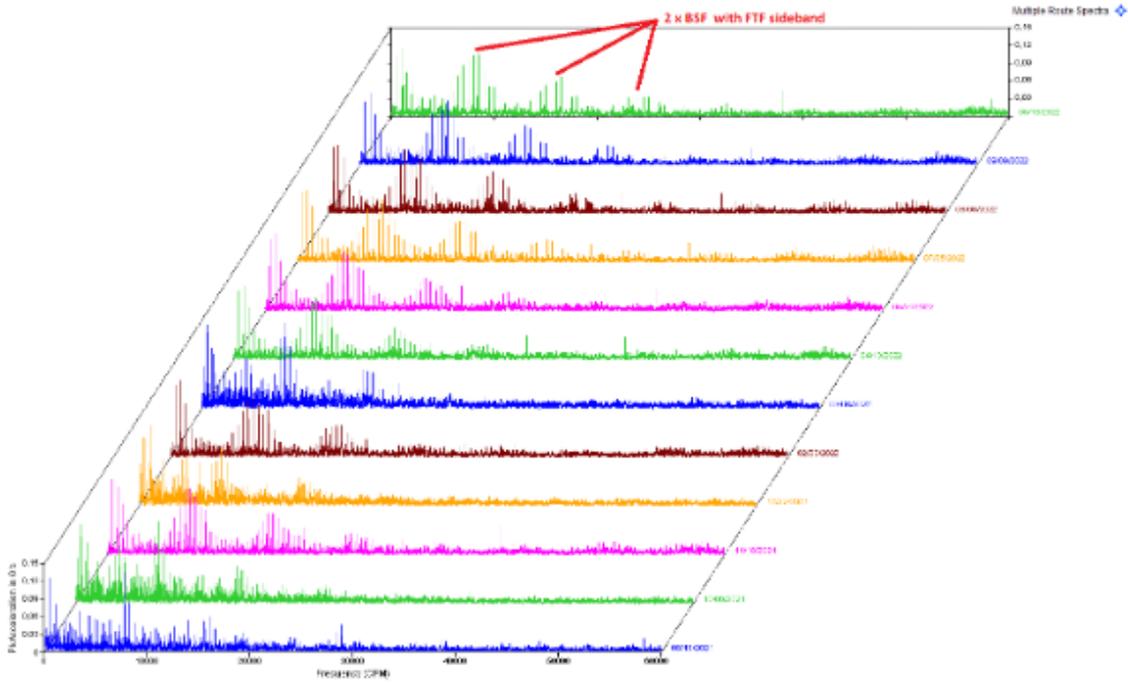
Lead Vibration Analyst, Jonathan Dion takes routine vibration measurements on this plant's critical equipment. Back in 2018, a defect was detected on the pulley side of the fan (SKF 22232). It has since been evolving. Using the acceleration envelope filter in Peakvue, it can be seen clearly.

Figure 1 – Envelope Spectrum (Peakvue)

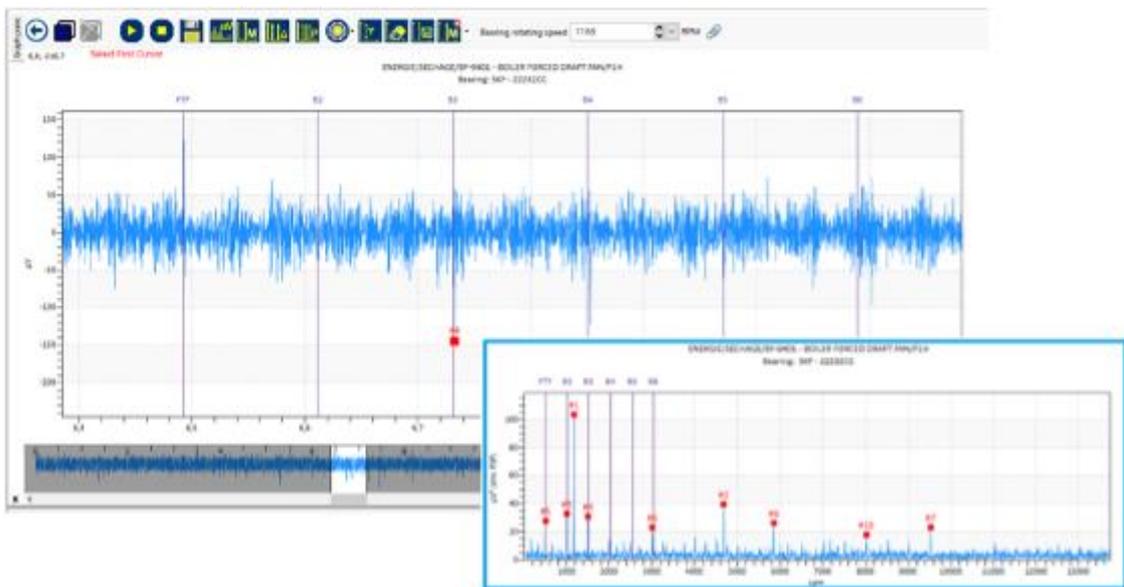
The following ultrasound readings were taken on September 9, 2022, helping confirm the findings from the Vibration readings.

Figure 2 – Ultrasound Readings (UAS3)

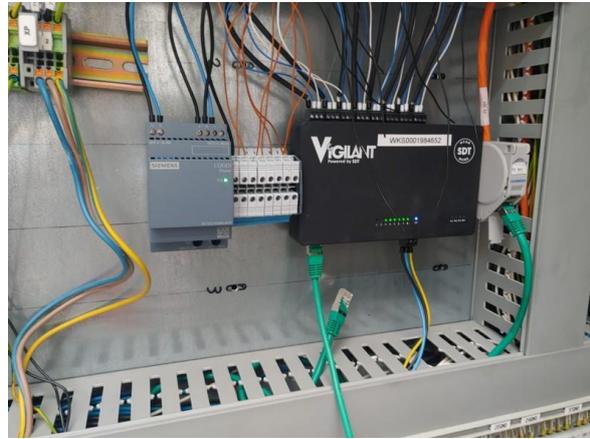
The Vigilant System is an 8-Channel Online Condition Monitoring Solution that combines the versatility of ultrasound and the analytics of vibration. Vigilant comes standard with its own embedded software that any member of the reliability team can access using the correct network credentials.

Vigilant System

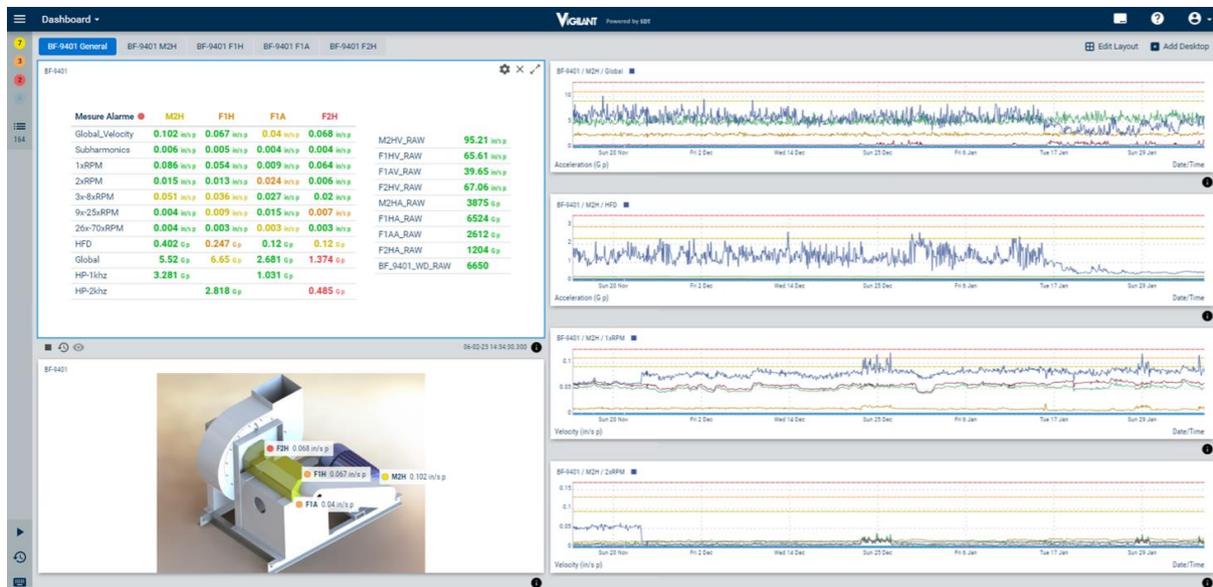
- M2H horizontal drive motor
- F1H : fan side drive Horizontal
- F1A : fan side Axial drive
- F2H : fan opposite drive side Horizontal

Figure 3 – Vibration Sensor Configuration & Dashboard (Vigilant Embedded Software)

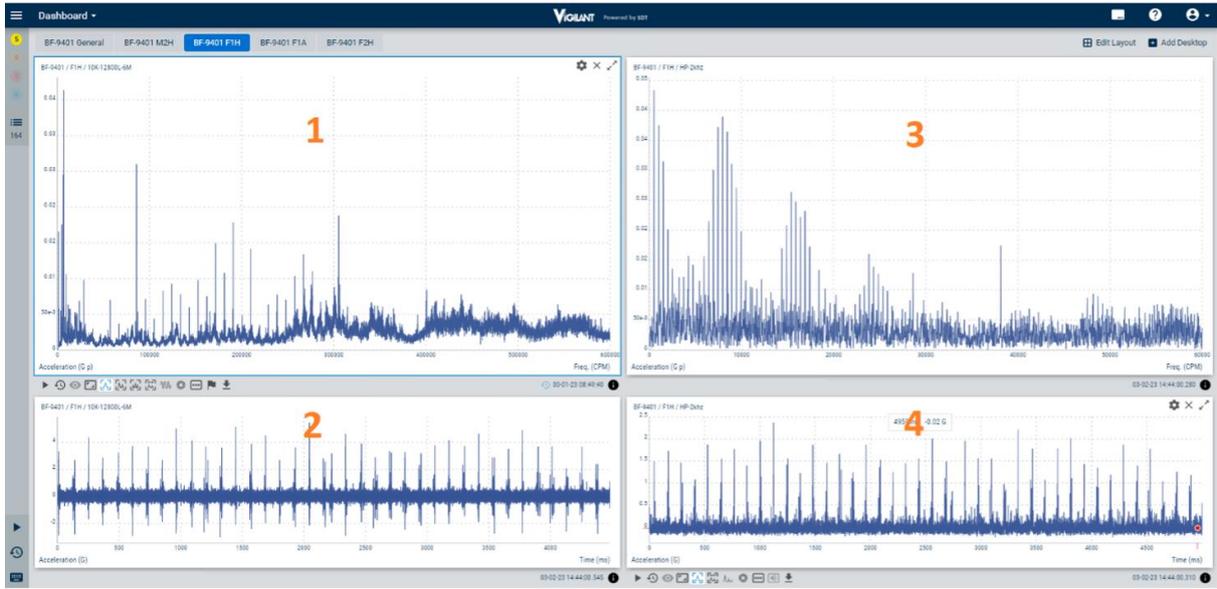
The reliability team's focus was monitoring data collected by the F1H Accelerometer. Monitoring technicians split their windows into 4, all with different lines of resolution as to see rapid changes as well as changes over a long period of time.

Figure 4 – Vigilant Window Configuration

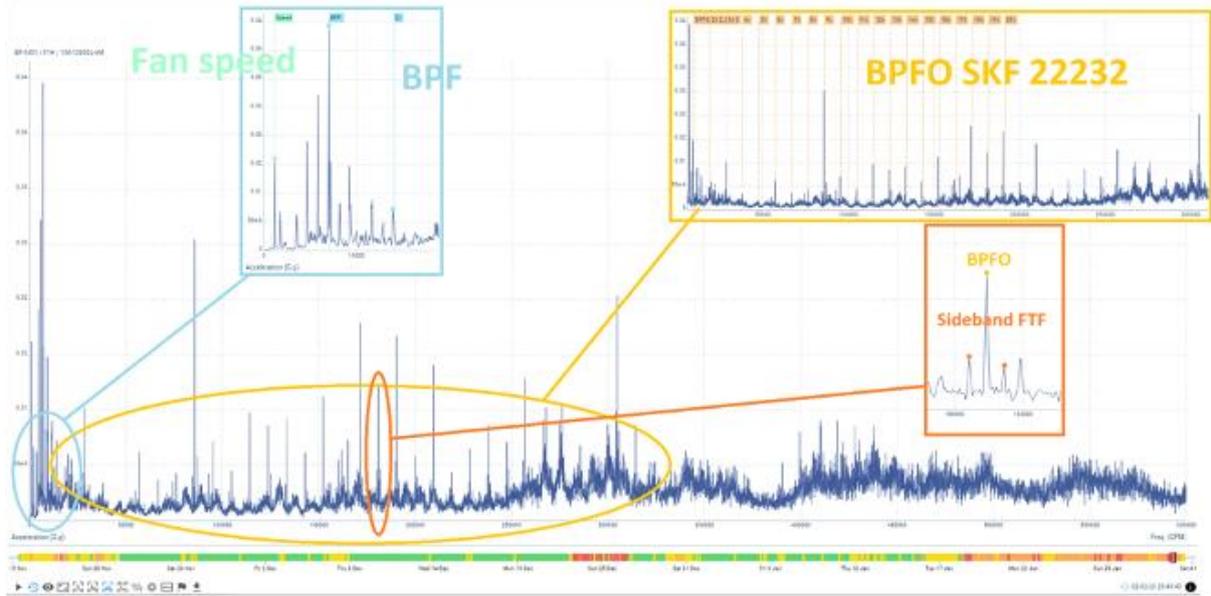
Window 1 - Max. Frequency 10000hz, Lines 12800, Averages 6 – February 2, 2023
