SUCCESS STORIES

Ultrasound Solutions

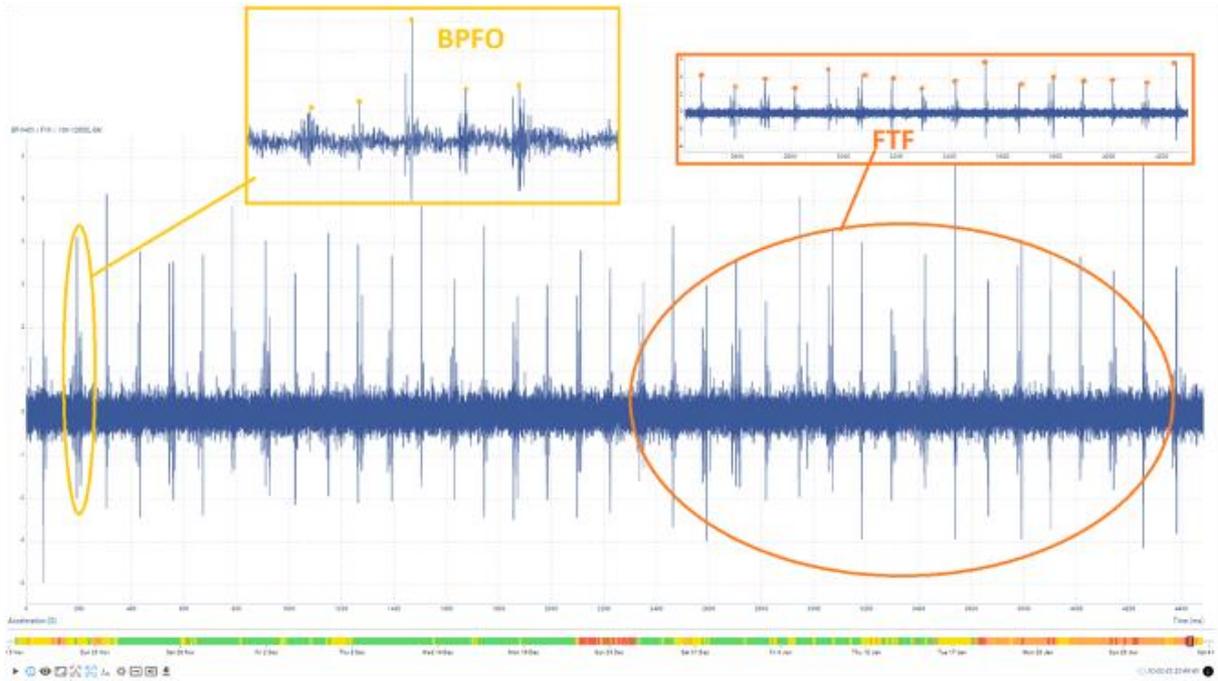
Window 2 – Time Waveform – Duration: 4.485 seconds – Points: 114817 – February 2, 2023

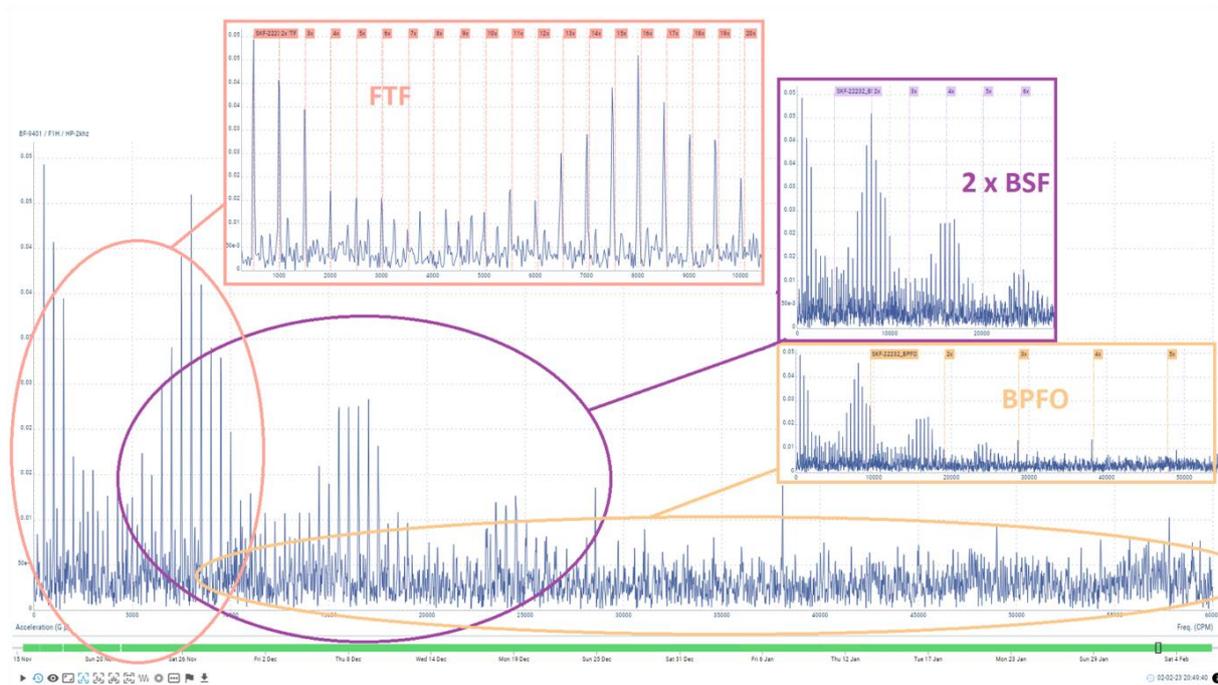
Window 3 – Envelope Spectrum – High-Pass Freq. 2000hz, Max. Freq. 1000hz, Lines 3200, 1 Average – February 2, 2023

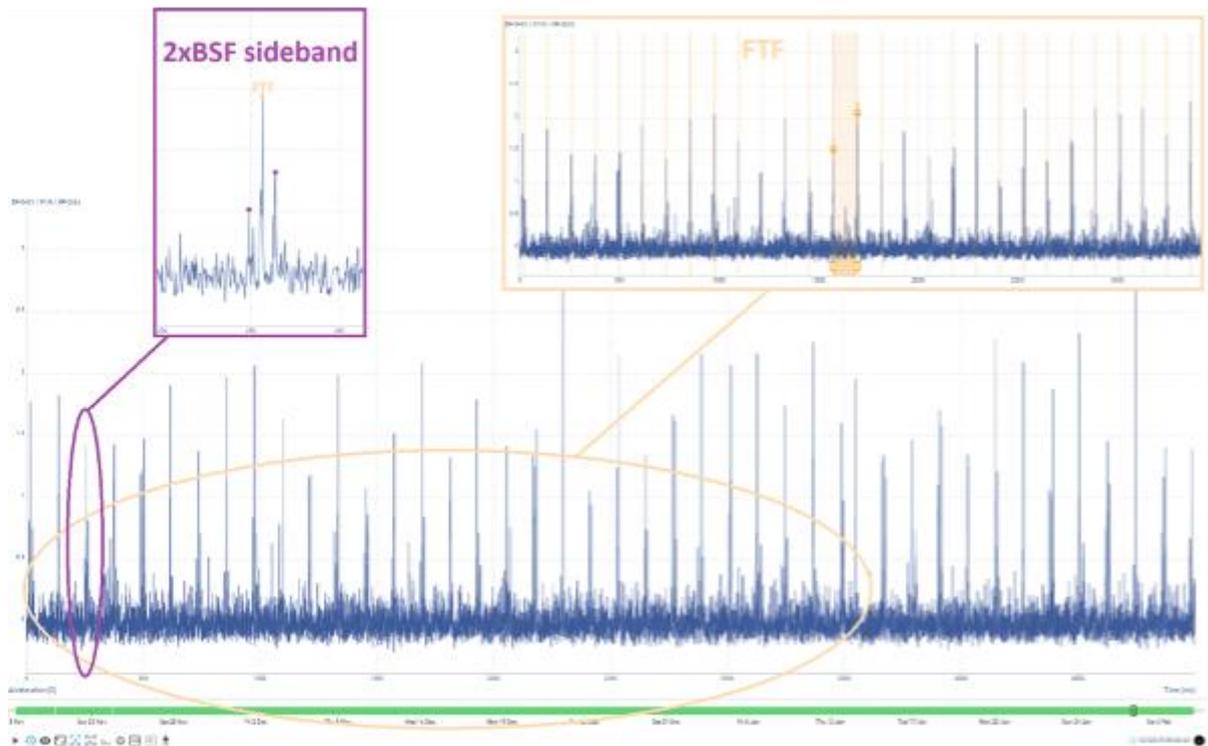
Window 4 – Envelope Time Waveform – High-Pass Freq. 2000hz, Duration: 5.05 seconds – Points: 12800 – February 2, 2023

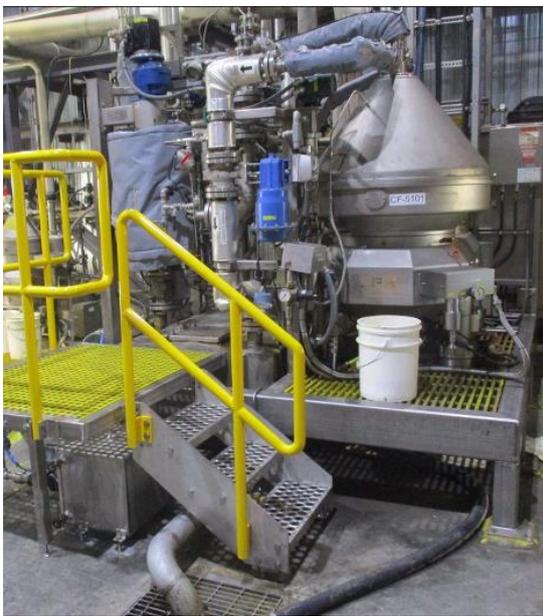
Figure 1 - Centrifuge - Greenfield Ethanol

This centrifuge in question rotates at 5250RPM, and it has a suspected bad bearing. The following Figure 1 & 2 depicts the bearing & the asset.

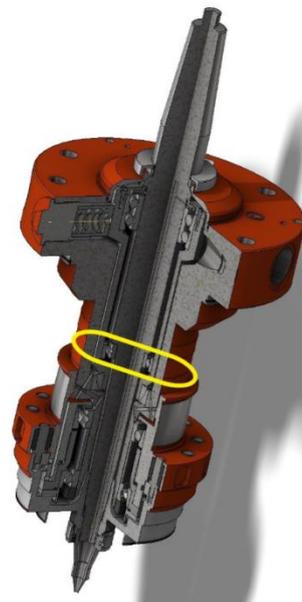
Figure 2 - Centrifuge Diagram - Bad Bearing in Question

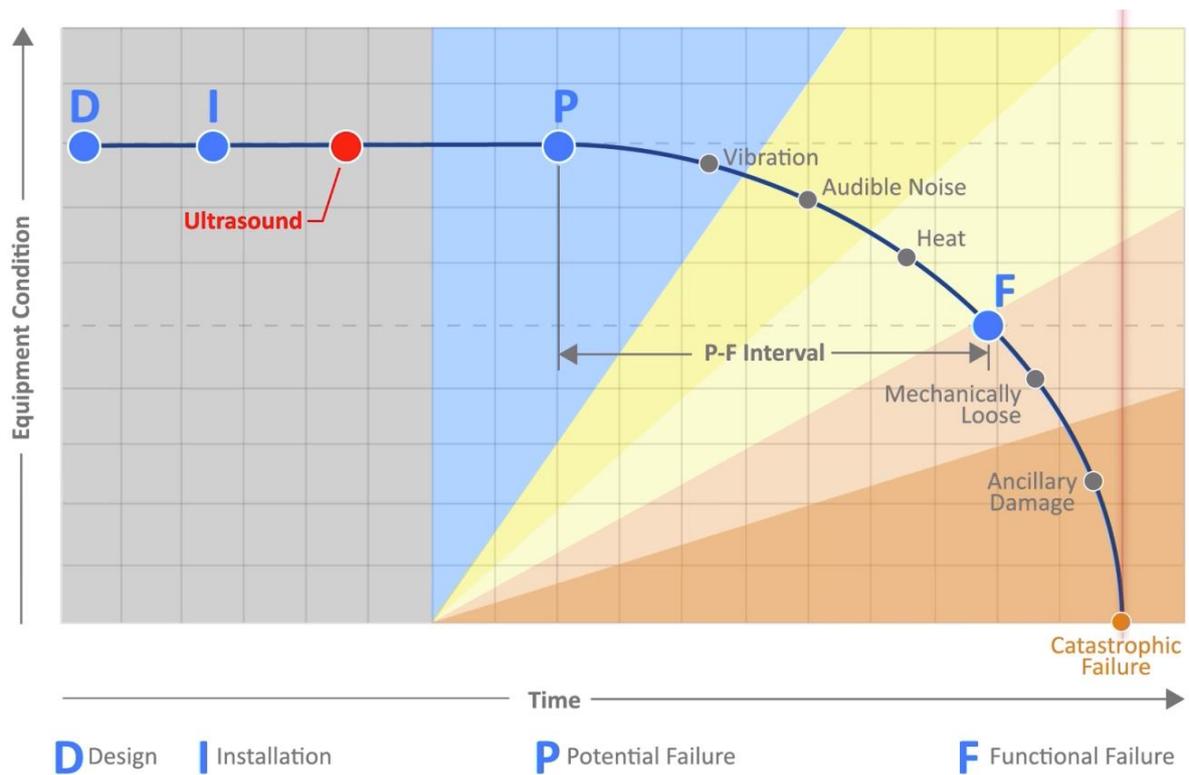
Figure 3 - DIPF Curve

A similar situation arose at his plant. He discovered a bad bearing on a centrifuge using his SDT Ultrasound Data Collector. The fault was not yet visible with his vibration analysis tools. No cause for concern yet, the bearing had a lot of life left, but it was in the early stages of failure. Still, no reason to use unplanned downtime to replace the bearing. The plan is to replace the bearing during the next scheduled shutdown. Please see the DIPF curve in Figure 3.

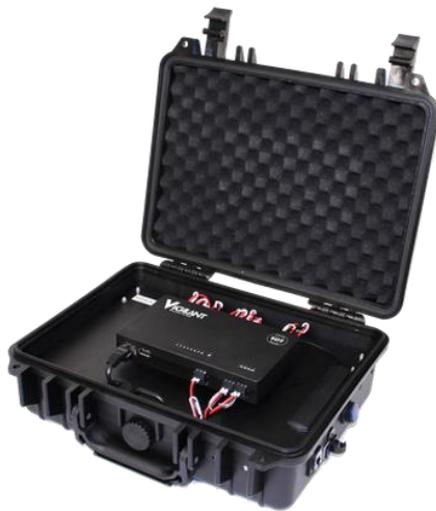
So, Jonathan did what any savvy reliability engineer would; used his Vigilant System (as per figure below) to establish permanent monitoring on this critical bearing, as operations and production continued. Jonathan used both ultrasound and vibration to monitor its condition.

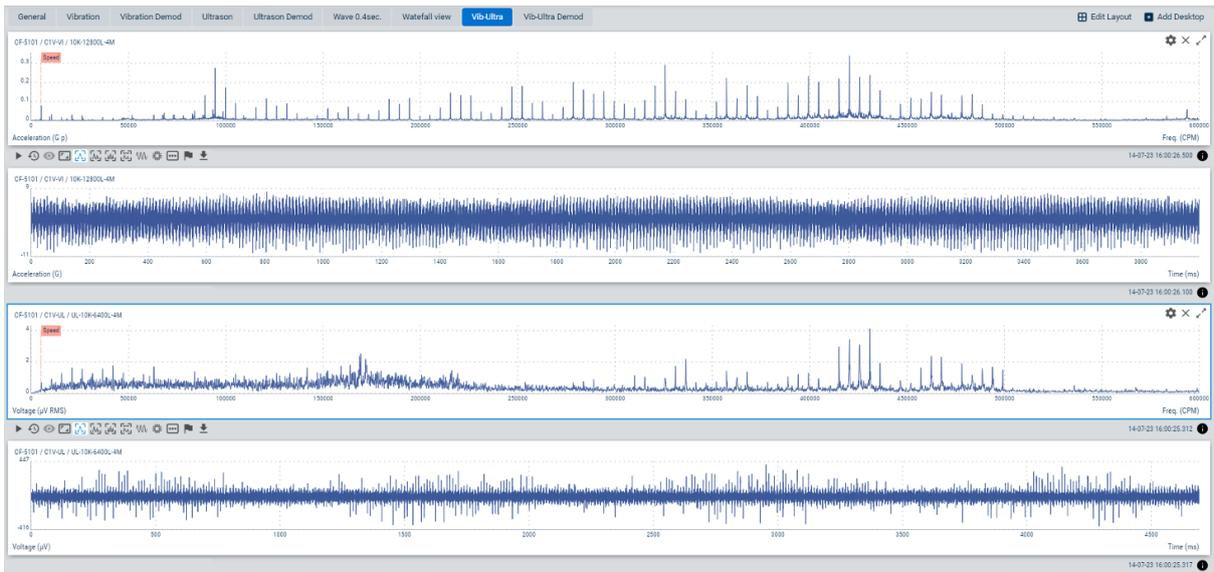
For the next few months, the bearings condition continued to slowly deteriorate in the ultrasound spectra. It was eventually visible and well defined in the vibration spectra and demodulated spectrum, as seen in the data in Figure 4 & 5.

Figure 4 - Vigilant Dashboard - Ultrasound & Vibration Spectra

The severity of the problem has clearly increased since it was first discovered with ultrasound. It is now visible in the vibration spectra, showing a ball pass frequency outer race defect with 1x rpm sidebands.

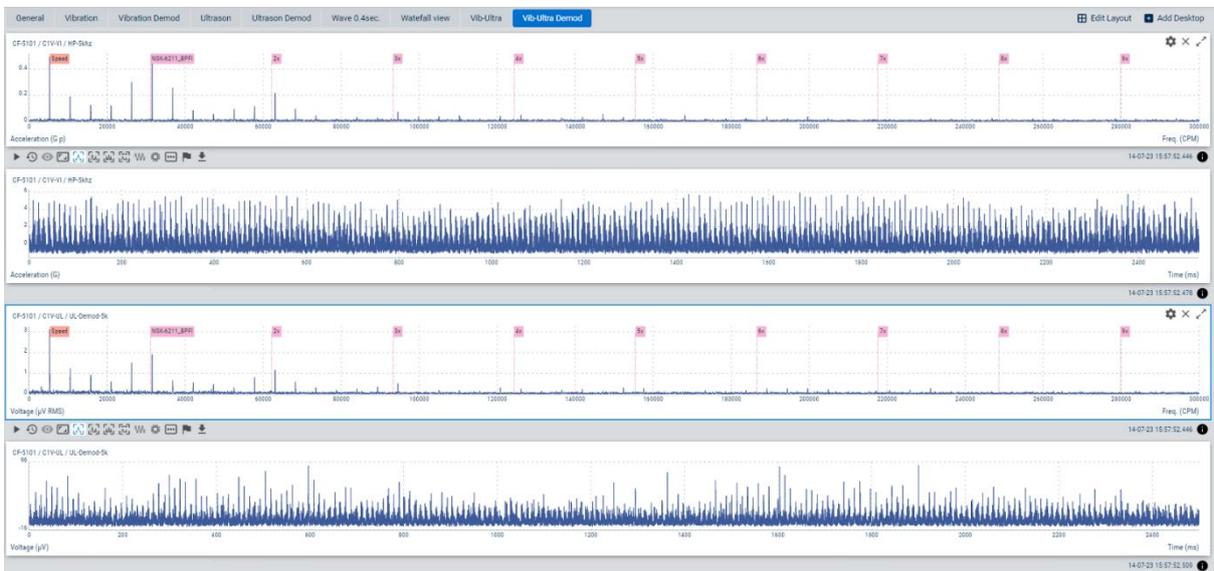
Figure 5 - Vigilant Dashboard - Ultrasound & Vibration Spectra Demodulated

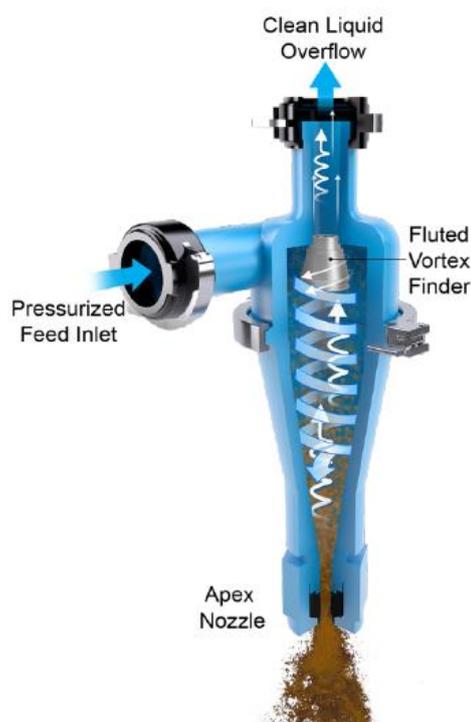
The major components of each centrifuge within the nest can be seen depicted in Figure 1. Key components include:

- Feed Inlet (Where the slurry of pulp enters the centrifuge)
- Fluted Vortex Finder (Where the vortex occurs)
- Apex Nozzle (Where concentrated solids exit the vortex)
- Overflow (Where diluted solids exit the vortex)

Figure 1: Hydro-Cyclone Components

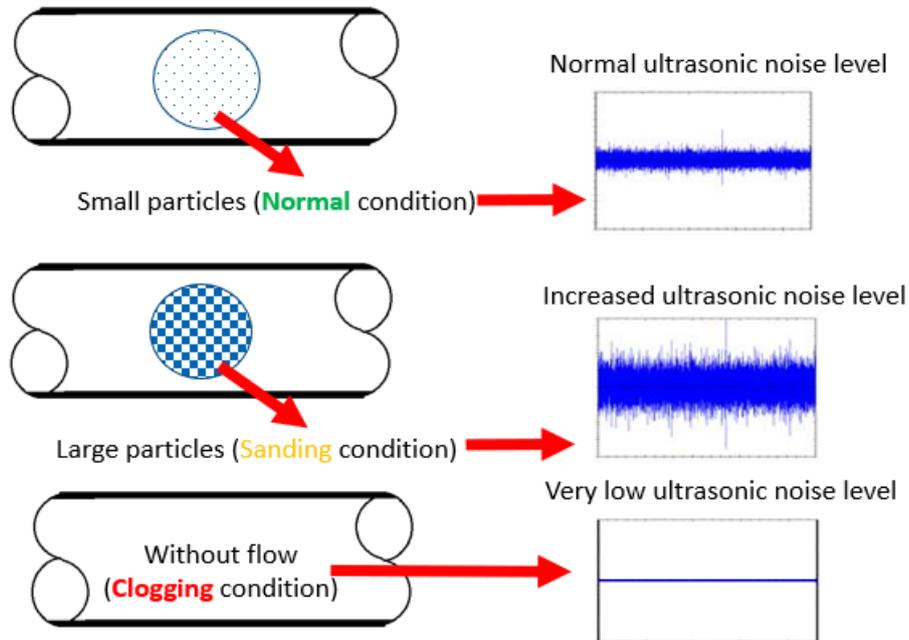
- Small particles (normal condition)
- Large particles (sanding condition)

- Without Flow (clogging condition)

Figure 2: Normal, Sanding, Clogging Condition & their Ultrasound Signals

These can be further illustrated in Figure 2.

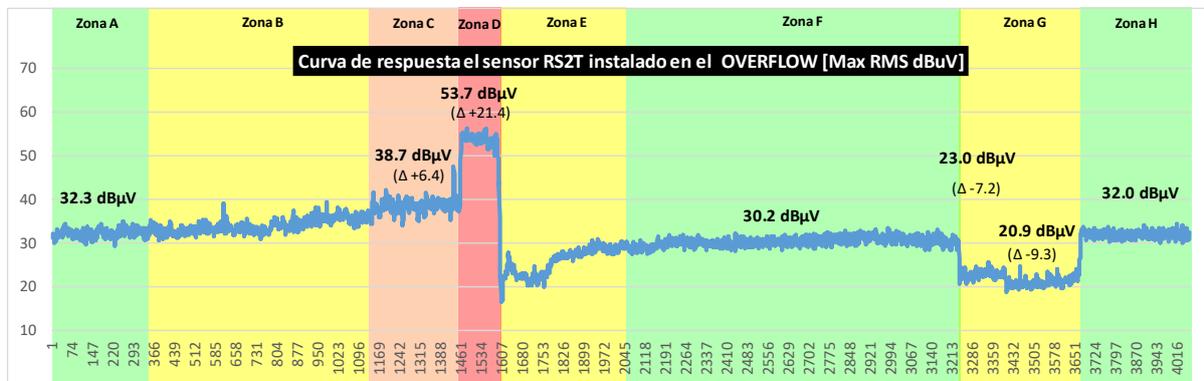
We conducted preliminary tests to ensure the installation & permanent monitoring would work. The results can be seen in Figure 3 below.

Figure 3: Preliminary Test Data

- Zone A indicates normal condition
- Zone B, C, D indicates sanding as it is intentionally induced gradually
- Between Zone D & E – Clogging occurred, the Emergency Stop was triggered
- Zone E – Process was restarted after the clog was removed
- Zone F – Normalized operation was achieved again
- Zone G – Flow was intentionally decreased
- Zone H – Normalized Operation was achieved again

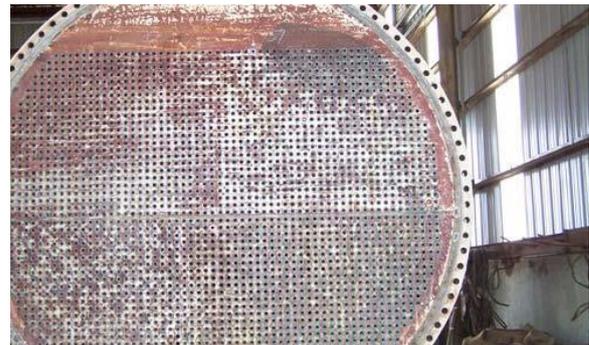
Figure 1 - Tube and Shell Condenser

Shell and tube heat exchangers consist of a bundle of steel tubes entombed in a shell. For the installation to perform effectively both bundle and shell must be leak free.

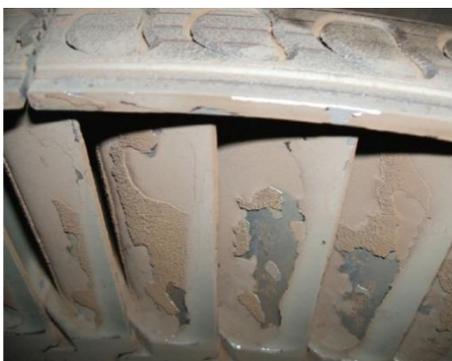
Figure 2 - Scaling on turbine blades

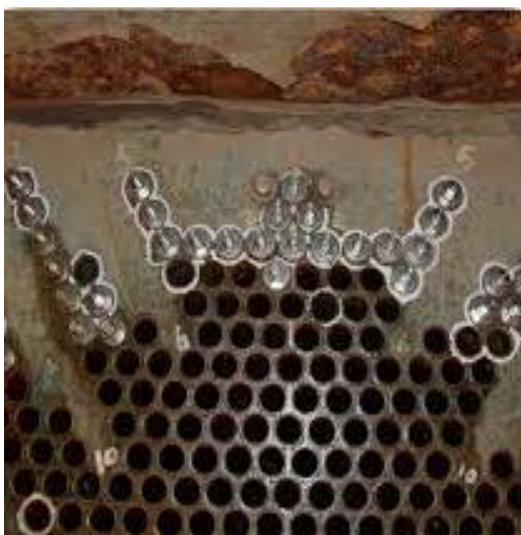
Figure 3 - Leaking tubes are identified and plugged

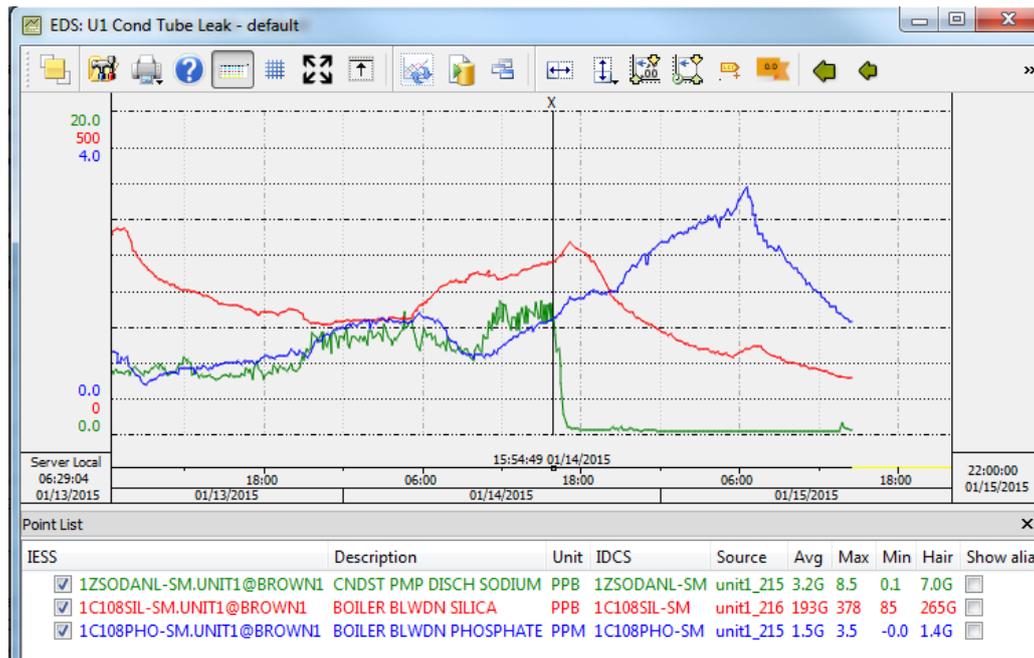
Figure 4 – Rising sodium and silica leaks in Unit 1 indicate small tube leaks. Condenser flushed on January 14, 2015, restored normal levels for now.

Figure 4 shows a typical graph trending higher silica and sodium levels in the cooling tower water on Unit 1. The presence of contaminants is below the 750 PPB threshold, but it puts Phipps' team on notice. On January 14, 2015, his team isolated and drained half of the condenser (Unit 1, 216) with the leak. The green line is the sodium and it immediately dropped; however, it takes a while for the silica levels to respond. The red line shows the gradual drop in silica. These levels will gradually rise again unless the tube leaks are found and isolated.

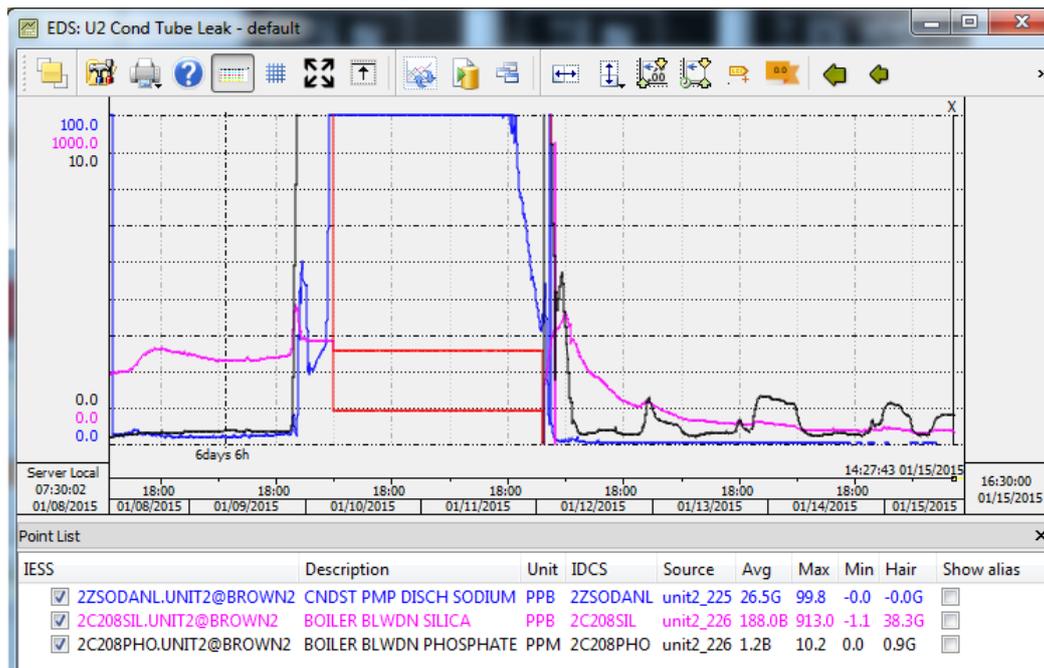
Figure 5 - Significant tube leak on Unit 2 caused reduction in output. Unit was shut down on January 10th and 11th for dye test. Leaks were found and isolated. Silica levels restored to normal by January 13th and 14th.

On January 10, 2015, sensors indicated high levels of sodium and silica in Unit 2. With valves they isolated and drained half of the condenser with the leak. See Figure 5.

We knew we had a tube leak in Unit 2's condenser, in fact, during a planned outage they did a dye hydro on it to locate the tube leak. This graph of Unit 2 shows the difference in the silica and the sodium when we have a tube leak. Disregard the area between January 9 and 12 as this was the area that the Unit was offline, and the condenser tube side was filled with water and dye. Just look at the difference in the "pink" (Silica) amplitude before and after.

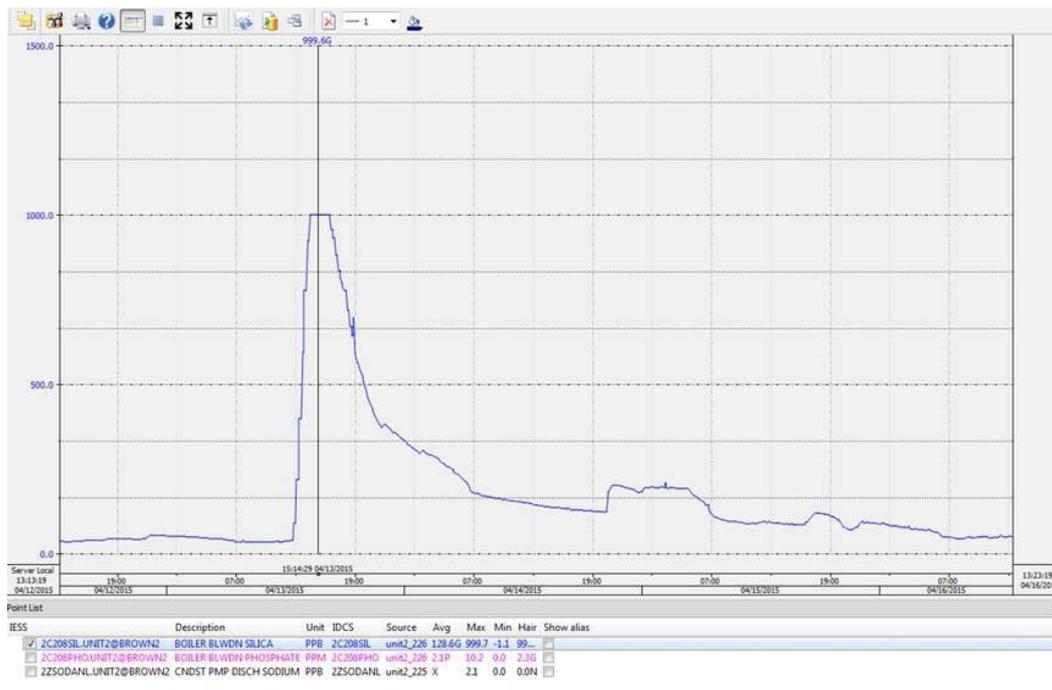
Silica levels spiked in the cooling tower blowdown water at 3:15 pm. Looking at the graphic below, the control room was alerted when blowdown silica spiked to 1 000 ppb (parts per billion).

Figure 8 - Silica levels spiked on 04/15 indicating new and significant leaks on Unit 2 226.

This graphic conveniently points out the source of the spike too. Unit 2 226 tells them which side of the condenser to valve out. The turbine can keep running, albeit at reduced capacity, while the ultrasound team heads in to find the leak.

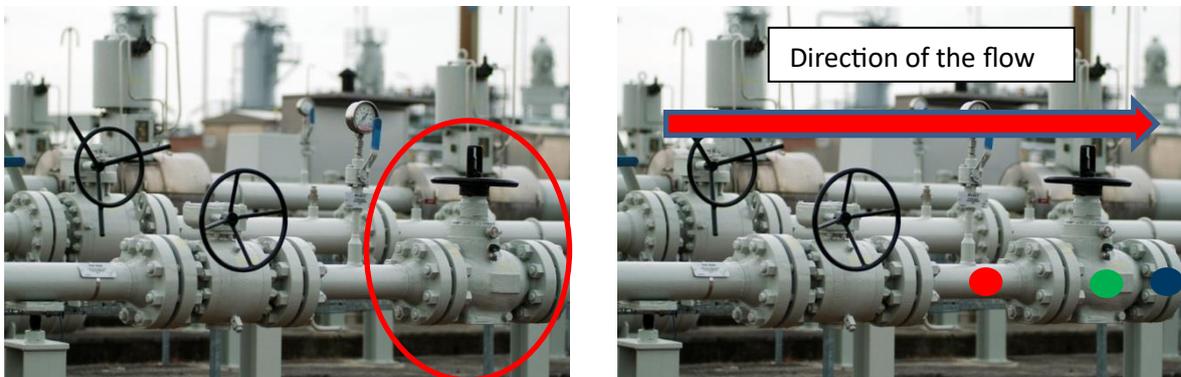
Inspection of a pressure reducer on a natural gas installation. measurement

● Upstream measurement ● Seat measurement ● Downstream

With an SDT detector, valve testing involves placing a contact sensor at three points: upstream, on the seat and downstream of the valve. Diagnosis is quick and immediate, based on a comparison of the 3 measurements. A rise in pressure on the valve seat indicates that the valve is leaking. This is confirmed by listening: the operator actually hears the leak.

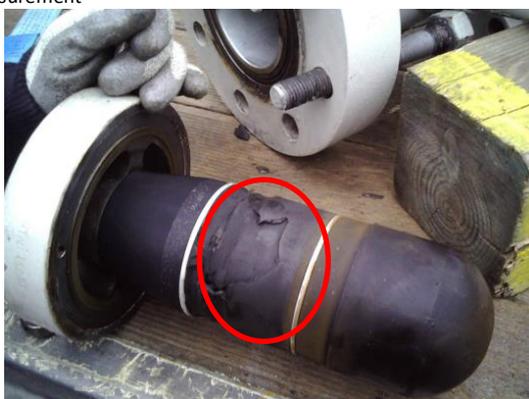
The customer's assessment after dismantling the regulator

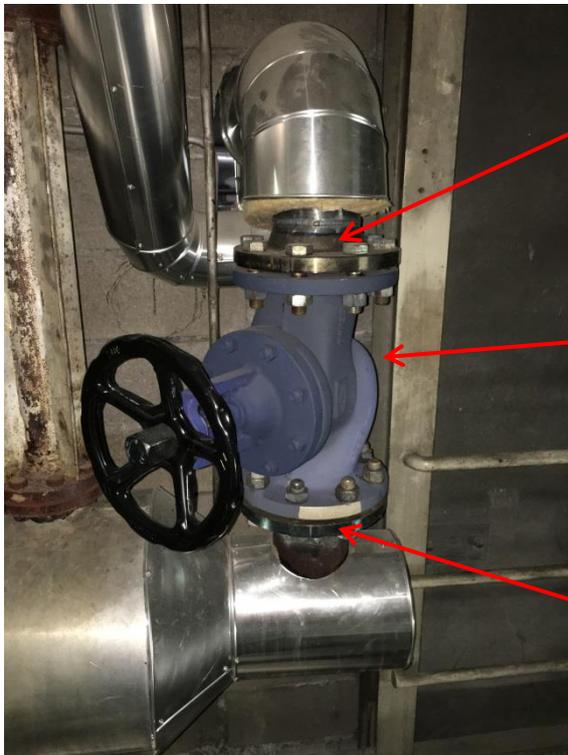
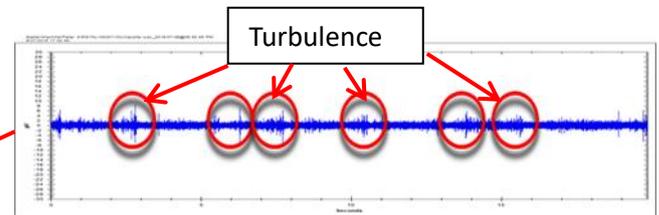
Below is a second example of a leak test on a steam valve in a boiler room at a cardboard plant.

Measurement downstream of steam valve

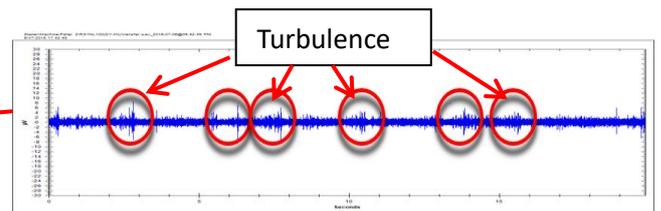
Measurement on steam valve seat

Turbulence on the steam valve seat and downstream of the piping (highlighted on the spectra above), demonstrates that this component is leaking. This enabled the Maintenance Manager to confirm the failure of this component, which could cause a problem in the boiler room process.

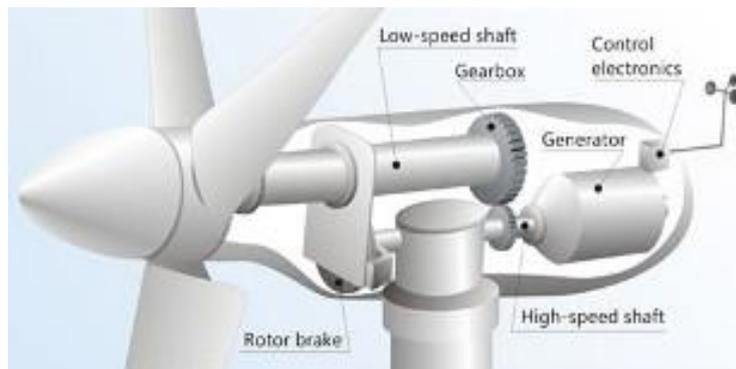
Inside the Nacelle

Choosing the right condition monitoring technology enables maintenance and reliability technicians to perform their job better and more efficiently. A look inside the nacelle depicts a wind turbine's critical components. The main bearing connects the turbine blades to the rest of the mechanism. This main turbine shaft turns around 10-20 rotations per minute, depending on wind speeds. The turbine's gearbox, and the generator drive end, and non-drive end turn much faster than the slow-speed main shaft.

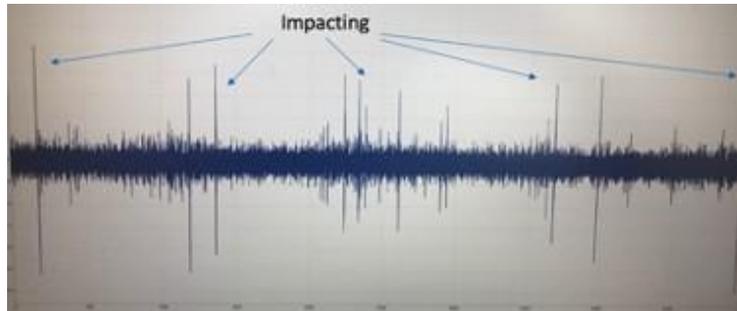
Planetary Bearing - As expected from the initial vibration data, ultrasound reading confirmed the presence of impacting.

The wind turbine maintenance technicians benefitted from installing the Vigilant System by gaining 7 permanent ultrasound data collection points on the critical components of their wind turbine. Using their new data, they were able to confirm a suspected defect on the planetary bearing which was originally detected using vibration analysis.

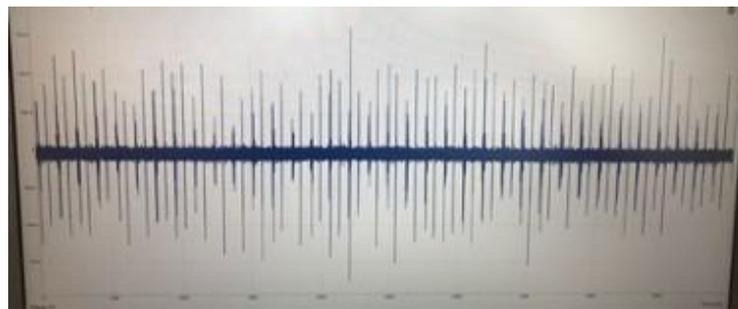
Slow-Speed Main Bearing - The initial ultrasound reading on the main bearing came back higher than expected with lots of impacting. SDT's recommendation was to lubricate the bearing. Ultrasound decibel levels dropped afterwards, indicating a reduction in both friction and impacting as seen in the figure below.

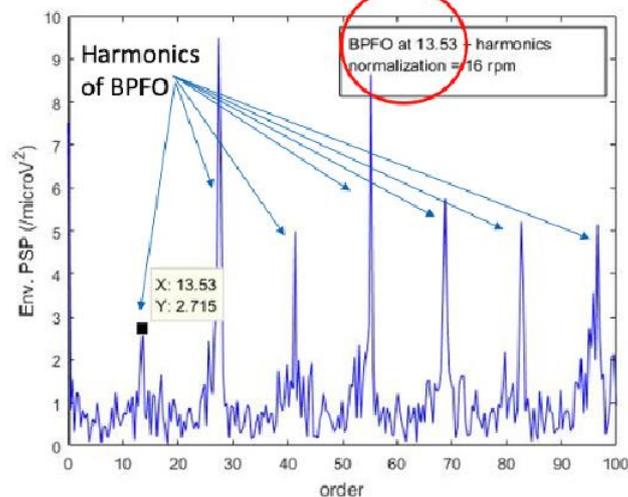
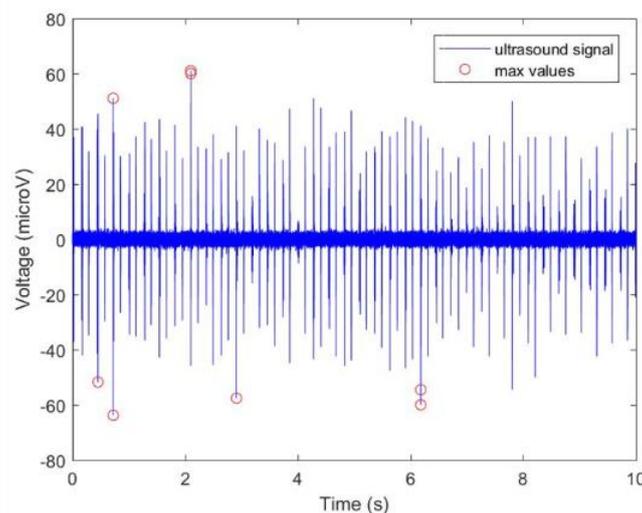
16RPM approximately at time of collection

Additional analysis was conducted on the main bearing. Repetitive impacts were discovered at a BPFO of approximately 13.5x running speed, consistent with an outer race defect. SDT's recommendation was to closely monitor the condition of the main bearing. The defect will eventually result in the main bearing needing to be replaced.

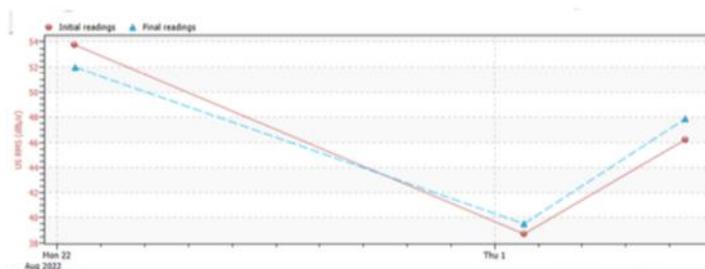
Drive End – September 5

As seen above, lubricating the drive-end bearing increased friction, indicating over-lubrication or a suspected bearing failure. Lubricating the non-drive-end bearing drastically reduced friction indicates a lubrication success. However, the LUBExpert still issued a suspected bearing failure warning on the non-drive-end bearing. This additional analysis from the LUBExpert was backed up by the vibration analysis performed by Khaled, which indicated mechanical looseness, as seen in the harmonics of the impacts in the vibration spectra below.

Since switching to the ultrasonic condition-based method for greasing their bearings, Torki and his fellow lubrication technicians noticed a steep decline in grease consumed. Where it used to be 50 grams every two weeks for both the drive-end & non-drive-end bearings, it dropped to 16 grams for the drive-end and 14.4 grams for the non-drive-end during the most recent successful lubrication task, which can be seen in the following two figures.

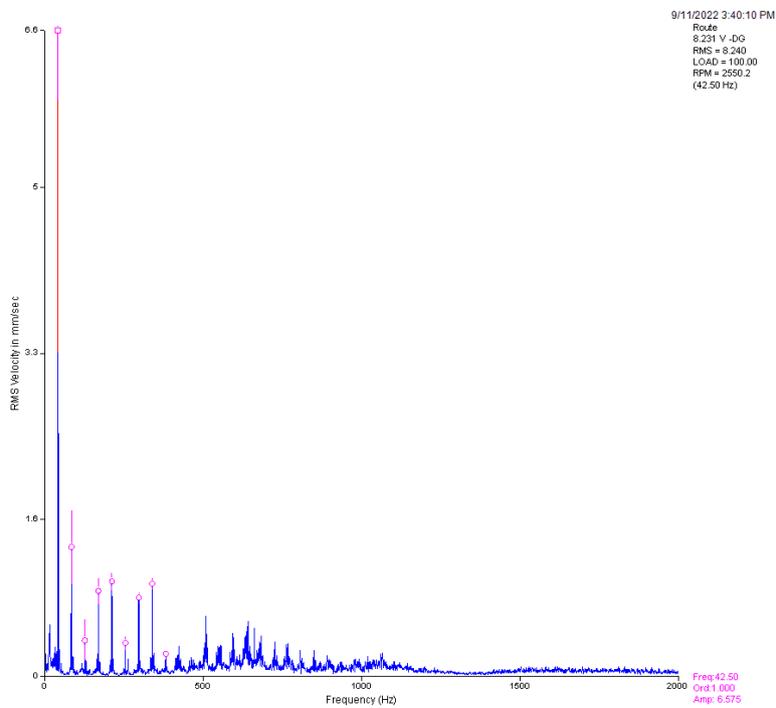
Vibration Spectra – September 11

As seen in the vibration data, the bearings were in a failed state due to mechanical looseness and required replacement. They were replaced during the next shutdown, and new vibration measurements were taken on the machine. As seen below, the overall RMS went from 8.2 to 2.7 after the bearings were replaced.

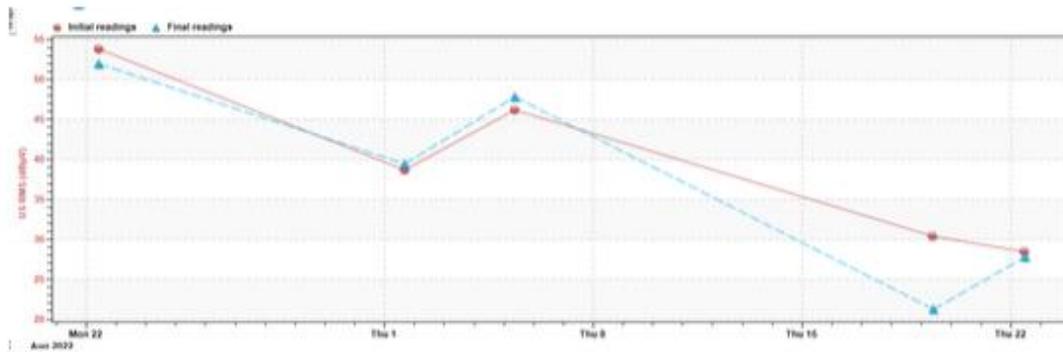
Drive-End – September 22

After the bearings were installed on September 18, they were lubricated successfully 4 days later on September 22 using the LUBExpert Static. The data can be seen below!
